24th COBEM - 2017

COBEM-2017-1440

**VORTEX-INDUCED CRACKS ON STAY VANES OF A FRANCIS
TURBINE: AN APPLICATION OF EXPERIMENTAL AND NUMERICAL
ANALYSIS**

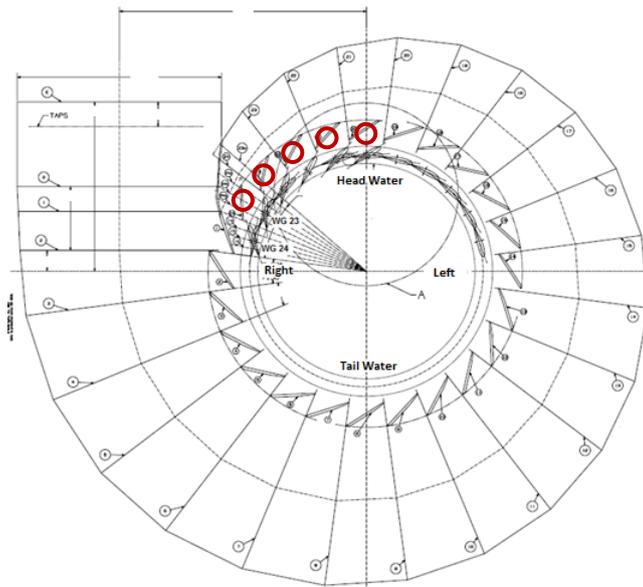
The Power Unit (PU) studied is a 105MW, 73m head Francis turbine which has records of cracks on the stay vanes since 1974 (Gummer and Hensman, 1992). The stay ring is composed by 24 vanes that can be divided into four geometry groups being group 1 (vanes 1 to 7), group 2 (vanes 8 to 13), group 3 (vanes 14 to 19) and group 4 (vanes 20 to 24). A top view of the stay ring is shown on Fig. 1 with the red circles identifying the vanes from group 4 which have a history of cracks occurrence.

Figure 1. Stay ring top view. Red circles highlight vanes from group 4.

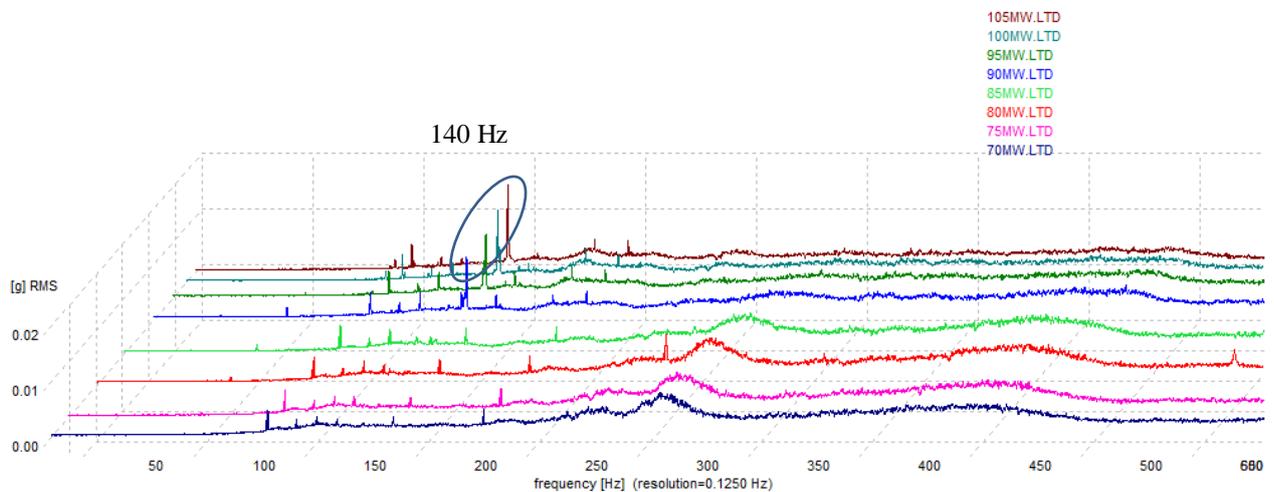
Despite being an indirect vibration measure, it was able to identify a characteristic peak frequency of 140 Hz rising at, approximately, 80% of the output until the maximum power available at the moment of the tests, as shown at Fig. 4. This indicated that the first torsional mode of the stay vane which corresponds to the 2nd natural frequency was being excited by the flow.

Figure 4. FFT as a function of the turbine output for original vane profile. Sensor installed at the stay ring.

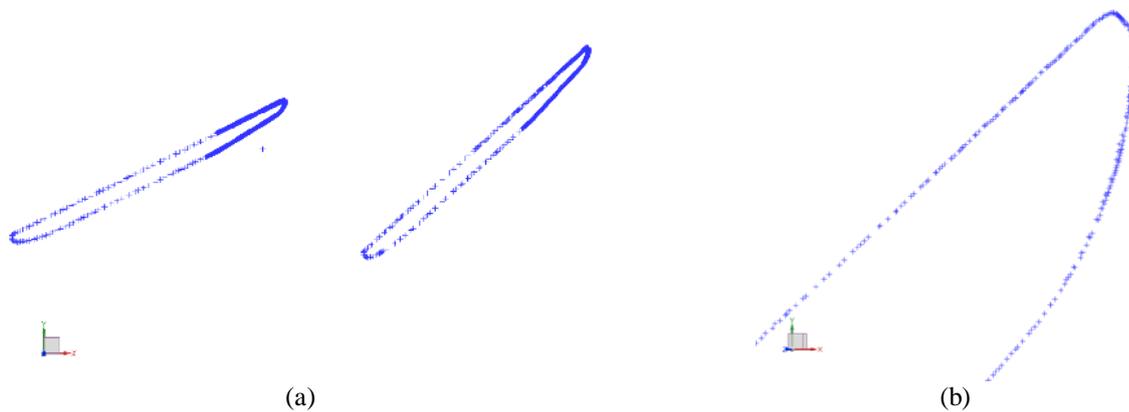
A third step to characterize the vibrational behaviour of the stay vane was to perform a transient Computational Fluid Dynamic (CFD) simulation to reproduce the flow around the stay vane. Based on the cracks occurrence history, the geometry of stay vanes 22 and 23 were measured at site using a three-dimensional technique and vane 23 was used as the model for the numerical flow simulation with commercial software CFX®16. Figure 5 presents the measured geometry emphasizing the trailing edge.

Figure 5. Three-dimensional geometry measurements: (a) Vanes 22 and 23 profiles and (b) vane 23 trailing edge.

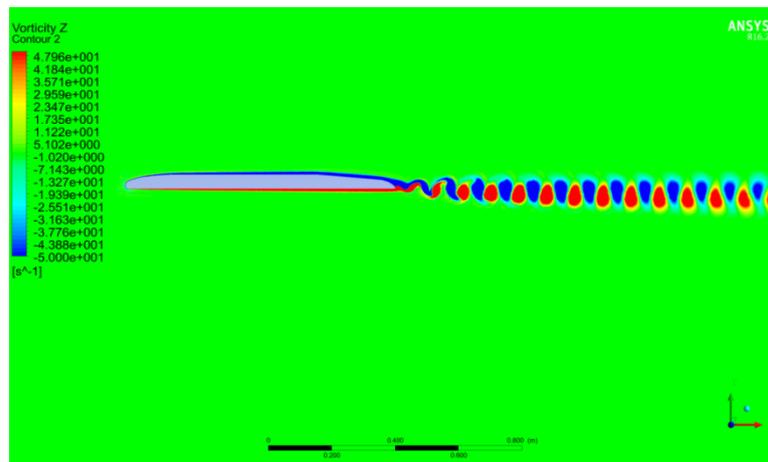
CFD simulation of the selected stay vane was performed based on the Finite Volume Method and using $k-\omega$ SST as the turbulence model, it revealed that a periodical vortex shedding develops at the trailing edge of the stay vane, as shown in Fig. 6, with a vortex emission frequency of 122 Hz. The presence of a vortex shedding leads to an oscillating force with a frequency close to the second natural frequency of the stay vane, implying on higher dynamic stresses that may lead to nucleation and propagation of cracks.

Figure 6. Vortex shedding at the trailing edge of the stay vane.

Therefore, a geometrical modification, based on Voith Hydro's know-how, was proposed to eliminate the vortex shedding. The modification was designed to change as minimum as possible the original profile.

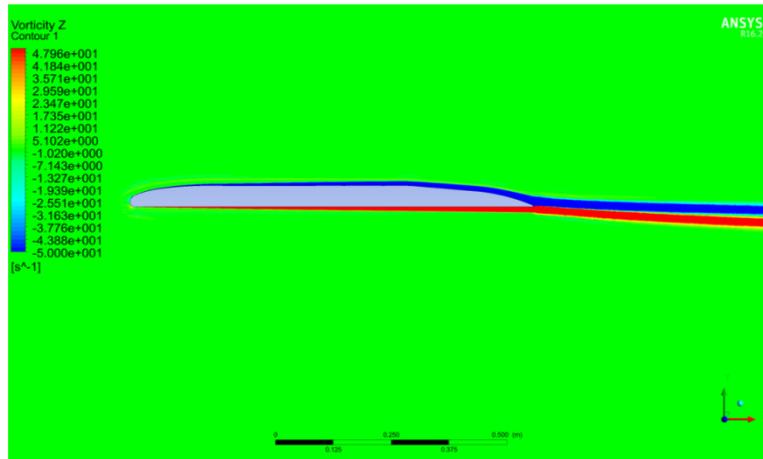
A new CFD analysis was performed with the modified profile using the same boundary conditions of the previous simulation. Results shown that the new geometry indeed eliminated the vortex shedding at the trailing edge, as can be seen on Fig. 7.

Figure 7. Simulation results of the modified profile.

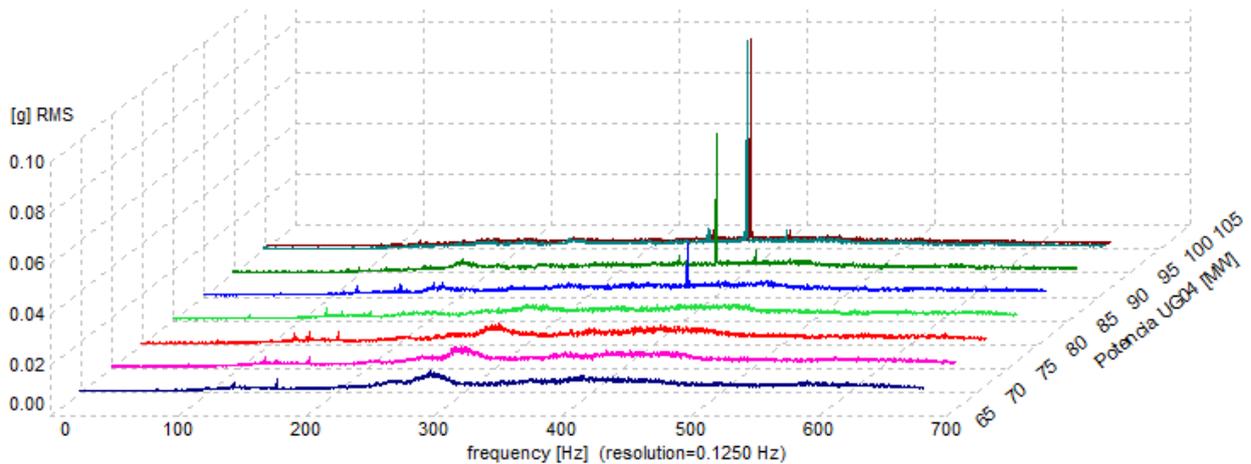
Figure 8. FFT as a function of turbine output for changed vane profile. Sensor installed at the stay ring.

Comparing Fig. 8 with Fig. 4 it is possible to notice that the characteristic peaks identified on the first measurements at approximately 140 Hz no longer exist indicating that the geometry modification proposed was able to eliminate the excitation of the first torsional mode.

However, another resonant behavior can be identified at a frequency of approximately 375 Hz. The very nature of the indirect measurement does not allow the conclusion that this resonance is actually related to the stay vanes, since the position of the sensor permits the measurement of many other components vibration. Furthermore, there is no record of modes other than the first bending or first torsional being excited at stay vanes (Gissoni, 2005) and this same study also demonstrated that stress amplitudes decrease as the order of the excited mode increases, thus reducing the chance of cracks propagation.

After the trailing edge geometry of stay vanes 20 to 24 were changed, a new measuring campaign following the same settings as the measurements prior to the modification was performed at PU04 on April 2017. The results are shown at Fig. 8.
