25th ABCM International Congress of Mechanical Engineering
October 20-25, 2019, Uberlândia, MG, Brazil

COB-2019-0325

FAILURE ANALYSIS OF A COIL SPRING APPLIED IN THE REAR SUSPENSION OF A CITY VEHICLE

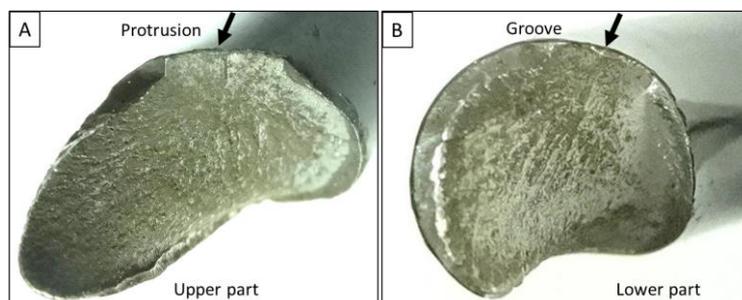
Both fracture surfaces generated from the spring failure were analyzed, being labeled as upper end fracture surface, attached to the fragment with smaller diameter (Figure 1A), and of the lower end, attached to the remaining coils of the spring (Figure 1B). In the fracture origin, complementary geometries were observed: the upper end surface presented a protrusion and the lower end surface, a groove.

Figure 1. Fracture surfaces generated after the complete rupture of the coil spring.

From the defect found, ratchet marks were observed, indicating the initiation of a fatigue process. After the fatigue propagation zone, there were radial marks, which indicate fast crack propagation. The edges presented a sharp and shiny appearance, characteristic of the final fracture zone (shear lips).

The fatigue origin occurred in the upper region of the cross section of the spring wire, a fact that does not correspond to the region of higher active stresses, considering that the combined loads of torsion and bending should generate a peak combined stress in the inner part of the wire cross section (PRAWOTO, 2008). The fracture was completed in a plane located at approximately 45° with respect to the length of the spring wire, a typical characteristic of fractures caused primarily by torsion loads in materials with high hardness and low tenacity (brittle torsional fracture).

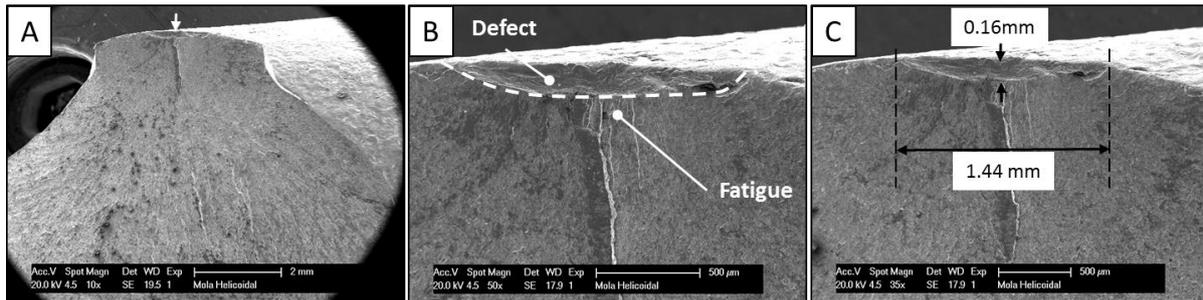
The Scanning Electron Microscope (SEM) inspection showed a smooth surface with no fracture mechanisms in the fracture origin, indicating a lack of cohesion of the material before the fracture, that is, a manufacturing defect (Figures 2A and 2B).. Starting from the surface defect found, there was the development of ratchet marks, characteristic of fatigue (Figure 2B). The micromechanism found in the region was striation, also representative of fatigue. The defect was 1.44 mm wide and 0.16 mm deep, as shown in Fig. 2C.

Figure 2. Fracture origin: (A) general view, (B) surface defect found at the fracture origin, (C) surface defect dimensions.

After gathering the aforementioned evidence, it was possible to backtrack on the origin of the defect, the radial forging process used to reduce the diameter of one end of the spring wire. There was a fracture in one of the forging hammers, which left the helical pattern marks, found only in the region of diameter reduction. The determination of the root cause associated with the radial forging process can then be used as a foundation to guide improvements in the manufacturing process, which can reduce the incidence of this failure mode.

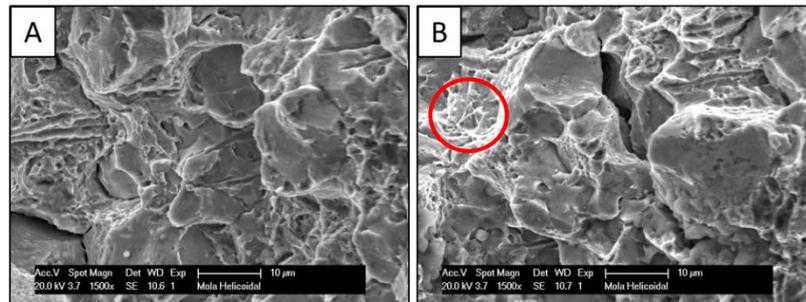
After the fatigue zone, a mixed mechanism of brittle intergranular fracture and dimples (microvoids) was observed, which is an evidence of an accelerated crack propagation in tempered steels with high hardness, such as the SAE 9254 steel alloy used in the coil spring (Figure 3).

Figure 3. Mixed fracture mechanism of brittle intergranular and dimples.

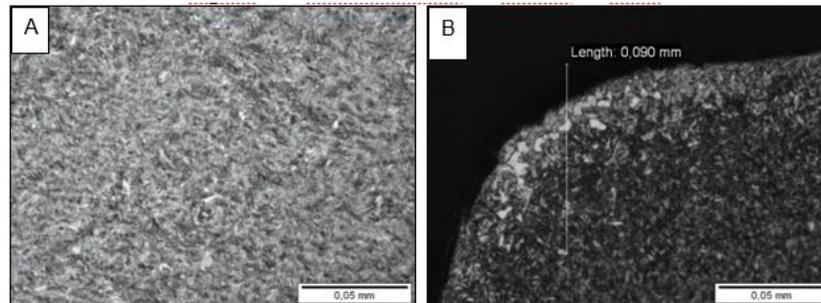
In the metallographic assessment, a martensite microstructure was identified in the spring core, as prescribed in the coil spring design (Figure 4A). The fracture origin was cross-sectioned, where the presence of partial decarburization was identified up to a depth of 0.09 mm (Figure 4B). This evidence indicates that there was an unacceptable material defect at the fracture origin. Cross-sections were also made in the surface marks, which formed a helical pattern along the spring wire, and, similarly, partial decarburization was found inside these defects. Those features, both at the beginning of the fracture and inside the superficial defects, suggest that the fracture started at one of these defects. In addition, the existence of decarburization within these defects indicates that they were already present in the part prior to the heat treatment.

Figure 4. Coil spring metallography: (A) core and (B) fracture origin
