25th ABCM International Congress of Mechanical Engineering
October 20-25, 2019, Uberlândia, MG, Brazil

COB-2019-0983

FAILURE ANALYSIS BY NUMERICAL SIMULATION OF A CRANKSHAFT MODEL MWM 229

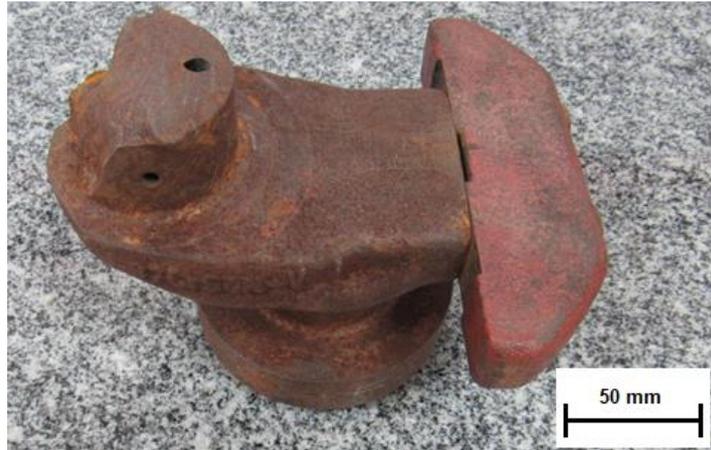
Figure 2 below shows the fracture surface as received. There was a need for superficial pickling for deeper cleansing with nitric acid.

Figure 2. Representation of the fracture surface received for analysis. Source: Authors (2019)

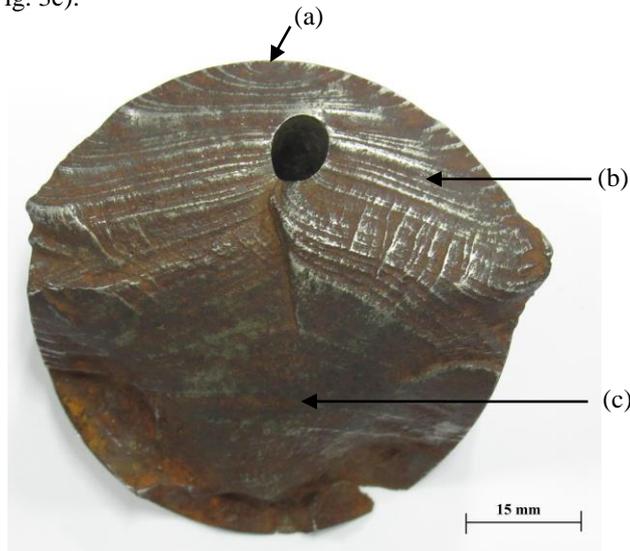
Figure 3 presents the fracture surface after cleaning treatment with nitric acid. We see through this macrography the presence of nucleation punctual (Fig. 3a), followed by beach marks observed by fatigue stretch marks until the internal middle of the crankshaft (Fig 3b). The presence of fibrous surface on the bottom is marked by catastrophic failure by not supporting external effort (Fig. 3c).

Figure 3. Representation of the fracture surface of the crankshaft in analysis. We can observe perfectly the three zones: nucleation in (a), propagation in (b) and final fracture in (c). Source: Authors (2019)

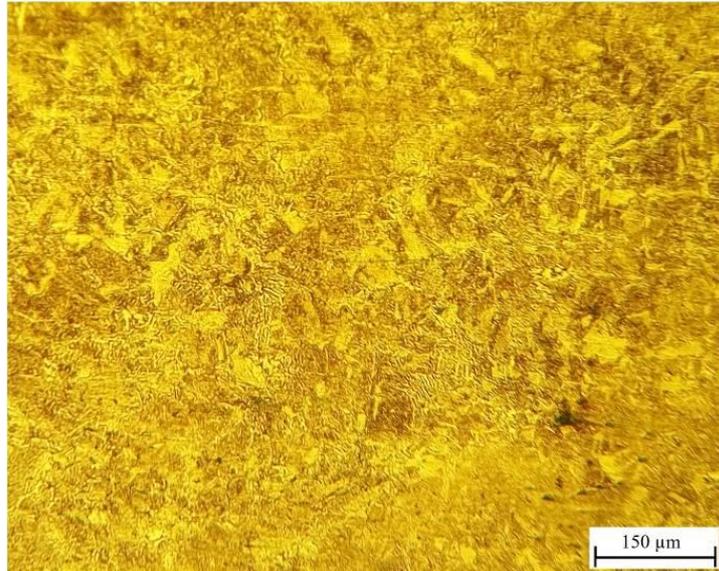
The crankshaft microstructure observed in Fig. 4 is characteristic of a perlitic steel of medium hardness. We observed the presence of ferrite and perlite in the entire microstructure. The crankshaft microstructure observed is characteristic of a AISI 5135 Steel.

Figure 4. Crankshaft metallography. It was observed region of pearlite and ferrite characteristic of medium carbon steel.

The analyzed crankshaft has a microhardness of 230 HV. This hardness is characteristic of a steel-chromium AISI 5135, commonly used for manufacture of forged crankshaft.

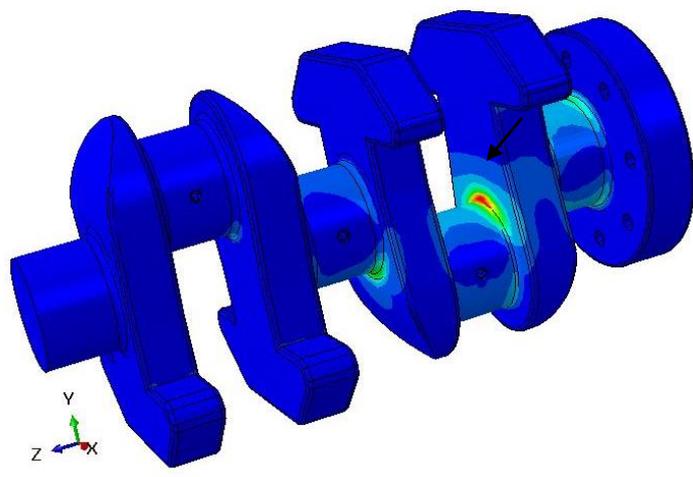
The numerical simulation analyses were able to observe that the highest tension concentrations during the simulation of the crankshaft is at the base of the concordance radius precisely where the nucleation started.

The numerical simulation showed that probably an imbalance of the crankshaft caused a roto-flexion during use and caused the tension concentrations at the nucleation point of the failure to overcome the fatigue limit for the AISI 5135 steel.

Figure 5 presents a study of the stress concentration regions that coincides exactly with the failure of this component. A small rounding radius presented by the arrow shows a stress concentration that caused premature failure of the component in service. A possible imbalance must have caused the acceleration of this failure.

Figure 5. Numerical simulation of the crankshaft. The reddish areas present higher stress concentrations.

Therefore, through the analyses presented it was possible to observe that the failure occurred due to an imbalance submitted to roto-flexion, concentrating punctual stress above the fatigue limit of the AISI 5135 Steel.
