25<sup>th</sup> ABCM International Congress of Mechanical Engineering  
October 20-25, 2019, Uberlândia, MG, Brazil

## COB-2019-0275

# FATIGUE FRACTURE ANALYSIS IN DRIVE SHAFTS OF CHIPPING AND REFINING MACHINES IN A CELLULOSE PULP AND PAPER PLANT

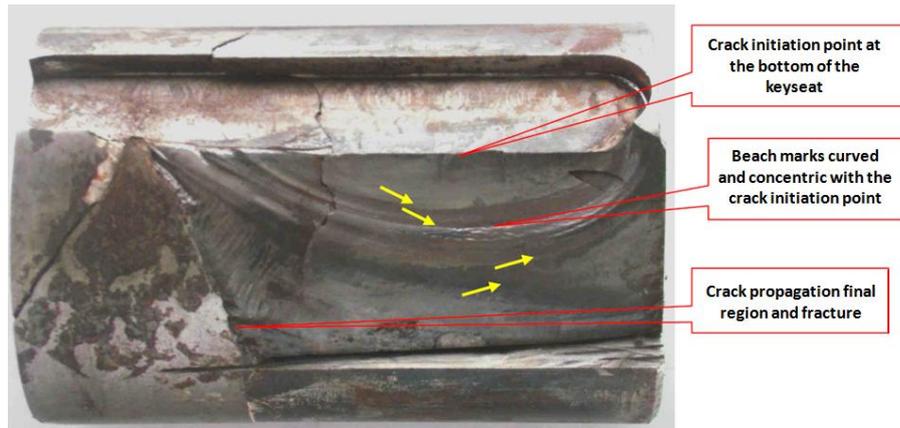
Figure 2. Shaft fracture surface

Figure 2 presents the fracture general aspect. Crack initiation is located at the bottom of the keyseat with “beach marks” in curved shape and partially concentric to crack initiation point. The region near the line of the keyseat bottom reflects more intensively the light. The region opposed to the keyseat indicated as crack propagation final region presents a bright surface marking a brittle fracture as a result of unstable crack propagation.

The refiner shaft failure was due to crack nucleation and propagation related to torsion mechanical loads the equipment is subjected during operation. The structural deterioration initiated at a region of stress concentration that is the edge of the keyseat. Once initiated the crack, the failure followed the stages characteristic to fatigue mechanism.

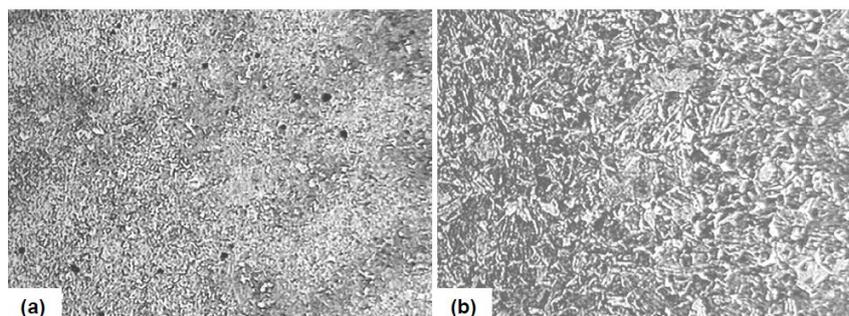
Figure 3. Microstructure of tempered martensite matrix (a) Nital 2%, 100x (b) Nital 2%, 400x

A surface for metallographic analysis was selected in the area of crack nucleation. A sample was taken, prepared and etched (Nital 2%) for microscopic investigation. Figure 3 presents the microstructure constituted of tempered martensite matrix.

From the microscopic investigation of the failure surface it is possible to confirm the fatigue as the main mechanism leading to crack nucleation and stable growth. The fracture surface has a mainly flat surface without plastic deformation in the load direction, that is, at the torque direction to rotate de shaft, and presents beach marks. It also presents a region of transition from stable to unstable crack growth and the final fracture with typical characteristics of brittle fracture.

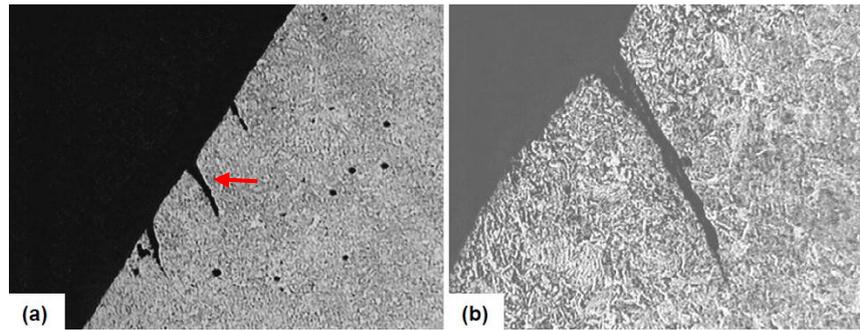
Figure 4. Micro cracks nucleating at the bottom edge of the key seat and a detail from the indicated transgranular crack  
 (a) Nital 2%, 100x (b) Nital 2%, 400x

Figure 4 presents a micrographic image from a region at the bottom of the keyseat with nucleation of micro cracks. These cracks are nucleating in a high stress concentration point of the shaft at stage I of fatigue cracking as indicated at Fig. 5.

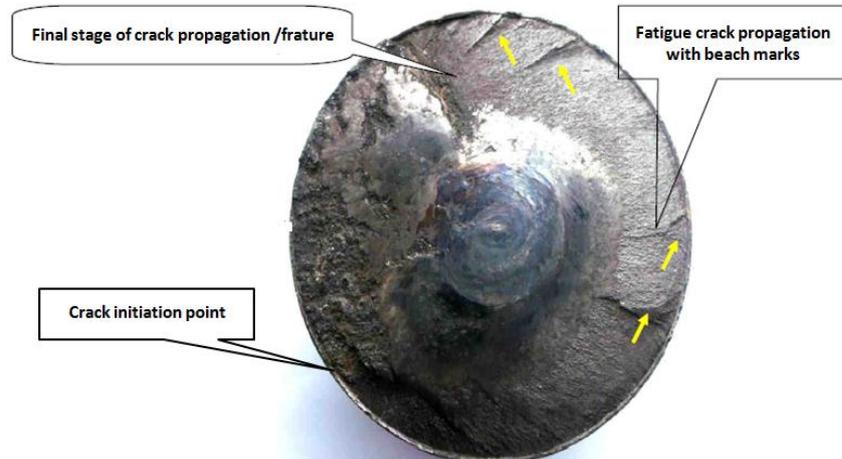
Figure 7. Shaft fracture surface

Figure 7 presents the fracture general aspect. Crack initiation is located at the interface of the shaft base material with the thin layer of coating. The region of crack propagation reflects more intensely the light. The surface presents “beach marks” around the shaft axis with direction opposite to the shaft rotation.

The region around the shaft center presents a smoother surface due to rubbing contact between the two parts of the shaft after the fracture. Pulley side section was decelerating and the motor side section was still rotating with drive rotation.

Through surface macro analysis taking into account light reflectiveness and apparent roughness it is possible to identify the crack initiation point, the region where the crack propagated in a stable way, the crack propagation final region and the brittle like final fracture.

Similar characteristics could be observed at the wood chipper shaft where a crack nucleated at the surface in a stress concentration point followed by a stable growth and ultimately a catastrophic failure. The investigation of the failure surface suggests that the root cause was fatigue with crack nucleation at a point of discontinuity at the shaft surface.

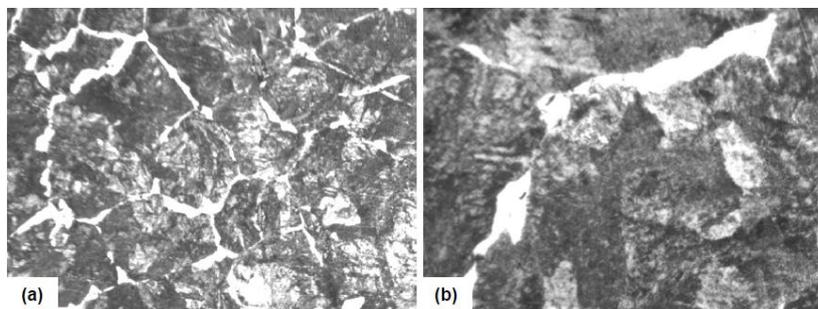
Figure 8. microstructure of pearlitic matrix with grain boundary ferrite (a) Nital 2%, 100x (b) Nital 2%, 400x

A surface of a region near the crack initiation point was metallographically prepared, etched with Nital 2% and analysed in optical microscope. Microstructure is a pearlitic matrix with ferrite in grain boundaries as shown in Fig. 8. Based on ASTM E112 the grains size is 3.

The observed microstructure is in accordance to the expected since the shaft was manufactured from a rolled round bar. According to Silva (2012), the rolling process in metal forming requires the component to be plastically deformed in one or more operations to near the net shape dimensions in order to reduce metal removal requirements resulting in significant material and energy savings during manufacturing.
