25th ABCM International Congress of Mechanical Engineering
October 20-25, 2019, Uberlândia, MG, Brazil

FAILURE ANALYSIS OF A TRUCK SHAFT

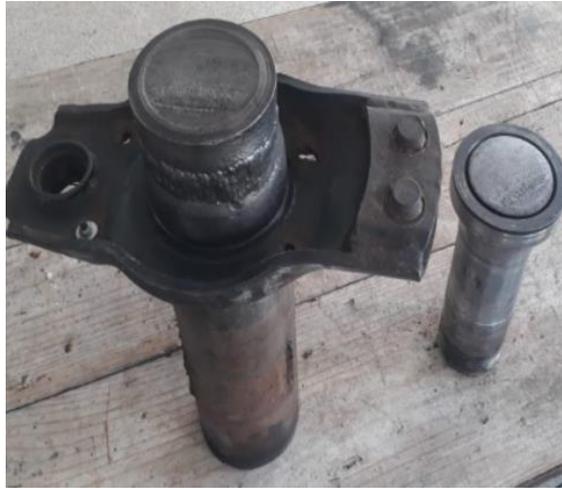
The material analyzed is an axle of the semitrailer used for tritrem forest cargo transport. Figure 1 shows the axis as received for analysis.

Figure 1. Semi-trailer axle used to transport forest cargo tritrem. Source: Authors.

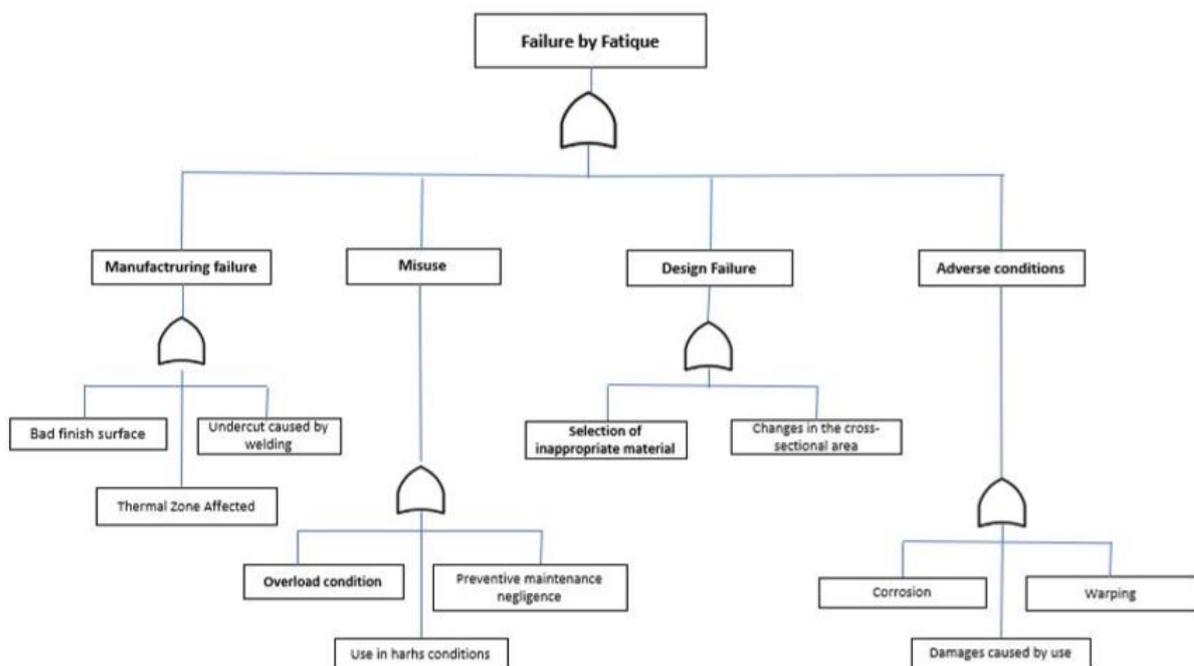
In the figure below the FTA of the studied equipment is presented, it was verified during its study that faults such as; Poor surface finish, welding bites, presence of a thermally affected zone, presence of corrosion, presence of stress concentrators live corners, were detected and may have been fundamental for crack nucleation and propagation through the fatigue mechanism.

Figure 4. Fault tree analysis of truck shaft. Source: Authors.

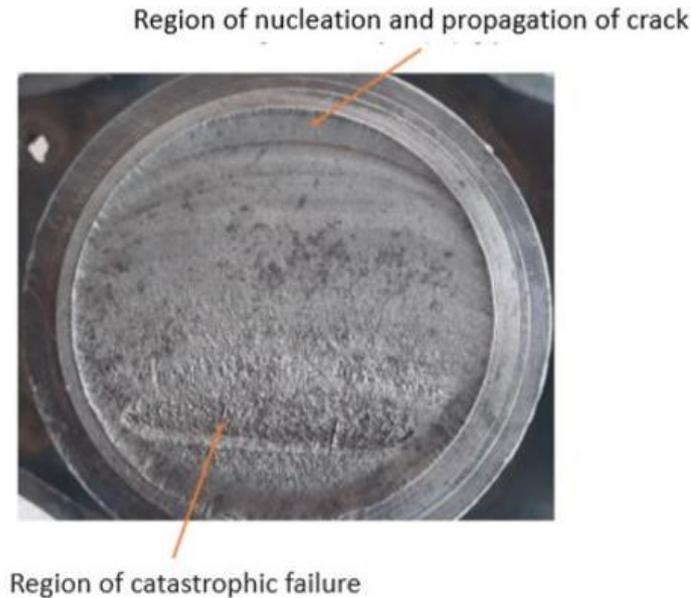
When analyzing the axis in question it is noticeable that there was no care for the part to have a good surface finish, a crucial aspect for elements that are subject to cyclic stresses, since generally the maximum tension in a mechanical component is found on its surface. Therefore in most cases of mechanical failure by the fatigue mechanism, crack nucleation occurs on the surface of the component, poor surface finish can work as a voltage amplifier. Another stress concentrator that changes the life in fatigue is the presence of live corner in the axis when its section is reduced, in a good design the reduction of section would have the incorporation of a sweetening rounded so that there are no corners. The Figure 5 shows the fault region in the cross section of the axis, and the propagation of cracks, also called "beach markings", can be observed.

Figure 5. Surface of the fault. Source: Authors.

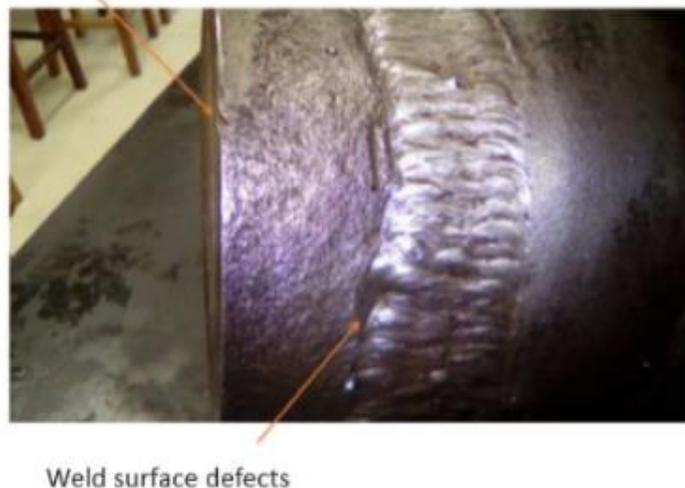
Surface defects

The axis studied has already undergone the process of welding which originated undercuts, common defect in the welding process, the causes of undercut could be, when the voltage is very high, if use the wrong electrode or if the angle of the electrode is wrong or high electrode speed is also one of the reasons for this defect. The figure bellow shows undercutting defect around the weld. Peres (2008) says that these types of notches cause a non-uniform distribution of the stresses along the part with a tension in the region near the notch larger than the average tension in the more distant regions, then acting as a tension lift or tension concentrator. If a gradient of tension is formed on the notch surface, this gradient plays a key role in the crack initiation process.

Figure 6. Defects in the surface of the weld and in the machined surface. Source: Authors.

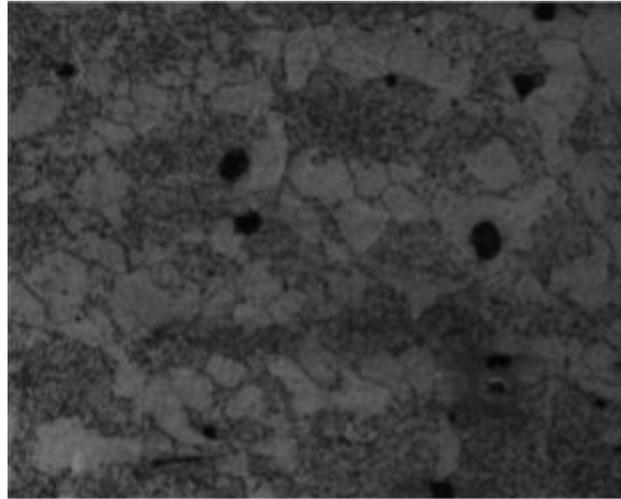
In addition to surface defects, the welding process creates a heat affected zone (HAZ), a zone that had its micro-structure altered by the heat produced by the welding process, so the mechanical properties in this zone have been altered and may be a factor that facilitates nucleation of cracks. According to Gouveia (2013), welded structures have lower behavior than the base metal, because the welding process determines deep microstructural changes, making them harder and fragile, since the reduction in austenite content occurs, as well as the formation of defects, such as porosity and inclusions. In the figure below are dark spots that may be inclusions, future studies will be done and confirmed.

Figure 7. Micrograph showing inclusions from the welding process. Source: Authors.

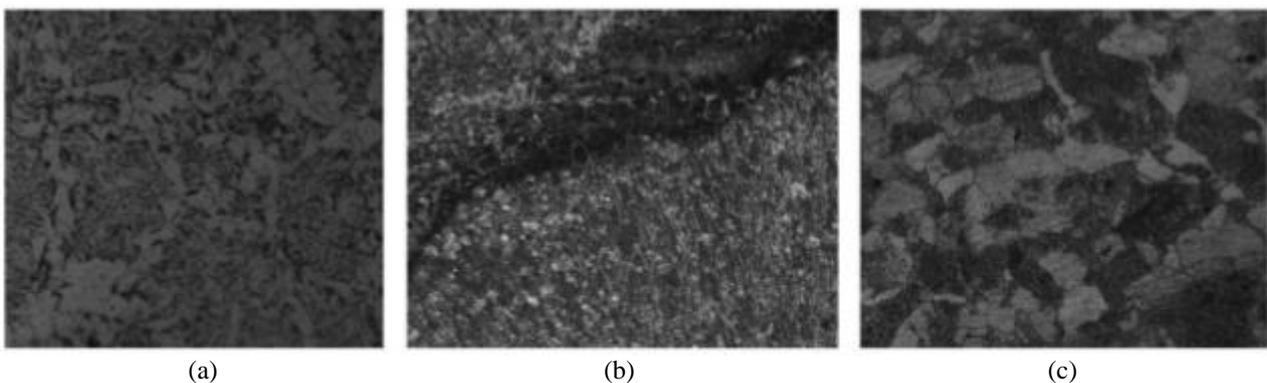
The Figure 8 shows the images obtained in the micrograph of the three regions examined in the weld, with a magnification of 500x. Figure 8(a) shows the part of the melting zone constituted by the metal addition, it is observed grain boundary ferrite (proeutetoid), and inside the acicular ferrite grains, this result is in agreement with D'Avila et al. 2016. In 8(b) presents a zone affected by heat and constituted of base metal, grains transformed with ferrite proeutetoid and zone metastable with martensite and bainite. In this image, it is possible to observe these tree distinct regions of the thermally affected zone. Already in 8(c) represents the stable phases, ferrite and perlite observed in base metal.

Figure 8. Micrograph taken along the test piece. Source: Authors.

With the hardness test it was possible to quantify the hardness difference along the body by the change of microstructure, zone 8(a) had a hardness of 75 0.5 HRB, zone 8(b) 53 0.5 HRB and zone 8(c) with 45 0.5 HRB. Therefore, the weld function as a weak element of the element.
