25th ABCM International Congress of Mechanical Engineering
October 20-25, 2019, Uberlândia, MG, Brazil.

COB2019-2286 PHYSICAL ANALYSIS AND CHARACTERIZATION OF A RAIL *SQUAT* DEFECT

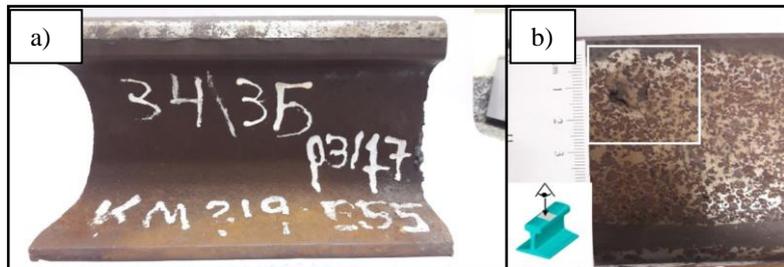
Fig.4 shows the rail that has the defect to be characterized. The image shows oxidation marks that mask the surface aspect of it. A horizontal cut was made at the top of the railhead at about 10 mm depth to obtain the defect sample to be characterized as outlined in Fig.5a. The sample was washed and dried to remove the oxidized layer. Fig.5b illustrates the cuts in the washed part that were made to obtain longitudinal and transverse cross-sections.

Figure 4. a) Longitudinal cross-section over rail section. b) Top view. The presence of oxidation on the material surface is noteworthy. Source: From the survey.

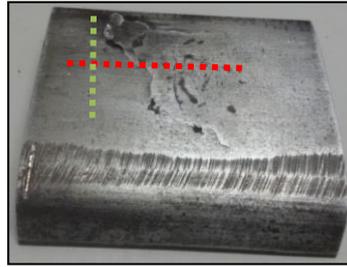
Figure 8. Sample cut and cleaned. Appearance of cracks crossing the full length of the running surface. The dashed red line corresponds to the section in Fig.9 and the dashed green line corresponds to the section in Fig.11. Source: From the survey.

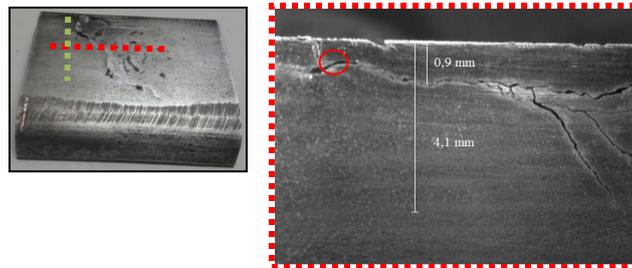
The macrofractography of the longitudinal cross-section (Fig.9) shows the crack propagating subsurface about 0.9 mm deep, then branching until its branches reach about 4.1 mm deep. This crack is dangerous since it propagates in the transverse plane of the rail and its uncontrolled growth can cause the transverse fracture of the component.

Importantly, authors such as Kaewunruen and Ishida (2015) and Deng et al. (2018), investigating the evolution of squats and associating with grinding, in their work showed that the applied grinding removed about 1.0 mm depth of material, which does not guarantee the removal of deeper squats. In this case, this remaining 3.1mm branched crack would continue to grow within the rail.

Figure 9. Cracks propagating in subsurface. Magnification: 16x. Source: From the survey.

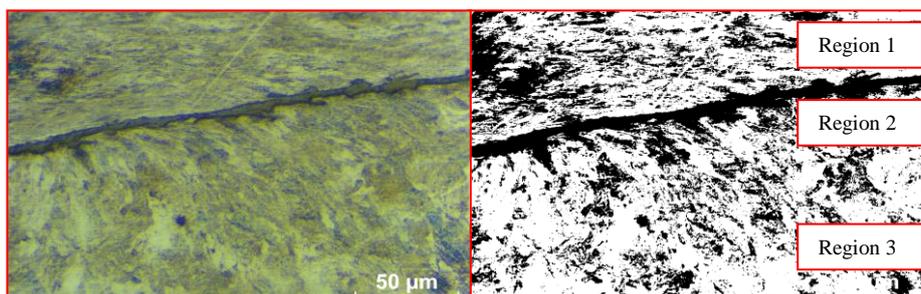
From Fig.10, which represents the 500x magnification of Fig.9 red region, it is possible to see how the microstructure presents heterogeneity close to the crack. This one can be seen in Fig.10b through dark and white effect. At the top is the most aligned microstructure (Region 1), due to ratcheting. The microstructure just below the crack is deformed following the crack propagation direction (region 2). Below is the more dispersed microstructure, justified by the non-interference of the contact (region 3).

Figure 10. Microstructural aspect of the crack highlighting three distinct regions: Region 1 with perlite lamellas alignment caused by loading, region 2 with the cracks aligned in the direction of crack propagation and region 3 without visible deformation. 500x magnification. Source: from the survey.

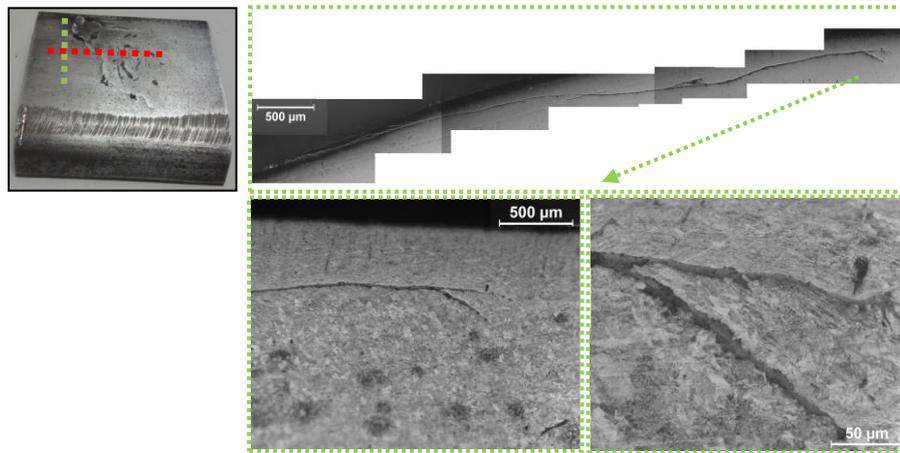
It was observed in the field corner through transverse cross-section an isolated crack propagating in the subsurface. Comparing with the literature, this crack is associated with the head check defect. It starts at the edge and penetrates the material until it branches (Fig.11).

Figure 11. Crack propagation and magnification in or near the crack tip region. Magnification: 200x and 500x. Source: From the survey.

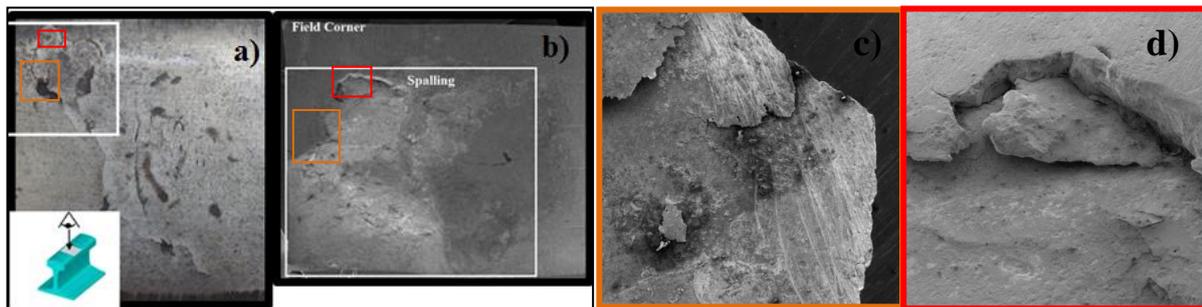
In order to observe the defect using SEM, the sample was washed and cleaned ultrasonically. The material above the defect (peel) was broken off to check internally (Fig.12b). In the internal surface, several wear marks (peelings) were observed, which are removed from the surface after several loading cycles, as shown in Fig.12c and 12d.

Figure 12. Surface appearance a) before and b) after removal of the upper shell. c) Peelings and d) spalling of material internally to the defect. Magnification: 1200 and 500x Source: From the survey.

The cracks are similar to squat cracks as referred in literature (Steebergen, 2017). There is presence of oxidation associated with fatigue cracks. The literature highlights the influence of fluids (water and oil) entrapped internally in the cracks, which justifies the presence of oxidation (Simon et al, 2012).

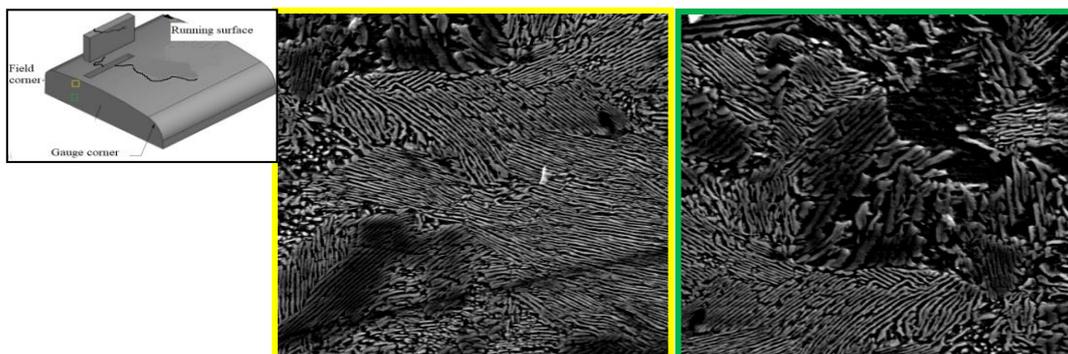
The microstructure was confirmed as pearlitic (alternating lamellae of ferrite and cementite). They were obtained in the superficial region about 1.0 mm deep and more internally about 5 mm. Fig.13 shows the difference in orientation of the lamellae, where, when approaching the surface, the lamellae become more aligned and condensed due to loading, featuring ratcheting onset or eutectoid dissociation and increasing hardness.

Figure 13. Rail pearlitic microstructure. Magnification: 2700x. Source: From the survey.

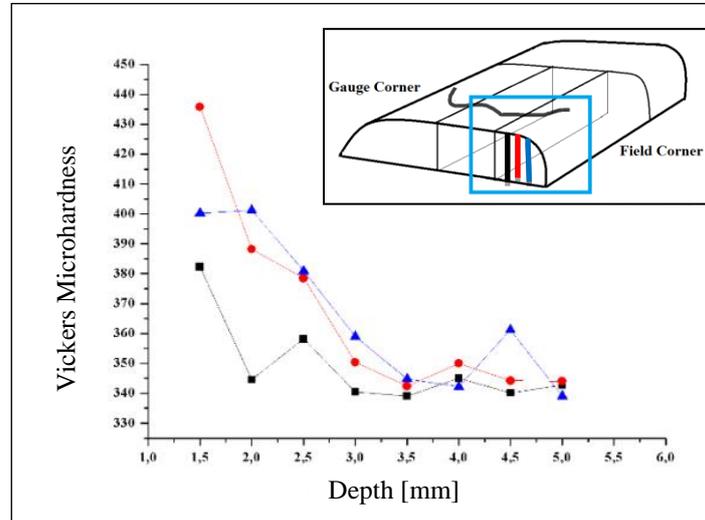
The microhardness results in the transverse cross-section allowed us to observe an expected characteristic. Higher microhardness values in the upper rail layers, with values between 390 and 436 HV. High values may be justified by the degree of hardening experienced by the rail surface after several loading cycles. Penetrating more and more into the rail these values decrease until about 5.0 mm deep are found about 350 HV.

Figure 14. Vickers microhardness of transverse section. Rail hardness may be significantly lower in the lower part of the rail head. Source: From the survey.
