## COB-2021-1727

# MATERIAL CHARACTERIZATION AND ANALYSIS OF CRITICAL FAILURE IN EGR COMPONENT FOR DIESEL PICKUP TRUCKS

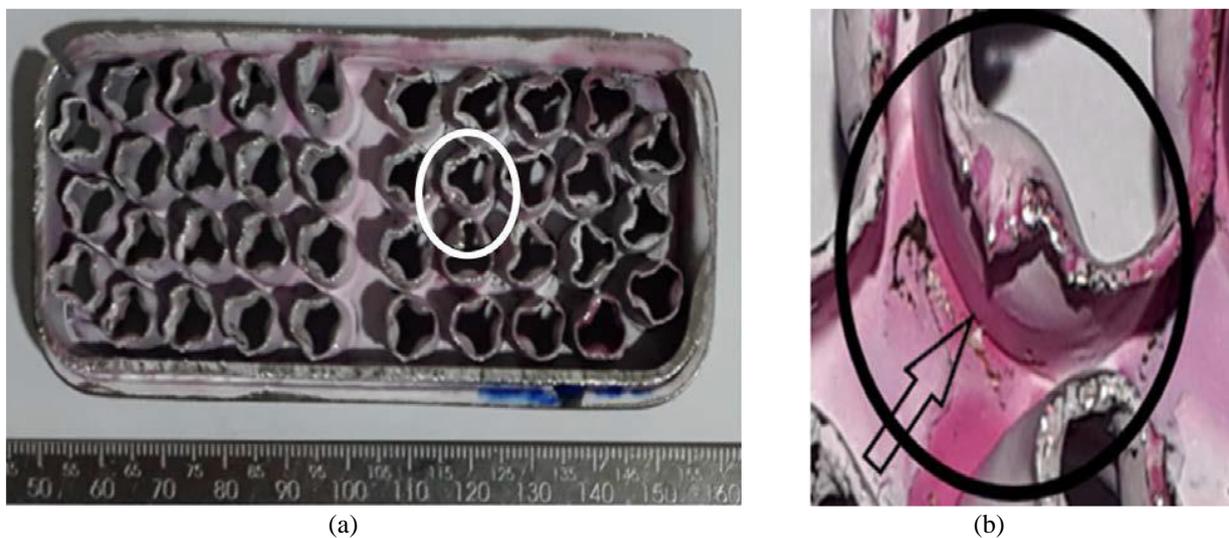
During the tightness test with water at 110 °C, considerable leaks were noticed in the radiator end plates, around the fitting of the tubes. During the fabrication of the parts, to produce a tight closure, the tubes are expanded against the holes in the mirror, preferably by boring and welding. Thus, leaks can be related to the manufacturing processes used.

The use of penetrating liquid revealed the presence of cracks in the region where the mirror fits with the tubes, exemplified by the more intense red line shown in Fig. 4b, explaining the leaks observed. In both the boring and welding operations, residual stresses are common, which favors corrosion if the medium presents favorable characteristics (Mukahiwa et. al., 2019). In fact, in vehicle cooling systems, although manufacturers recommend the addition of appropriate coolant with additives that retard corrosion, many drivers do not change the fluid regularly or use tap water, which contains considerable amounts of chlorine and aluminum, between other ions. In this sense, the possible presence of these ions together with residual stresses and typical weld defects, such as inclusions and carbide precipitation in the grain boundaries, may have led to localized corrosion and caused these types of cracks observed.

Figure 4. (a) Mirror of the EGR radiator box (part of the box with the tubes were cut transversally). (B)

- It is recommended to change the material of the tubes to an austenitic steel with higher nickel content, such as AISI 316, in order to increase the corrosion resistance of the tubes at high temperatures in the possible presence of salts and chlorine ions, aluminum, among others.

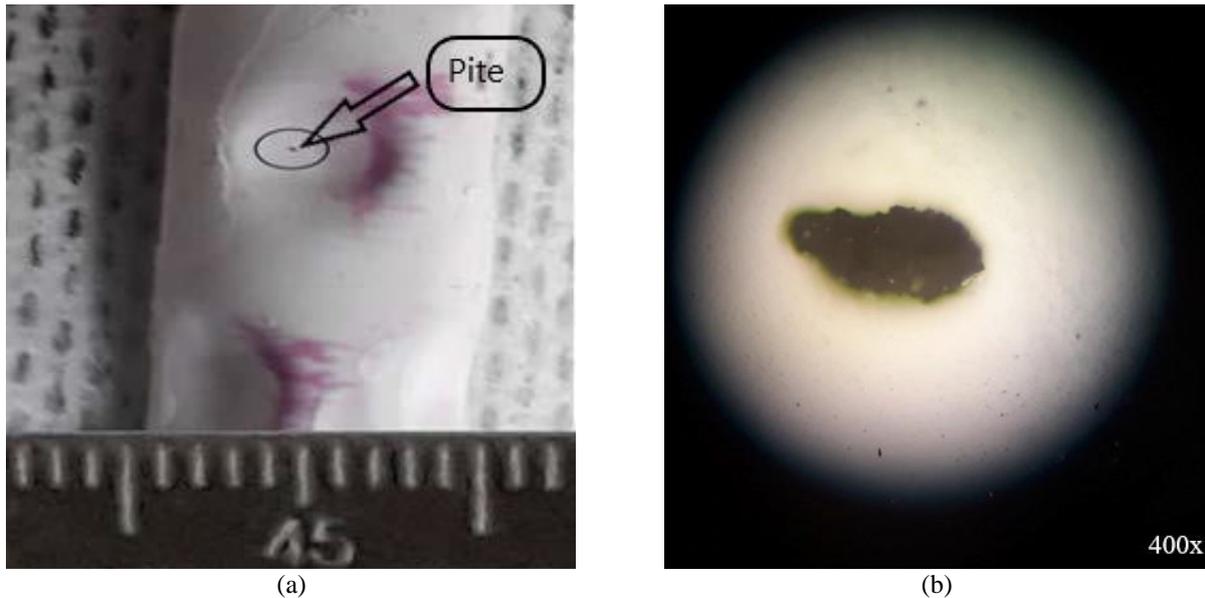
In addition, some pitting corrosion was found on the surface of the tubes, as shown in Fig. 5. This type of corrosion occurs locally and normally originates from the removal of the passivating layer, creating a galvanic cell where the point under corrosion acts as anode (Pradhan et. al., 2019). As this mechanism progresses mainly in terms of thickness, again the presence of chlorine and residual stresses, however low, can lead to the appearance of small holes in thin stainless steel plates (Zhu et. al., 2013). This process is further favored by the high temperature of the exhaust gases that circulate inside the tubes and is especially important when incrustations are present, as shown in Fig. 6. This way, the corroded material has low resistance and may be removed by coolant flow, taking off the passivating layer and exposing the bare metal to corrosion. This phenomenon is a strong indicator that the water used by the vehicle owners were contaminated in some cases, since it contains a high content of aluminum and silicon oxides that usually make up the incrustations.

Figure 5. (a) Corrosion pit revealed by penetrating liquid. (b) Microscope magnified image of the pit.

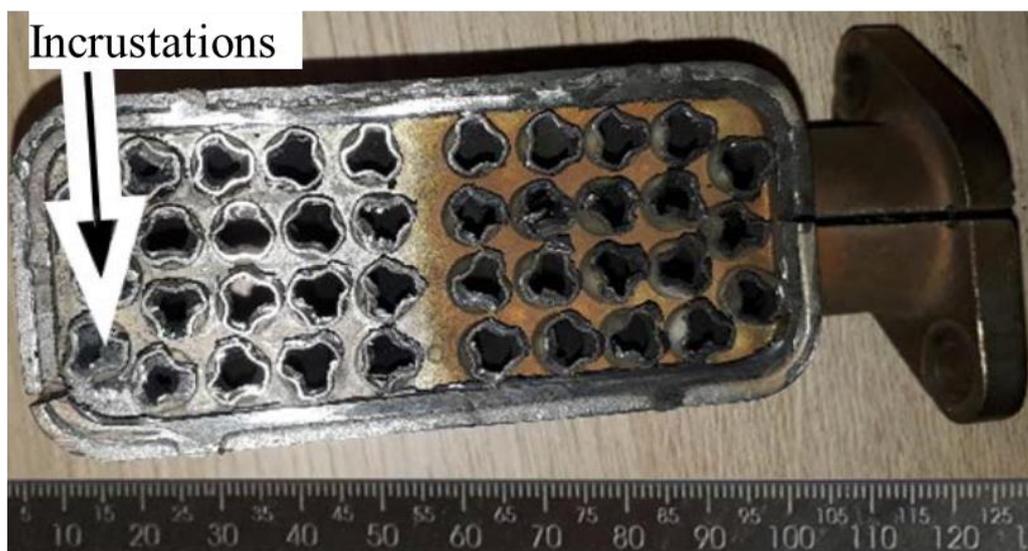
Figure 6. Incrustations formed inside the tubes of the EGR heat exchanger.

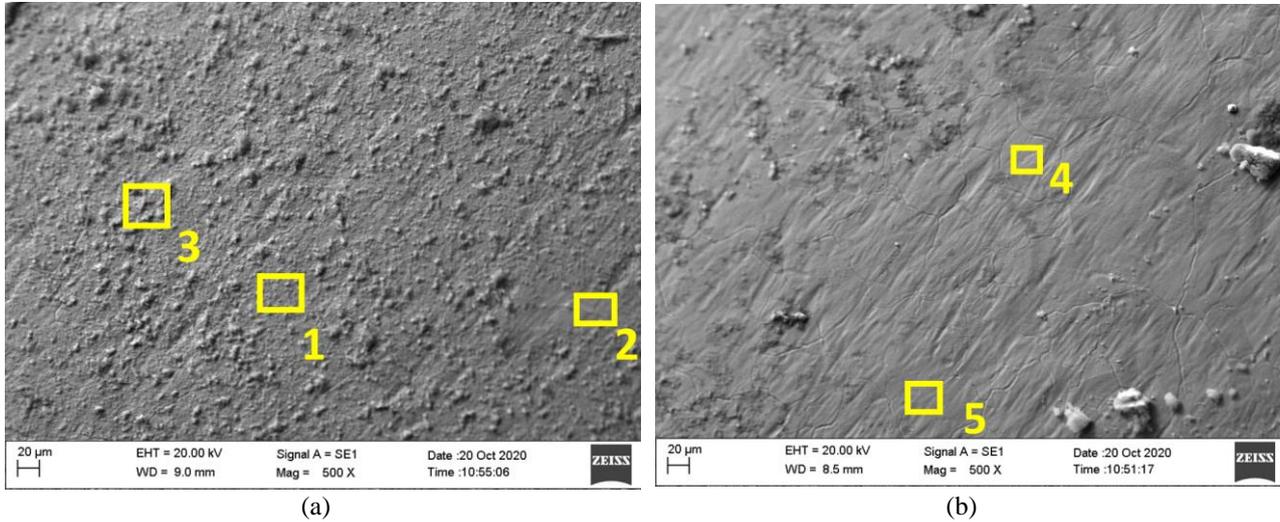
The analysis by electron microscopy of the tubes was carried out in two regions: oxidized, as shown in Fig. 7(a), and non-oxidized, shown in Fig. 7(b). Table 1 shows the respective chemical compositions of the points sampled by EDS. In the first region, high amounts of oxygen and aluminum can be seen, probably in the form of oxides adhering to the surface, which explains the visible aspect of encrusted material. These oxides form from salts dissolved in the water in the cooling system and are more common when the system is filled with tap water instead of the recommended products. In regions

with crevices and corners, such as those found in the fitting of tubes, these incrustations can lead to the phenomenon of crevice corrosion, in which the adhered material has low cohesion and can be removed by the passing fluid, taking with it chunks of the passivating layers and exposing the bare metal. This type of corrosion, very common in stainless steels with low nickel contents (Sulzer Pumps, 2010), may have been the main corrosion mechanism contributing to the cracks observed.

Figure 7. (a) SEM image of the oxidized region of the tubes and (b) non-oxidized region.

The unoxidized region, in Fig. 7b, represents the base metal of the radiator tubes, which has a chromium content around 17%, nickel above 6% and manganese below 2%. According to ASTM A240 (2020), this composition is typical of AISI 300 series austenitic stainless steels, which indicates a greater chance that the tube material is AISI 301 steel, for example, due to the lower nickel content compared to the other steels in the series; or even AISI 304 steel, which is more common and cheaper, although in this case it would have nickel below the standard required. In any case, the material characteristics for this application would not be adequate. The ASTM A632 (2019) standard recommends that in applications where corrosion resistance is required, AISI 301 steel should not be used, and that 304 should strictly meet the nickel content between 8 and 11%. Since this element hinders the occurrence of the corrosion mechanisms mentioned by increasing the stability of the passivating layer (Azuma et. al., 2004), its presence below the recommended minimum contributed to equipment failure.

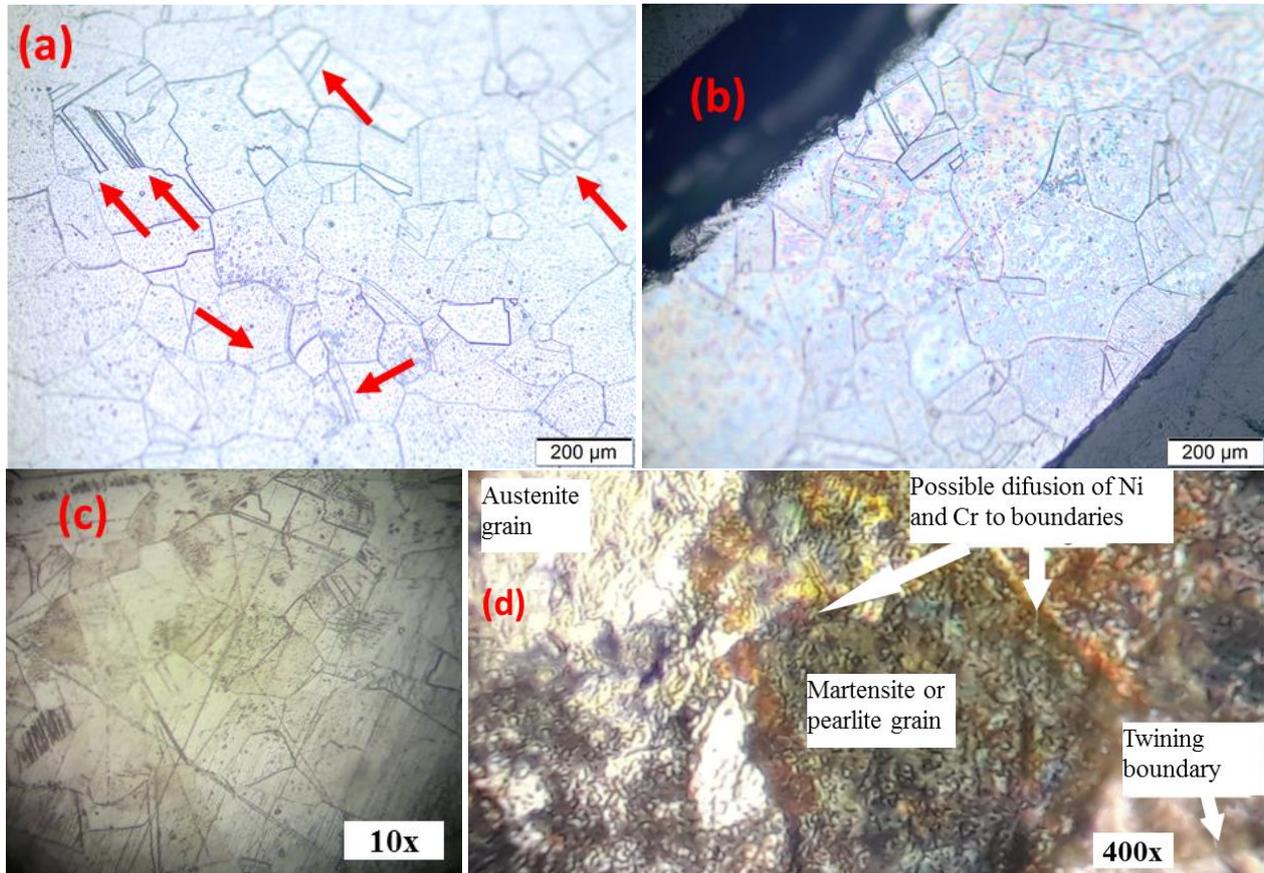
The microstructure images of the tubes are shown in Fig. 8, whereas the first two were obtained for the samples etched with  $\text{FeCl}_3$ , which reacts only at the grain boundaries and twinning regions, as pointed by the red arrows. These images show the microstructure of the tubes in their original state after lamination, for which the high strain produces more irregular and finer grains near the surface, as can be seen in Figure 8(b) at the borders of the section. In Figure 8(c), another portion of the grinded and polished sample was attacked with a mix of  $\text{HCl}$  and  $\text{HNO}_3$ , showing some textured grains typical from martensite and pearlite structures. Also, although Figure 8(d) was obtained after etching the annealed sample for 3 minutes without prior grinding or polishing, which complicated the visualization of the grains, the austenite phase could be distinguished again, since it is more homogeneously attacked by the acid and creates a more reflective surface. The twinning barriers pointed are the characteristic trait of this phase, since it only occurs in Face Centered Cubic system. On the other hand, the darker structure are a likely result of a heterogeneous attack that usually happens in lamellar structures such as pearlite and martensite.

The large size of the grains is also notable, which is a result of the annealing treatment. Although austenite is the predominant microstructure of the AISI 300 class of stainless steels, it is possible that the heat treatment also promoted diffusion of nickel and chromium to the grain boundaries, which would favor formation of the  $\alpha$  phase in the form of pearlite. Other possibility is that the sawing and opening of the tubes promoted martensite transformation at some regions from the original austenitic grains, which is a common phenomenon when the grain undergoes high mechanical stress (Smallman and Ngan, 2014). In both cases, the slow cooling process at the oven favors the diffusion of carbon out of the austenitic grains, which tends to form carbides with the alloying atoms. This phenomenon is consistent with the distinctive grain boundaries pointed in Fig. 8(d).

Figure 8. Microstructure of the internal stainless steel tubes of EGR radiator. (a) Twinning phenomenon and (b) refined grain at borders of section due to high strain in sample grinded, polished and etched with  $\text{FeCl}_3$ . (c) Textured darker grains possibly from martensite or pearlite phases in sample grinded, polished and etched with  $\text{HCl}$  and  $\text{HNO}_3$ . (d) Possible diffusion of Ni and Cr in annealed sample etched with 20 %  $\text{HCl}$  with no prior grinding nor polishing.

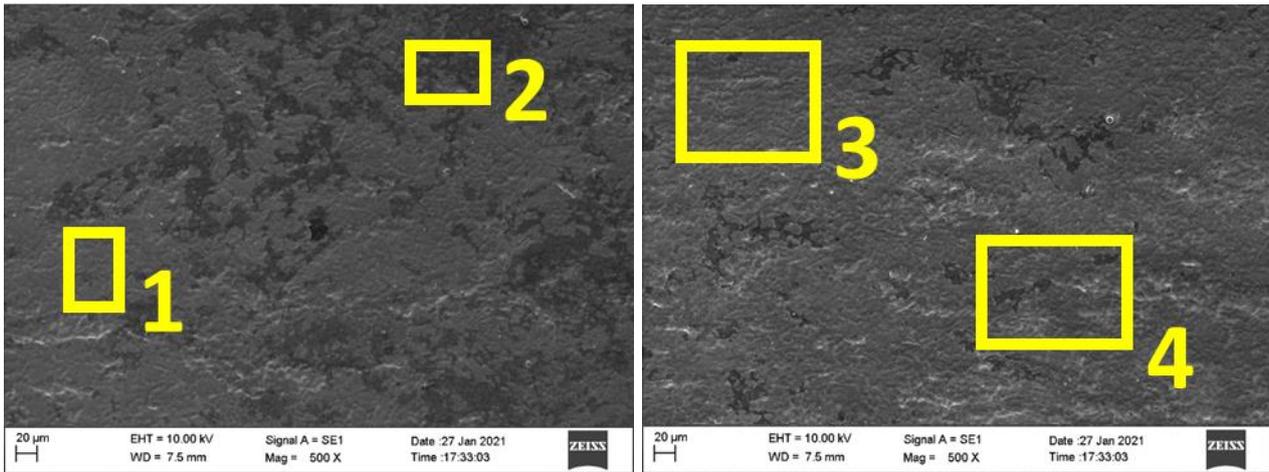
In the case of the radiator box plate, the SEM images are shown in Fig. 9, with much less oxides adhered to the surface. The chemical composition for different regions is shown in Tab. 2. It is observed that the nickel content between 9 and 10%, chromium on average 21.3% and the absence of molybdenum are close to steel AISI 304. Also, according to ASTM A666 (2015), it is recommended that this material in the annealed condition has a minimum hardness of 92 HRB, which is equivalent to 88.6 HR15T according to ASTM E140 (2019) in relation to austenitic stainless steels. This last scale was used in the tests due to equipment limitations, resulting in an average hardness of 98.6 HR15T of the EGR box material, which meets the standard specifications. In fact, it was observed that corrosion occurred mainly in the tubes and at their junction with the side plate of the box, with less intensity on the box structure itself. This behavior indicates that the higher nickel content of this part of the equipment was efficient in reducing crevice and pitting corrosion. Thus, one can also relate leak failures to the choice of pipe material during manufacturing planning.

Figure 9. SEM image of different regions in the sheet of the radiator box, showing less oxidation.

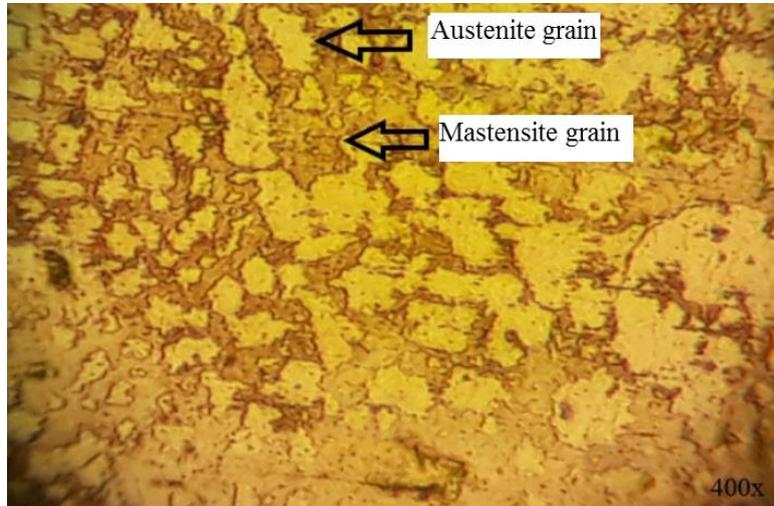
Figure 10. Microstructure of the stainless steel sheet of the outer box of the EGR radiator, showing distribution of austenite (clearer) and possible martensite (darker) grains.

Regarding the microstructure of the sheet that makes up the box of the radiator, the appropriate grinding and polishing together with reduced time for chemical attack significantly improved the visualization of the grains. Also, since the sheet samples were not annealed, the grains are conserved in their original smaller size, typically obtained in the rolling of steel sheets (Callister and Rethwisch, 2018). Again, the clearer grains show the predomination of the austenitic structure, with smaller darker areas where martensitic structure is possibly present.
