## COB-2023- 1478

### FAULT ANALYSIS IN ROAD SPRINTER OM611

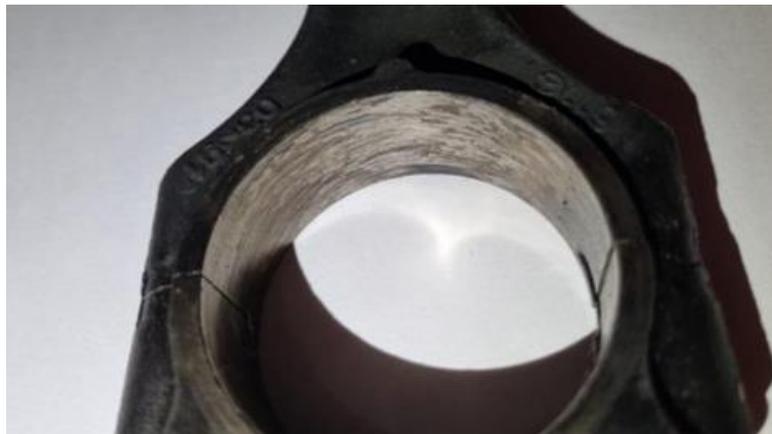
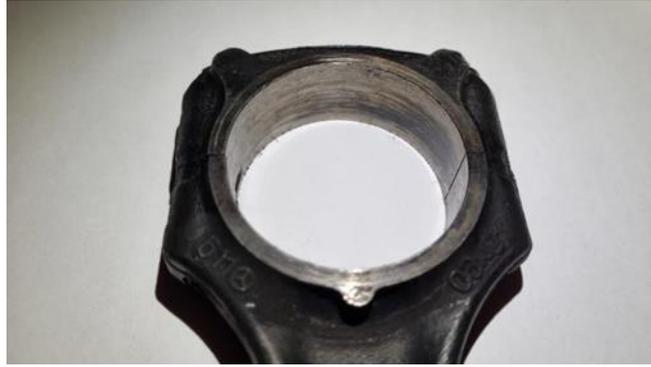
Figure 8. Connecting rod with lack of lubrication.

Figure 9. Connecting rod with lack of lubrication.

In Figures 8 and 9, which shows a connecting rod that failed due to lack of lubrication, the wear that was generated on the part is clear. The following characteristics are observed due to lack of lubrication: scratches and wear on the bearings that always occur in the direction of rotation of the shaft. An irregular noise is usually observed in the operation of the engine when such a failure occurs.

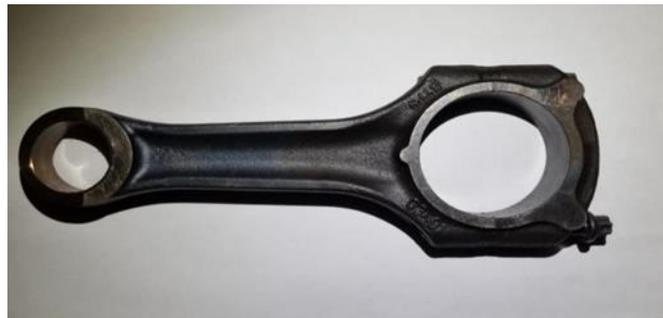
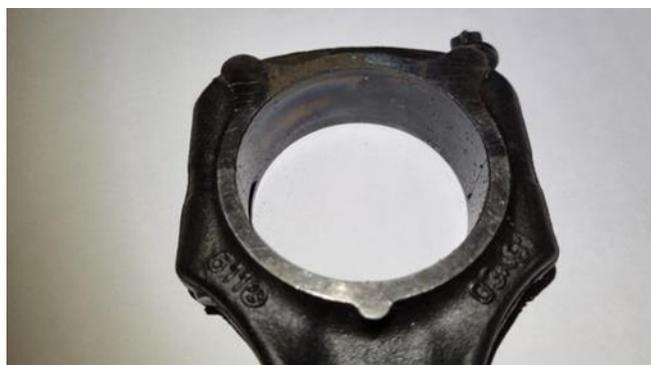
Another failure that occurs in connecting rods is failure due to heating. The connecting rods that suffer failures due to heating have changes in their characteristics, one of the main ones and the clearest is the change in color located where there was a greater increase in temperature. What leads to overheating failure is the lack of engine heat exchange. A cooling system with irregular operation is one of the main causes that can lead to connecting rod failure due to heating. In Figures 10 and 11 you can see a connecting rod that suffered overheating.

Figure 10. Heated connecting rod.

Figure 11. Heated connecting rod.

We cannot fail to mention that after a connecting rod assembly error or wrong application outside the correct characteristics of the specific model, it may present failures due to heating due to excess torque or measurements outside the specified range.

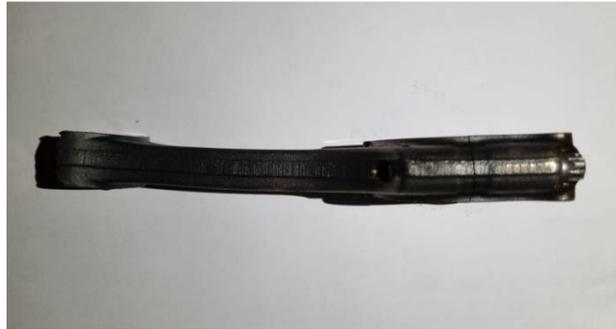
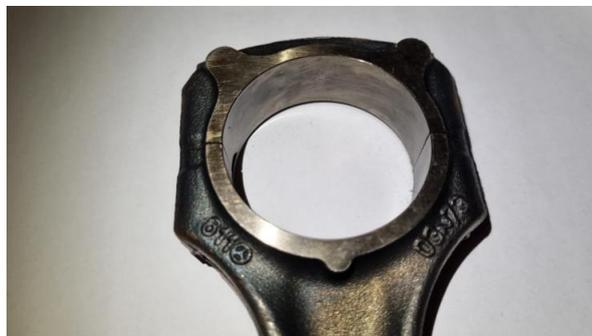
Another fatality that can occur is connecting rod warping failure. This failure is common to happen due to failure factors of other components. In Figures 12 and 13, a bent connecting rod can be seen.

Figure 12. Warped connecting rod.

Figure 13. Warped connecting rod.

What leads a connecting rod to suffer failure due to warping is the occurrence of hydraulic wedge in the engine combustion chamber. Failures in fuel injection components, valve gasket burning that retains coolant and even external factors such as driving the vehicle in inappropriate places (flooding), can cause water to be aspirated by the engine. At the time of compression, if there is any liquid inside the cylinder, be it fuel, coolant or water, the volumetric capacity of the combustion chamber may not be enough to accommodate such liquids, causing failure in the connecting rod due to warping.

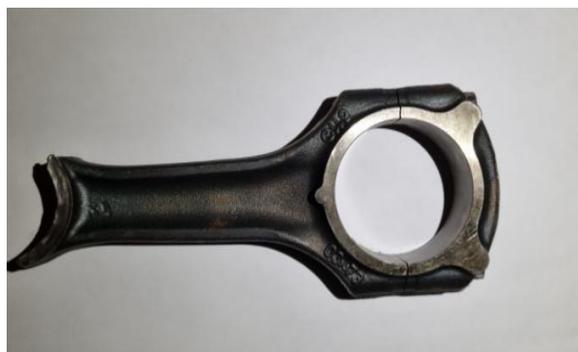
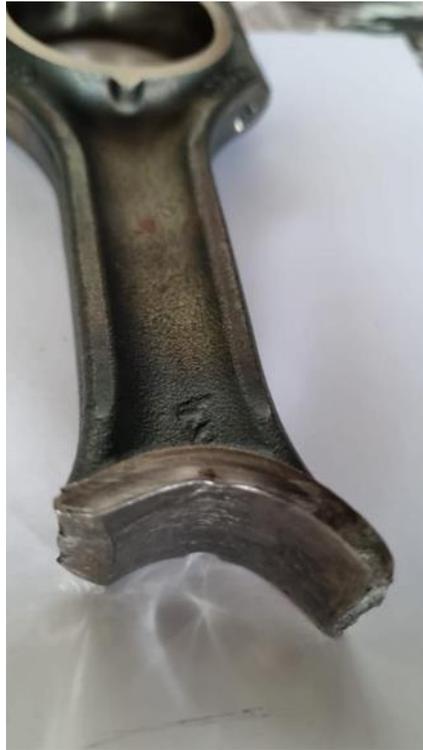
There is a case of failure of the connecting rod due to breakage, such failure can occur due to the symptoms presented above, such as lack of lubrication and heating, but it is more common that there is a failure due to breakage due to other factors such as: failures in the crankshaft shaft or in the camshaft can lead to this failure of the connecting rod breakage. Mounting or even application of wrong force, leads to such a failure. Part breakage can occur in different areas. In Figures 14 and 15, a broken connecting rod can be seen in its upper hole, also known as connecting rod foot.

Figure 14. Broken Connecting Rod.

Figure 15. Broken Connecting Rod.
