24th ABCM International Congress of Mechanical Engineering
December 3-8, 2017, Curitiba, PR, Brazil

COBEM-2017-2560

FAILURE ANALYSIS ON EQUIPMENT MAINTENANCE OF A CRUSHING UNIT

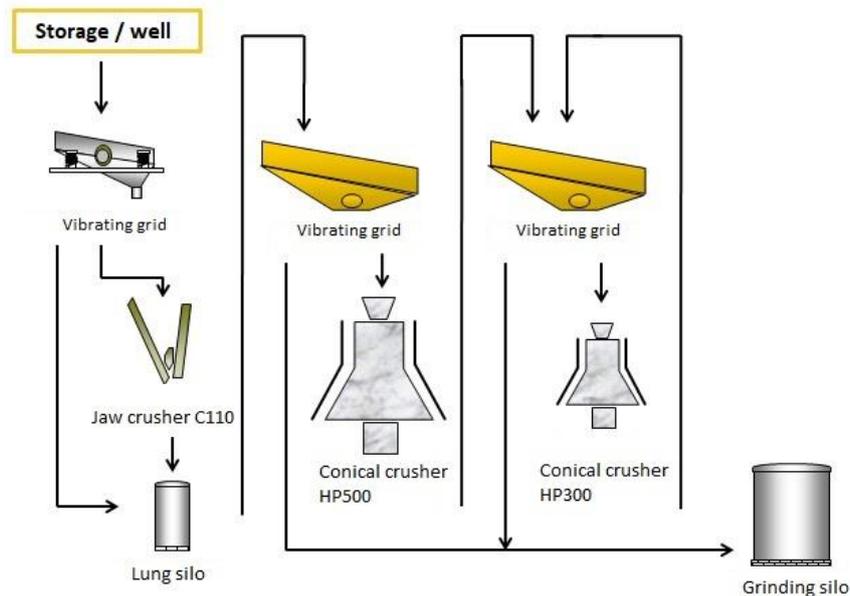
Defining the main concepts involved in a crushing unit and describing the equipment of the unit, the simplified flow diagram of the process is shown in Figure 1. It is noted that there are three crushing lines: the primary, secondary and tertiary.

Figure 1. Simplified Process Flowchart.

In primary crushing, the ore comes from the well (underground mine) or from the stockpile (whose ore comes from another mine of the company). It is directed to the vibratory grid, where the passing material goes to the lung silo (ore slurry reduced but still with an rough granulometry) and what does not pass in the template goes to the jaw crusher, undergoing fragmentation process. This non-passing material, after being crushed, is sent to the same silo. The lung silo has the function of reserving material from the secondary and tertiary crushing system when there is a shortage of ore in the well and in the square. In the secondary crushing, the material stored in the lung silo is conveyed to the first vibrating screen, the material that it is able to pass goes to the milling silo (ore slurry with reduced particle size, which is already the final product) and the non-passer goes to the first conical crusher. After this material is crushed it is sent to tertiary crushing. In tertiary crushing, the ore is directed to the second vibrating screen, the passing material goes to the grinding silo and what does not pass goes to the second crusher. After this material is crushed, it returns to tertiary crushing. It is noticed that in primary and secondary crushing the circuit is opened, that is, the ore passes through it only once, as soon as the tertiary crushing circuit is closed and the material recirculates in this step until it meets the specified granulometry and goes to the silo grinding. The grinding silo is where the final product of the crushing is intended. The ore that arrives at the crushing plant with an average granulometry of 150 mm. The final crushed product has a particle size of 9.5 mm. From the milling silo on, it is the ore beneficiation process, whose theme is not addressed in this work.

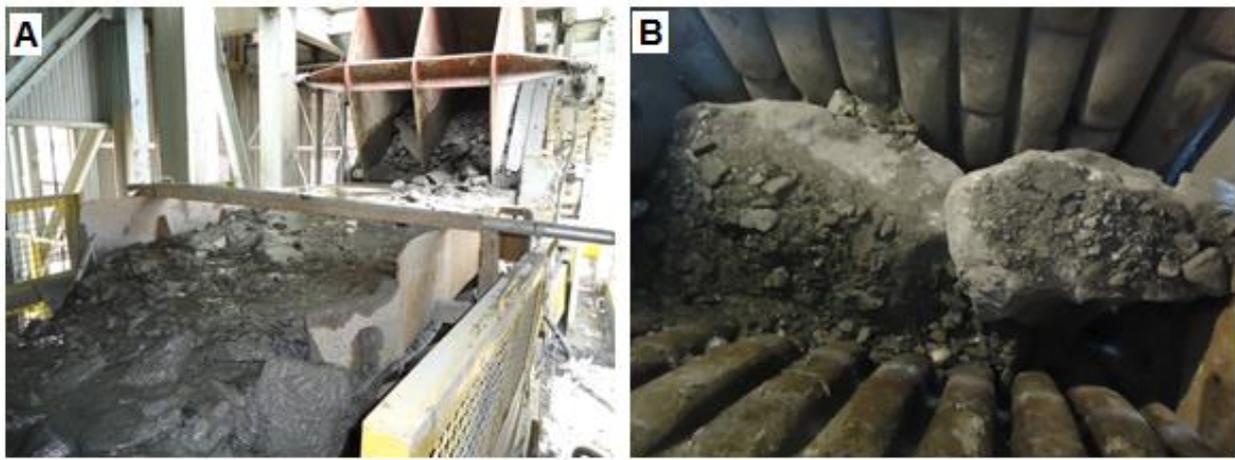
Figure 2 (A) shows the log of the problem caused by the clogging due to excess moisture in the ore coming from the well and the problem of clogging of the jaw crusher by boulders. Boulder can also lock the conveyor belt at some point when encountering an obstacle (jamb) at the top, or even at the sides if it is larger than the width of the conveyor belt.

Figure 2. (A) Clogging due to excess moisture (B) Blocked with boulders.

The established humidity of the ore is 3%, but in this situation the humidity percentage is well above. This causes the interruption of belt conveyor by weight overloading, mechanically affecting the drive assembly of the conveyor. The overflow of this mud (highly moist ore) contributes to the local dirt, creating difficulty for the area access. Contamination of other components of the belt conveyor, such as the rollers, accelerating their wear. If this ore continues, it causes clogging in the grate or in the primary crusher, and if it does that, it causes further damage by being stored in the lung silo in this wet form. From the lung silo for secondary and tertiary crushing, the ore with excess moisture clogs the screens of the vibrating screens, reducing their sieving capacity and making the material circular for a longer time.

Figure 2 (B) also presents the problem of clogging of the jaw crusher, but caused by boulders. The average size of the ore that reaches the crushing is 150 mm, but the ore from the storage place may have a higher grain size, as in this case. This problem causes the primary crushing line to stop for several hours (around 6 hours).

The problem of excess moisture from the ore was solved when it was sent to the storage square to dry, or to passing through a controlling process of humidity by the responsible team of the well not allowing the ore to go forward on the line with a high state of humidity.

The immediate solution to the problem of clogging caused by boulders is based on their removal by hydraulic clamping if they have entered the circuit. But this is not a definitive solution, as it depends on the surveillance of the operation team. The problem is solved by providing a hydraulic breaker in the square area to undo the bumps before they enter the crushing line. The abovementioned recommendations for eliminating boulders are relevant in order to avoid damage to the conveyor belt, support rollers and belt guide structures, since the maintenance required to recover the operation of the conveyor are based on emergency maintenance type, soon undesirable.

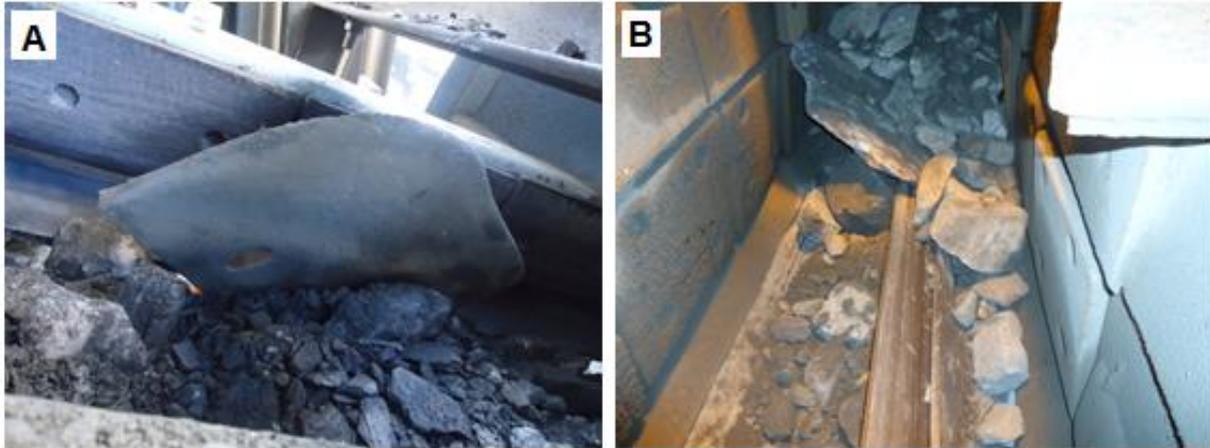
An inherent fact in the crushing routine is the presence of non-brittle material along with the ore to be crushed. There is equipment such as the scrap extractor and metal detector responsible for removing this non-brittle ferromagnetic material from belt conveyors. Failure to operate this equipment can be by the fact that the scrap extractor is deactivated by the operation, or even because the metal detector is saturated with ferromagnetic materials and has not been cleaned by operation personnel, and this can cause rips on the belts and the crushing unit will stand still for several hours until an amendment is made in them. This problem also occurs when lamellas of the ore, that is, in format of stone blades enter the circuit. Both the non-metallic material and the ore in lamella when attached to the walls of the conveyor and in contact with the belt act as a blade, tearing it. Figure 3 (A) shows a ferromagnetic material and Figure 3 (B) ore lamella, both cases caused tear in the conveyor belt in which carried them.

Figure 3. (A) Tear belt done by metallic material (B) Tear belt done by ore lamella.

Regarding the problem of tearing of belts by non-brittle material, it is necessary the replacement of the metal detector, which requires the presence of the operation personnel to remove the captured material, by a scrap extractor, as it has a dynamic system of operation and removes automatically the captured metal. It is important that the operation maintains these equipment actives during the conveyor work, or in case of maintenance of them, the movement of the conveyor belt must be interrupted until they come into operation again. Regarding the belt strains consequent on the ore lamellas, the operation should be attentive to this mineral format, removing the smaller stones or breaking the larger stones with the help of a hydraulic breaker after being diverted to the ore storage square.

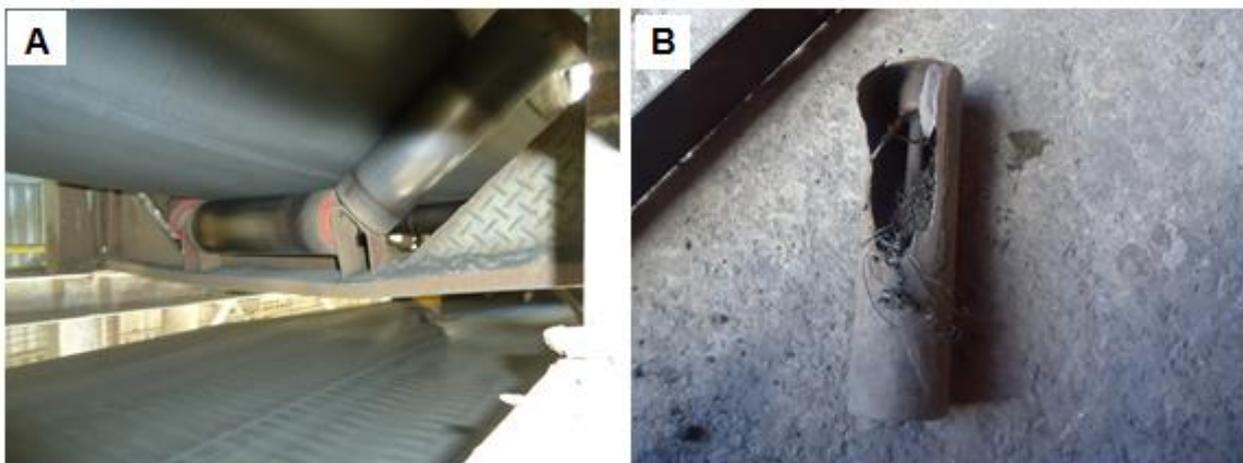
It was also contextualized the problem generated by boulders (fragments of ore with dimensions above the limit of granulometry defined by the unit) that enter the crushing circuit. In addition to the production loss caused by the time spent by the operating team to remove these boulders from the crushing circuit, damage to the physical structure of the belt conveyors may occur due to the weight and impact of them entering the circuit. There may occur fracture of trestles and stringers that make up the physical structure of the conveyor, as well as irreparable damage to the rollers that support and allow the belt to move, requiring replacement. Depending on the proportions of damage, that sector of the conveyor will need to be repaired for the belt re-operate. Figure 4 shows the support structure of the belt conveyor and a support roller damaged by the impacts of the boulders on the belt.

Figure 4: (A) Conveyor physical structure and belt support (B) Belt Conveyor Roller Damaged.

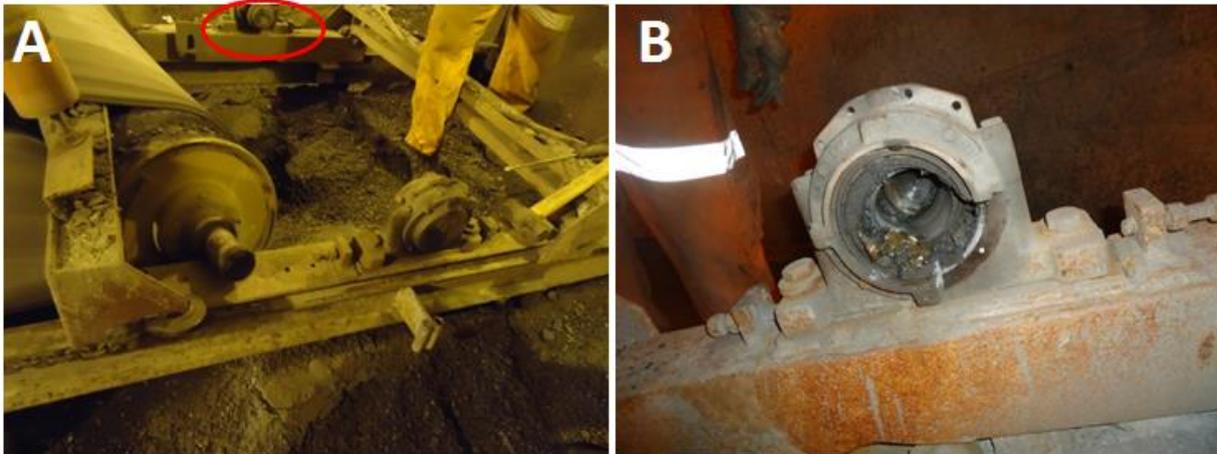
Each crushing belt has two drums, a motor drum that transmits the torque needed to move the belt overcoming the resistors and the driven drum, being that the drums are located at the opposite ends of the belt conveyor. This failure in the belt conveyor occurred by breaking the driven barrel axis which keeps the belt tensioned and moving (Figure 5-A), close to the bearing support, and by breaking the bearing of the other end of the shaft of the drum. When the shaft broke at one of the side of the drum, it provocate a radially movement and the other end of the shaft applied a momentum greater than the bearing could hold and consequently has broken either (Figure 5-B).

Figure 5. (A) Moved barrel shaft break (B) Bearing failure on the opposite side of the fractured shaft.

Due to the amount of boulders present in this ore, the overload of bending and torque applied on the shaft of the drum, the impact of falling rocks and also the process to transport this material, provided an accelerated process of fatigue on the axis. Due to the amount of boulders present in this ore, the overload of bending and torque applied on the shaft of the drum, also the impact of falling rocks and the process to transport this material, caused an accelerated process of fatigue on the axis.

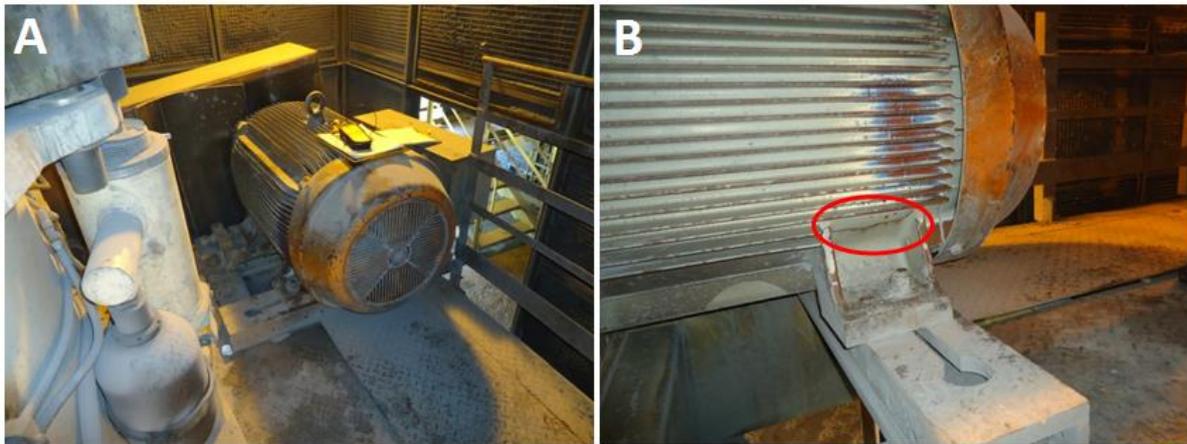
The failure occurred in the starting drive of the crusher which is performed by a high-power (500 hp) electric engine (Figure 6-A). There was a crack in one of its bases, responsible for maintaining it connected to the support structure at the floor. In figure 6 (B) stands out the cracked foot of the engine.

Figure 6. (A) Electric motor (B) Cracks at engine stand and detail of the fixing bracket.

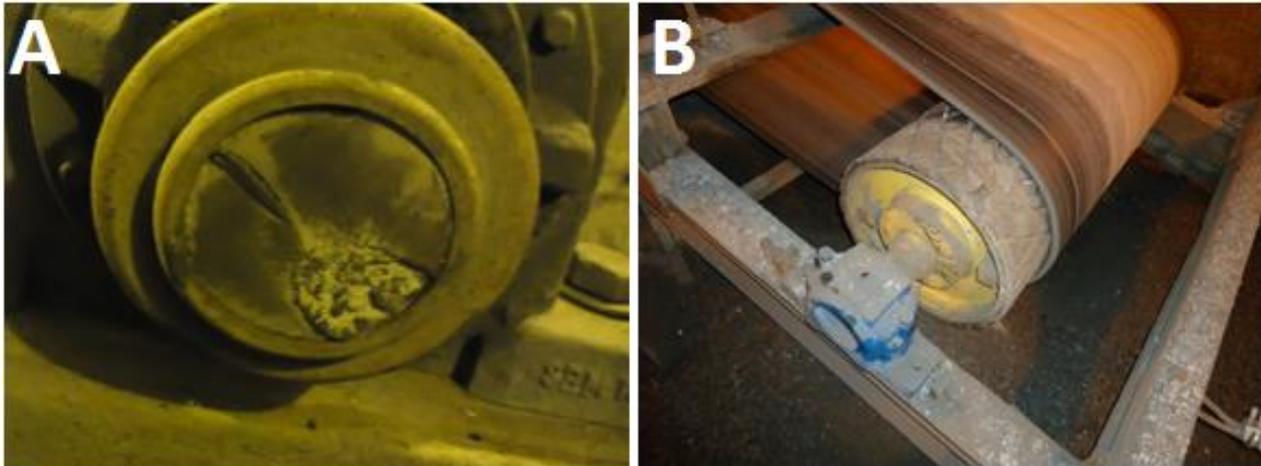
In this case, the fatigue failure is identified by analyzing the fractured surface (Figure 7 - A). A small corroded area is perceived representing the level of the final effort in which the fracture occurred, that is, the effort was low. It is observed that the crack propagates from the outer surface of the shaft, where the torsional and flexural stresses are greater, to the center. The cracking process evidences that the shaft has ruptured with a high stress concentration. The beach marks are not clear, but the rest of the shaft surface is smooth.

The aggravating factor in this emergency maintenance was that there were no spare parts in the warehouse, that is, the driven drum, rolling bearing type used and bearing case. An emergency purchase of the components was necessary, which contributed to the total time spent to re-operate the equipment being relatively high, although the maintenance team used 5 hours to perform the repairs. Figure 7 (B) records the time after corrective maintenance has been performed, where the belt conveyor re-operates. It would be necessary to keep in stock the spare parts of the aforementioned components, as a suggestion, to reduce the impact caused in the production due to the excess time in which the equipment was out of operation (total time of 48 hours), since it is complex to estimate the total numbers of life cycle for this drum axis because it is subjected to a very variable and intermittent applied load inherent in the process. Human and environmental risks are zero, however, the loss due to unproductivity is high, and is often caused by the long process of buying spare parts.

Figure 7. (A) Fracture of the shaft attached to the bearing (B) Drum and bearing after maintenance.

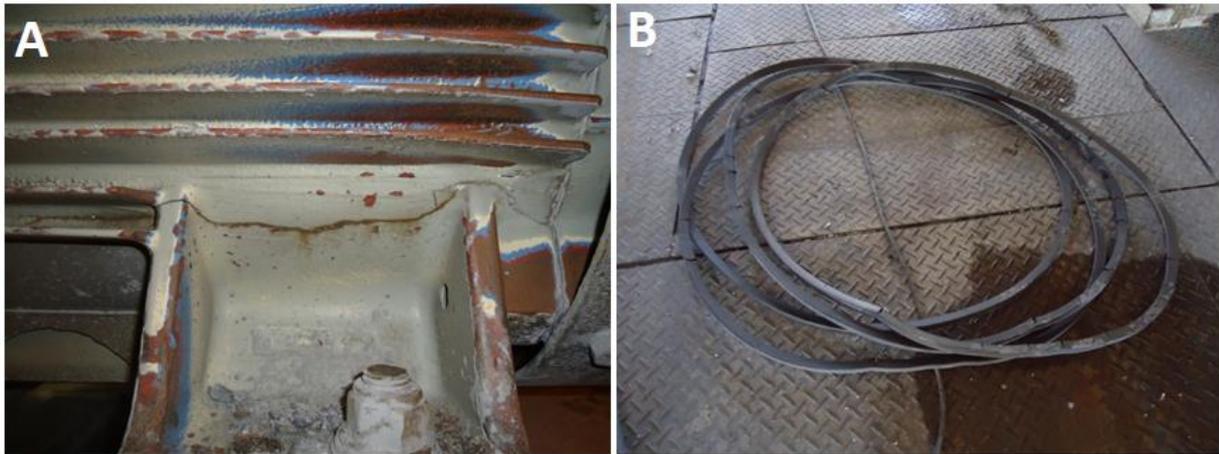
The operation interrupted the operation of the crusher after noticing unusual vibration of the electric motor. An inspection made by electrical crew found a crack in one of the engine support feet as highlighted in figure 8A. For safety reasons, the engine was replaced as a preventive measure to avoid the rupture of this cracked foot. In case of breakage the vibration would increase and the engine would become unstable and could be pulled out of the support and thrown, causing damage to other equipment and as a more serious risk to the employees of the area.

Critically analyzing the failure of the electric motor due to the appearance of a crack in its fixing foot, it is perceived that the causes of the problem are several. From the analysis of Figure 6 (B), it can be seen the non-conformity of fixing the foot of the motor to the support. The motor foot has two screw fixing holes and the foundation bracket has only one, allowing part of the foot to be out of the holder and thus secured by only one screw. This installation reduces the stiffness of the engine, making it vibrate more when starting up. There is also a hypothesis that this screw was poorly fixed, which provided a higher level of vibration of the motor and consequently the appearance of the crack in this foot. Detail of the crack can be seen in Figure 8 (A). It was necessary to change the electric motor and arrange for the motor with the crack to be sent to a company specializing in this type of repair. In addition to the engine change, the pulley driven by this engine and the power transmission belts were also changed. Figure 8 (B) reveals several cracks of the belts removed, evidencing their accelerated wear caused by the misalignment of the motor pulley with the driven pulley of the crusher. This misalignment caused significant vibration in the engine and the crusher, in addition to premature wear of the belts and possible damage to the pulleys. Another problem diagnosed was the mode of operation of the crusher powered by this electric motor. The crusher had its operation started many times with the ore loaded circuit, being necessary in the departure of the crusher extra application of power in relation to it start without load. This overload was passed to the electric motor and greater effort was required to start the crusher until it entered nominal operation, a fact that could be observed and heard by the sliding of the belts at the pulleys during the operation of the crusher (transient operating regime).

Figure 8. (A) Detail of the crack at the foot of the engine (B) Damaged crusher drive belts.

The new engine installation was made on the same support, however provisionally, because the production had to be resumed. Nevertheless, a specialized company was contracted to design a new support structure, adjusting the drilling of the support to the feet of the electric motor.

The cost for the recovery of the electric motor structure was high, since it was made necessary to replace the housing together with the stator winding, since it could not undergo a welding process. The high temperatures reached in a welding process to recover the housing could compromise the winding of the stator coils. The repair budget was R\$ 50,000.00, but a quotation of this same engine in the new state, was in the amount of R\$ 80,000.00. The crushing management chose not to recover the engine but instead of that to buy a new one for the warehouse.

Suggestions were made to avoid repeating this unexpected crash. Firstly, the engine mounting bracket must be changed and a new one installed with a larger base width and fastened by two screws, as well as the design of the electric motor. The fastening state of these screws must undergo a continuous inspection process to ensure their tightening since the vibration of the motor and the crusher can induce a loosening of the fastening of the screws. When installing the belts on the pulleys, it is necessary to apply an efficient alignment process to eliminate the possibility of vibration caused by the misalignment of these flexible elements when in operation. In addition, the operation team must be advised to unload the crusher if it is full of ore before putting it back into operation, thus avoiding engine overload and excessive vibration at its base.
