24th ABCM International Congress of Mechanical Engineering
December 3-8, 2017, Curitiba, PR, Brazil

COBEM-2017-1760

COOLING SYSTEMS FOR ELECTRICAL MACHINED COOLED WITH SEAWATER

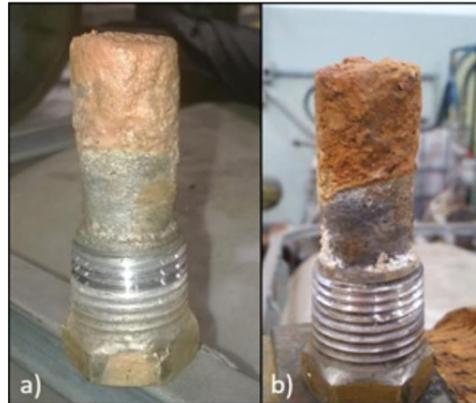
In this test it was decided to couple to the sacrificial anode system with zinc in the form of a pin and it was added to the refrigeration circuit, being in contact with the water flow in the system.

To validated this method of protection is to verify the existence of material loss on the zinc pin, in Fig. 03 the pin situation can be observed in two moments, in the middle of the test and after concluded.

Figure 3. Anode of sacrifice in the middle of test a) and after full test b)

The concentration of zinc in the water composition shows that a reduction of the zinc pin used for the cathodic protection occurred.

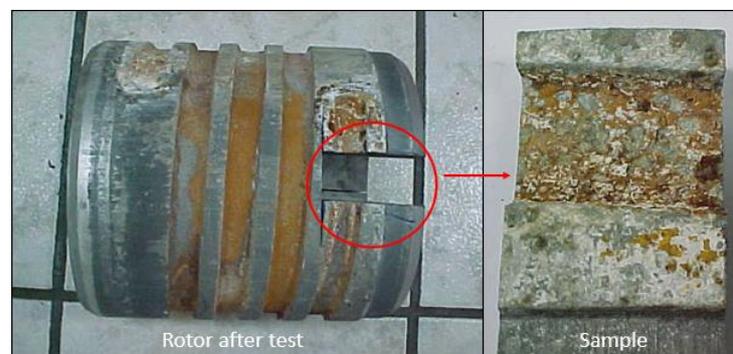
The objective of the metallographic analysis is to verify the constitution, structure and texture of the samples to relate the results obtained with the mechanical, physical and chemical properties. The Fig. 06 shows the spiral tube with coating and Fig. 07 is presented the metallographic analysis of this spiral tube.

Figure 6. Spiral tube with aluminum coating by arc electric spray

Both prototypes showed corrosion and oxidation, the coated prototype presented a lesser amount of corrosion of the material to be protected, as can be seen in the images. The expected objective for the coated condition was to avoid corrosion of the material to be protected and to exhibit oxidation only in the coating layer, but with the results of the analyzes it is possible to observe that the same occurred although at a much lower rate when compared to the system with anode of sacrifice. The reason for the interruption of the tests was due to the increased pressure loss and not because of corrosion, but it is necessary to take into account the corrosion rate presented in this time interval.

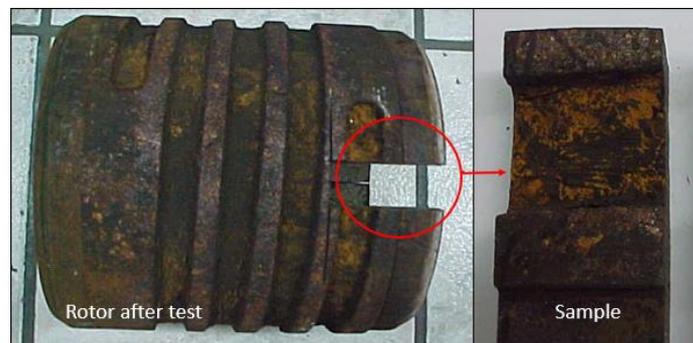
For the prototype with anode of sacrifice is shown in Fig. 08 and Fig. 09 shows the metallographic analysis of this tube. These components presented the most critical results from the point of view of oxidation.

Figure 8. Spiral tube without coating and cathodic protection.

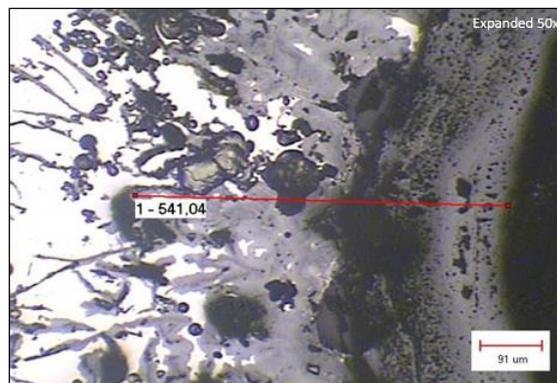
Figure 9. Metallographic analysis of spiral tube without coating and cathodic protection.
