25<sup>th</sup> ABCM International Congress of Mechanical Engineering  
October 20-25, 2019, Uberlândia, MG, Brazil

## COB-2019-0155

# EVALUATION OF THE MECHANICAL BEHAVIOR OF STEELS USED IN THE SLIDE RING OF A BALL MILL OF AN IRON ORE MINING PLANT

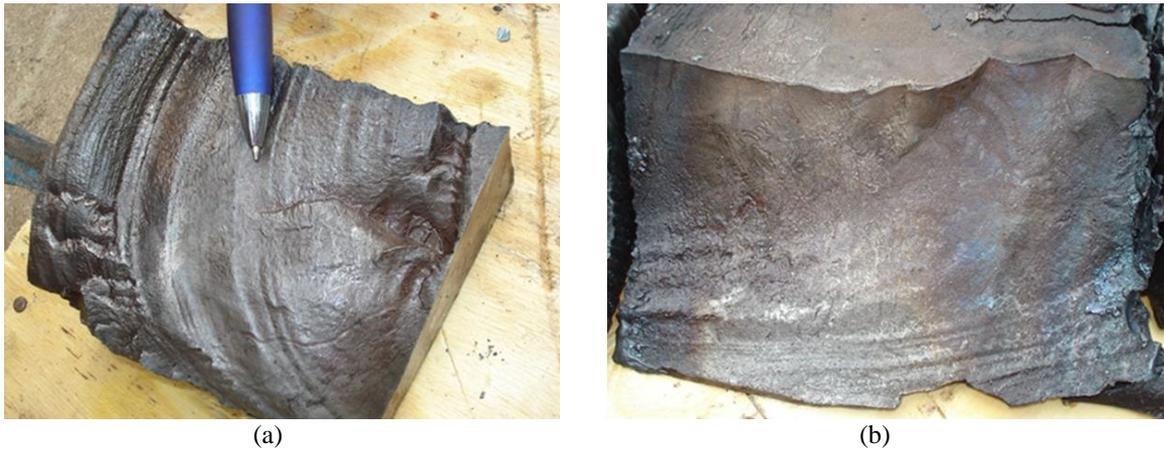
Figure 5. Fracture surfaces after forced opening of the cracks.

Fig. 2 presents a schematic representation of three cracks appearing on the slide ring in the transversal section of the ball mill. Figs. 3a and 3b are pictures showing details of the failure region. Fig. 4 presents a detail of the slide ring, showing part of one of the cracks that developed in the mill. Below this ring and close to the region of the crack is the welded head of the mill. The cracked region was subsequently separated for examination of the fractured surfaces. Some examples can be seen in Figs. 5a and 5b. From the details observed in this macroscopic analysis (flat surface and beach marks), and taking into account the characteristic operation of the equipment, it is clear that the failure was caused by fatigue.
