COBEM2019-1448

EVALUATION OF THE BEHAVIOR OF WORN OUT RAILWAY COMPONENTS OF THE SHOCK AND TRACTION SYSTEM THAT ARE RECOVERED BY WELDING

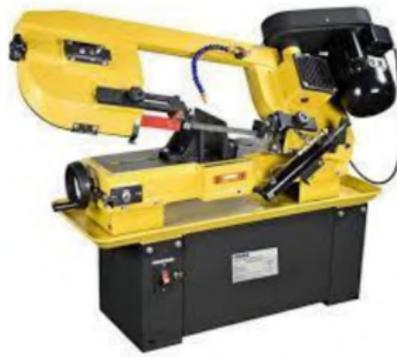
The samples were cut and properly identified in the UFJF laboratories, using a horizontal cooled band saw to avoid heating of the parts and consequent changes in their properties. Figure 1 shows the saw.

Figure 1. Horizontal cooled band saw for metals.

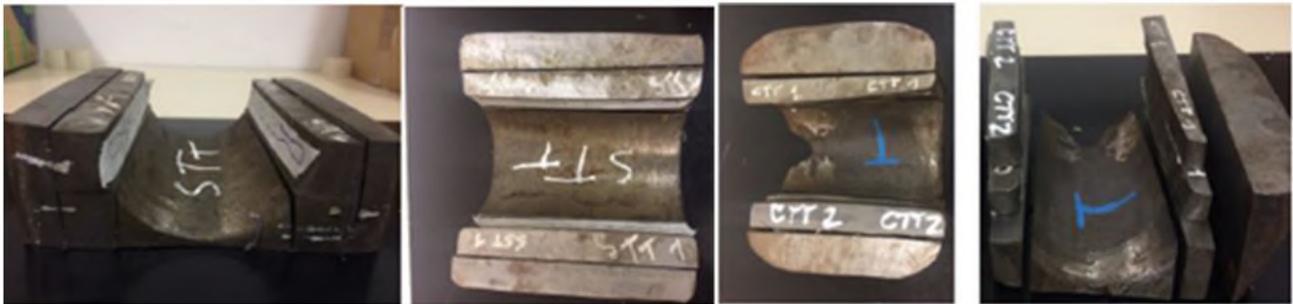
To carry out the tests, the samples were taken from regions recovered by welding. Figures 2 and 3 show the location where the samples were removed.

Figure 2. Specimens material cutting regions in the drawbars.

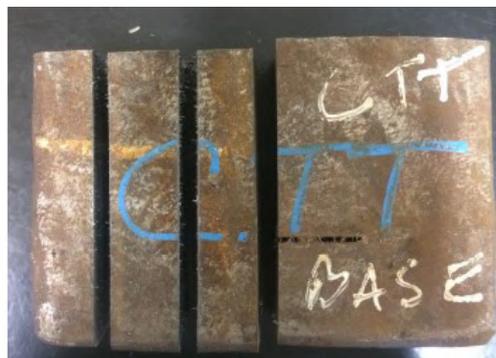
Figure 3. Specimens material cutting regions in the yoke with heat treatment.

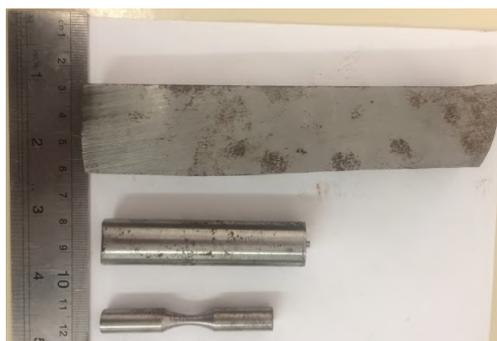
After cutting, the specimens were machined for fatigue and tensile test.

Figure 4. Test specimens obtained from conventional lathe and CNC lathe for the fatigue test.

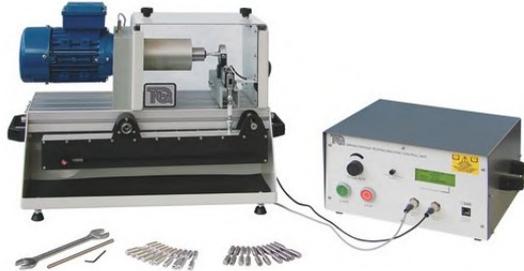
The fatigue test was performed using bi-supported rotary bar type equipment in accordance with ASTM A370-14 (2014) and Reed-Hill (1982). Figure 5 shows the equipment.

Figure 5. The rotary fatigue machine. Available from:
http://www.novadidacta.com.br/produtos-categoria-produto.php?id_cate=11&id_sub=110&id_prod=408

Tension was determined using as the basis a recent study (Alves *et al.*, 2015) in which the worst maximum tension condition for these same components was 210 MPa. A safety factor of 30% was applied so that the tests were done with a tension of about 273 MPa. The tests were carried out until reaching infinite life, with more than 10^6 cycles (Juvinal and Marshek, 2008) and (Budynas and Nisbett, 2011).

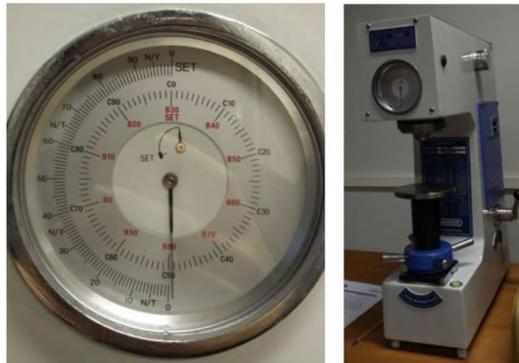
The hardness test performed was the Rockwell C according to ASTM E18-15 (2015). Twenty-two measurements were performed, spaced at 3.0 mm in the longitudinal direction of the samples. Figure 6 shows the equipment.

Figure 6. Hardness testing machine.

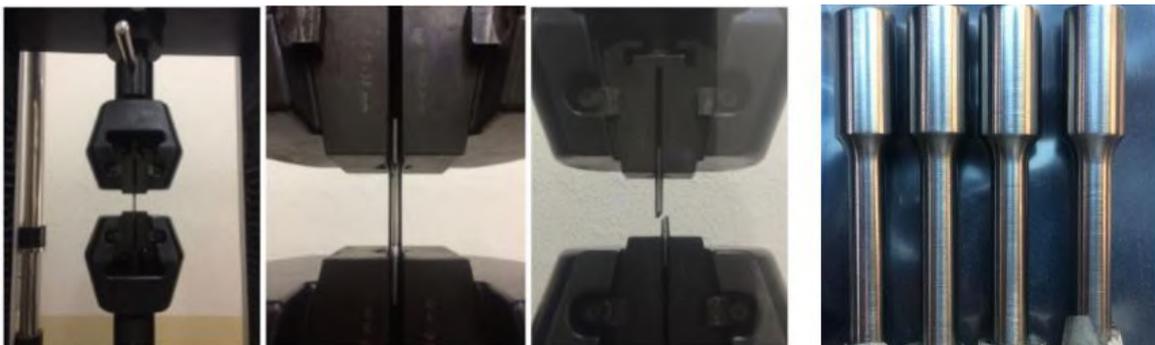
Tensile tests were performed using ASTM E8/E8M-13a (2013) as reference. Figure 7 shows the tensile test specimens.

Figure 7. Tensile test machine and the test specimens.

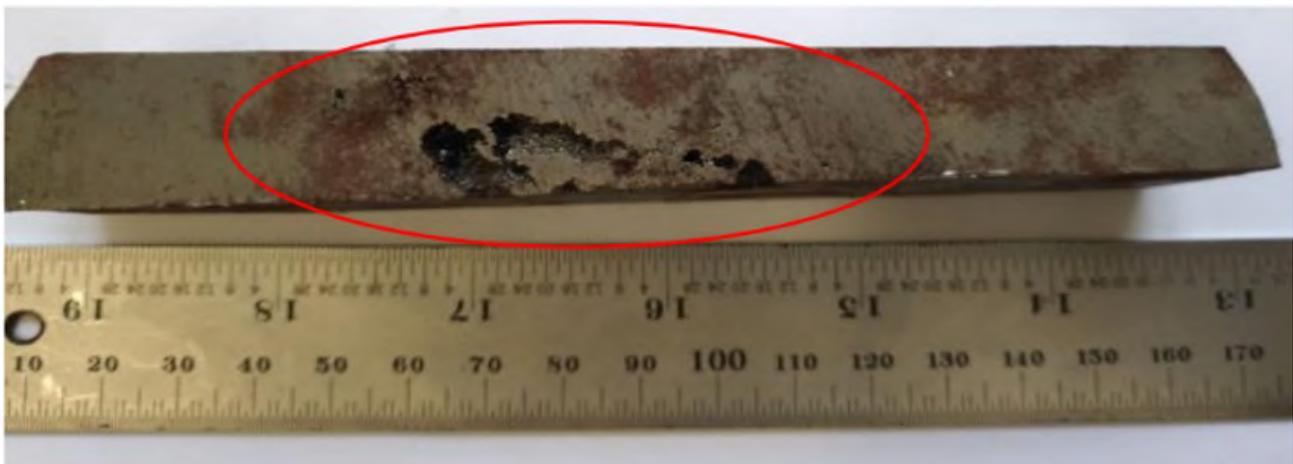
After cutting, a visual analysis was performed, before performing the machining of the specimens. In some sections it was verified internal shrinkage or spongy area lined with dendrites. Figure 8 shows a large shrinkage in the region of the bore of the drawbar rotating side. In addition to being in a critical area, this is a large defect. (AFS, 1994) and (ASM, 2008)

Figure 8. Section of the drawbar with a large internal shrinkage.

The parts recovered with heat treatment had failures in the fatigue tests, but they are due to the fact that the samples were taken from a region of the drawbar that presented a great shrinkage and porosity. As for the hardness values, they were very high, while the ductility and the reduction in area measured in tensile tests were low. This suggests that the temperatures employed in the tempering were very low.

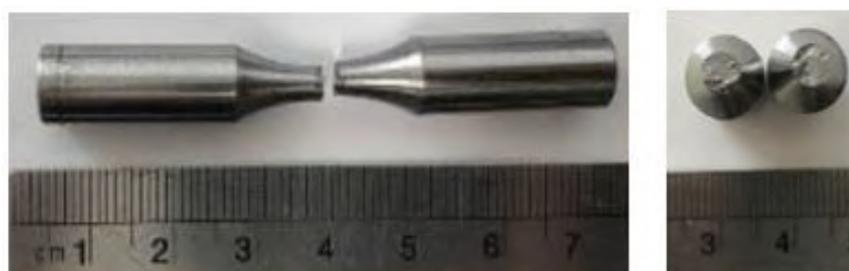
The fatigue tests were performed on new and used parts, taken from the raw material cutted from the yoke and the drawbars. The aforementioned parts had reached their infinite service life. The seven samples taken from each part had the fatigue testing performed. For welded samples without heat treatment, two of seven ruptured, one specimen from drawbar with 2.89×10^5 cycles and other from yoke with 2.72×10^4 cycles.

Figure 9. Fragile rupture of the specimen taken from the drawbar without heat treatment.

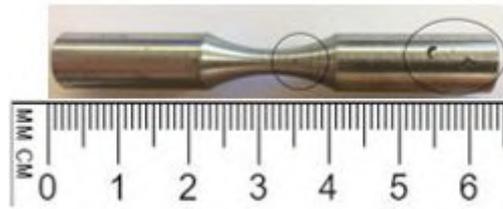
Finally, for welded samples with heat treatment, two of seven were fractured, one from the drawbar with with 4.58×10^5 cycles and other from the yoke with 1.2×10^3 cycles. The specimens removed from the drawbar had no apparent defect, although they were removed from the site where the shrinkage was found. Whereas the specimens removed from the yoke showed pores that culminated in the rapid rupture of the material. Figure 10 shows the apparent pores in the specimen.

Figure 10. Test specimen taken from the yoke with pores (material welded and heat treated).

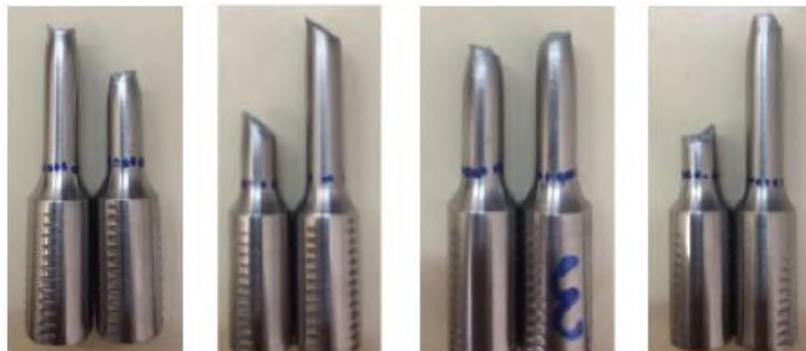
Figure 11. Specimens after the tensile test.

Table 2 shows the results of the tensile tests. The material without heat treatment had low mechanical strength, while the treated material had good mechanical strength, but low elongation and reduction in area. This is an alert point and indicates that the current tempering temperature should be increased.

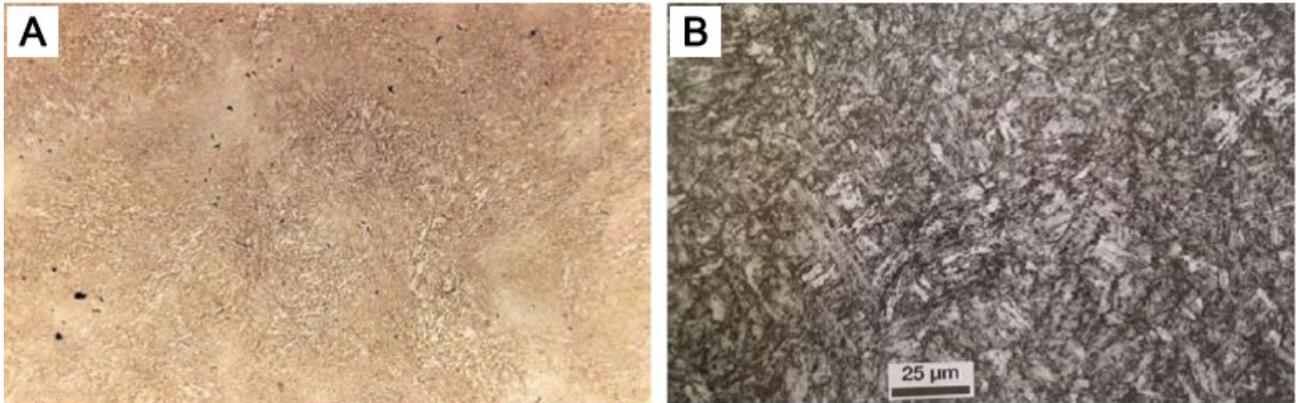
The metallographic analysis was performed for all the cases shown. According to Colpaert (1974), the expected microstructure for this material was tempered martensite, which is presented in Fig. 12.

Figure 12. (A) Typical photomicrograph of quenched and tempered AAR M201 Grade E steel (Alves and Sinatora, 1997); (B) Typical photomicrograph of low alloy steel quenched and tempered (Colpaert and Costa e Silva, 2008, p. 305).

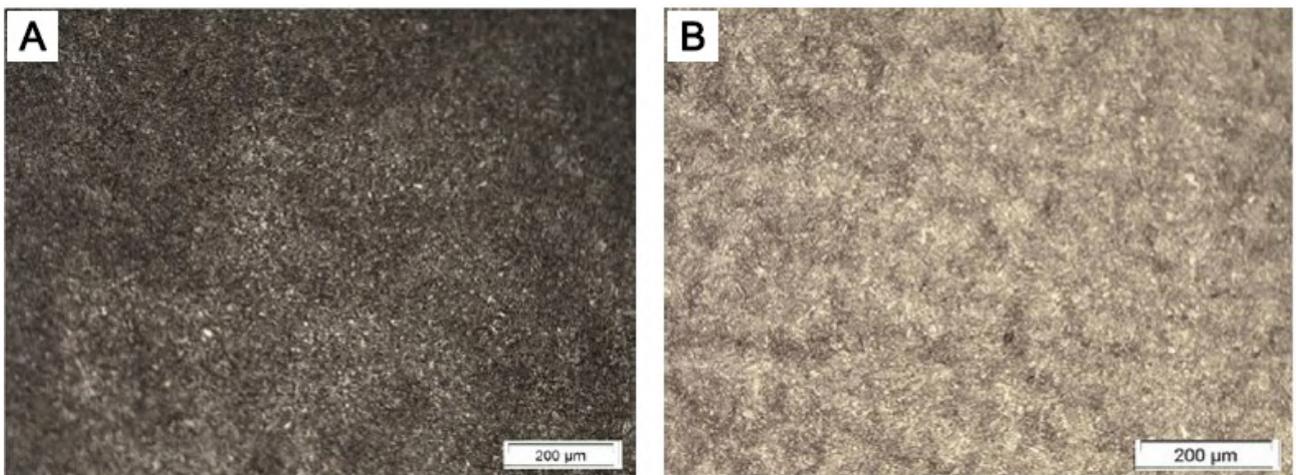
Figures 13 and 14 show the photomicrograph of the sample for new material, used material and welded material after heat treatment, respectively.

Figure 13. (A) Photomicrographs of the new material and (B) the worn one.

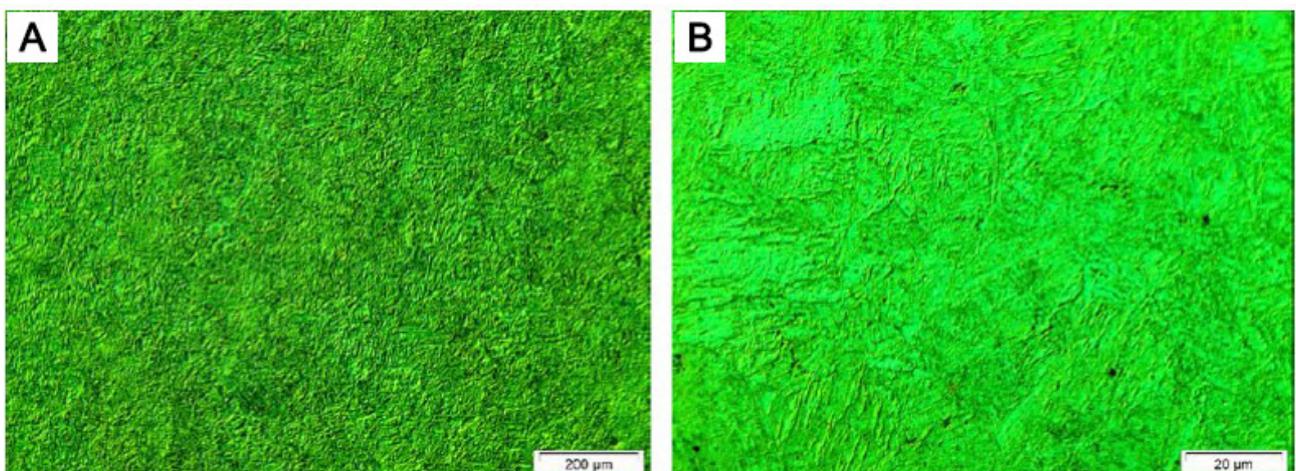
Figure 14. (A) and (B) Photomicrographs of recovered material with heat treatment.

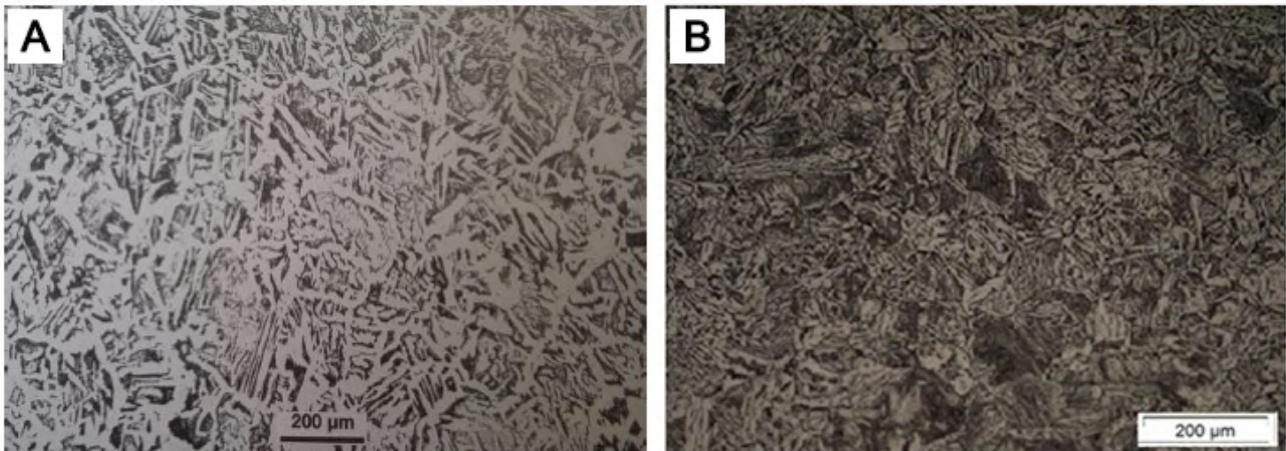
However, the material recovered without heat treatment showed a different microstructure, known Widmanstätten ferrite, being very brittle and undesirable for a material subjected to great stress. Figure 15(A) exemplifies this microstructure according to the literature and (B) in the material without heat treatment.

Figure 15. (A) "Widmanstätten" acicular ferrite (Colpaert and Costa e Silva, 2008, p. 232); (B) material recovered without heat treatment.

The materials recovered without heat treatment were rejected in the tensile and hardness tests, and had an inadequate microstructure that should have presented a worse fatigue behavior. But that did not happen. This is probably due to the position in which this fragile microconstituent was verified. But this presence of Widmanstätten ferrite is not recommended for this type of material.

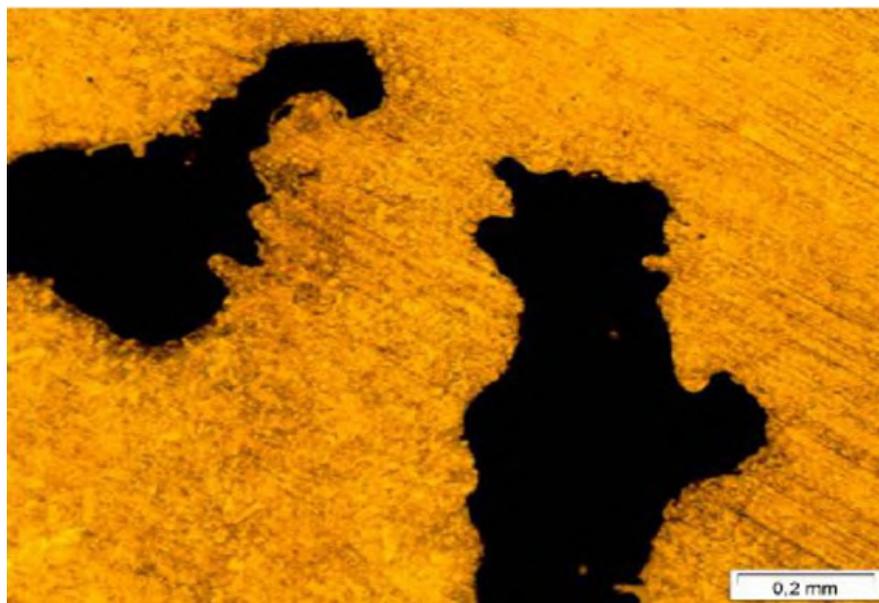
No expressive points of internal faults were found in the samples collected, however the pieces are not free of micro defects, as it can be observed in an optical microscope analysis.

Figure 16. Micro defects obtained under optical microscope analysis.

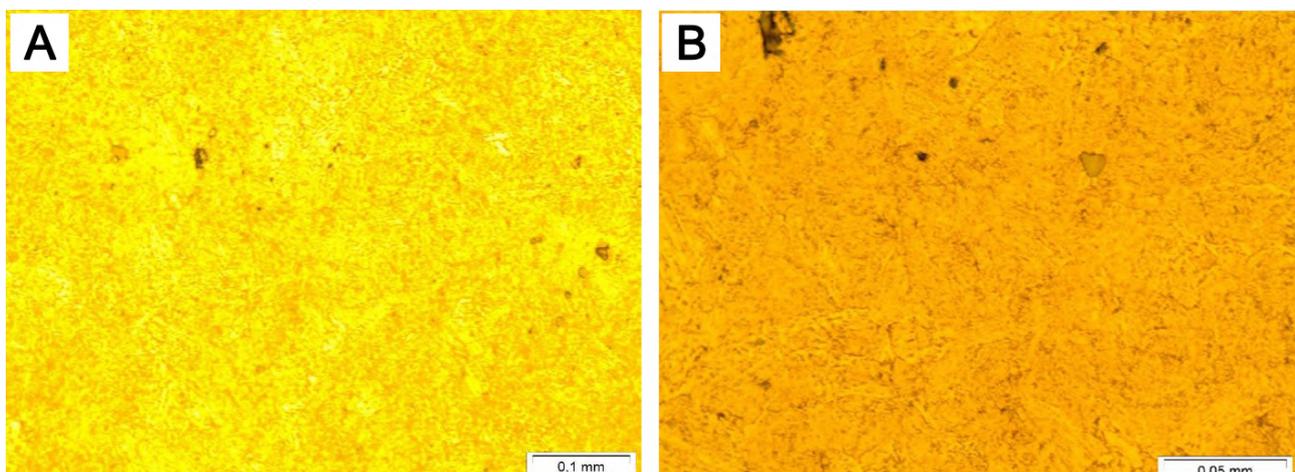
The microstructure obtained at the two temperatures employed in the tempering was the tempered martensite.

Figure 17. (A) and (B) Microstructure of the treated material at 560°C.

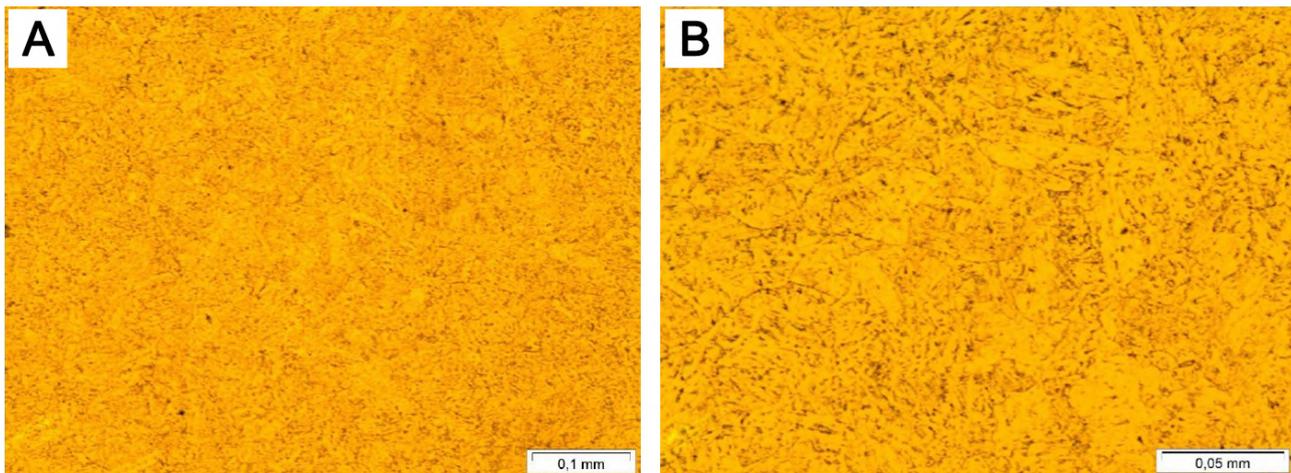
Figure 18. (A) and (B) Microstructure of the treated material at 590°C.
