25th ABCM International Congress of Mechanical Engineering
October 20-25, 2019, Uberlândia, MG, Brazil

DEVELOPMENT OF A DIDACTIC BENCH FOR SHAFT MISALIGNMENT AND ROTOR UNBALANCE EVALUATION OF VIBRATION LEVELS

Luiz Carlos Perrelli Halila
Giovanni Bratti

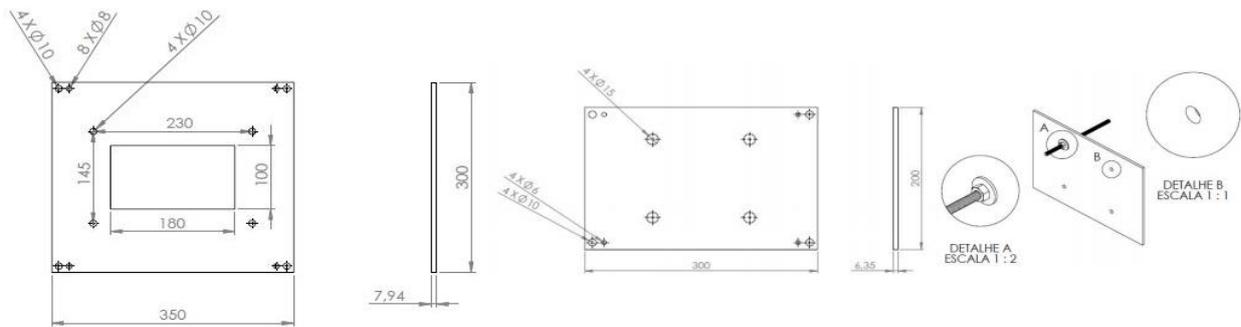
Figure 1 – Material used for the assembly

To develop the didactic equipment proposed in this paper, two configurations were projected, built and analysed. The main purpose of this was to choose which configuration would present higher levels of vibration while experiencing induced defects of misalignment and unbalance. And most importantly, the easiness of test execution and defect correction. In both configurations AISI 1020 steel sheets were used to sustain the induction motor and shaft, the dimensions of this are presented in Fig. 1.

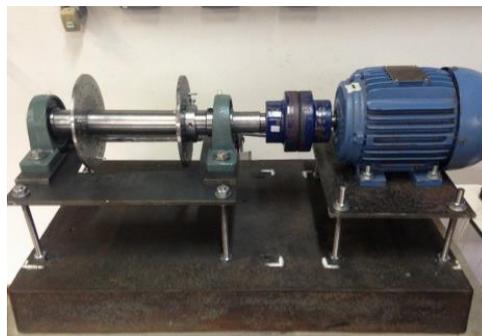
Figure 2 – First Configuration

The main difference within the two configurations was its fixation base. For the first one, it was chosen a threaded bars system with a stainless steel M08 bolts, the main characteristic for this configuration was low levels of damping and higher levels of stiffness. Furthermore, this configuration allows height adjustment of the steel bases from the nuts as demonstrated in Fig. 2.

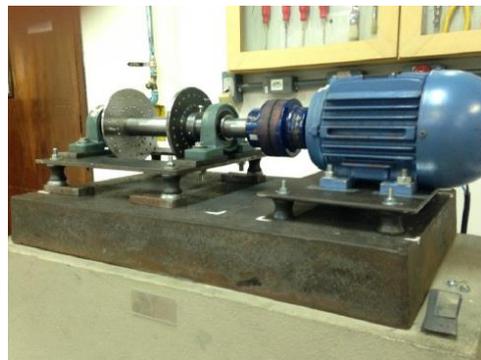
Figure 3 - Second Configuration

In the second configuration the system base is composed by cushions (stud vibration isolators). Therefore, higher levels of damping and lower levels of stiffness as presented in Fig. 3.

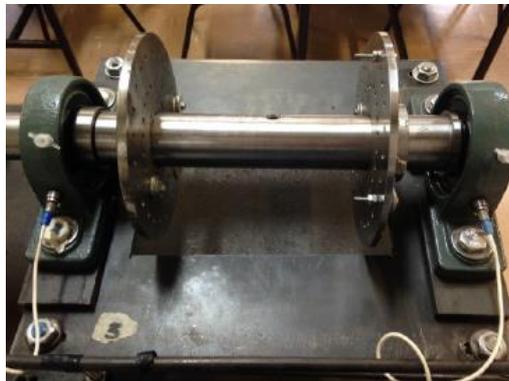
Figure 4 - Accelerometers in the radial direction

According to SCHEFFER & GIRDHAR, p. 90, 2004, it is possible to identify static and couple unbalance by the spectrum analysis for the amplitude peak. According to the authors, the vibration cross-spectrum for a rotor machine with an unbalance defect must demonstrate a peak at the rotor frequency, or 1x rpm for radial vibration. For this reason, and also to perform a phase analysis, two accelerometers were attached to the shaft bearings in the radial direction as shown in Fig. 4.

With the motor running, the signal was measured and stored in a computer for further mathematical processing. So, it was measured the vibration cross-spectrum between the signals in the radial direction, as shown in the Fig. 4. After this, the unbalance mass was removed to evaluate the vibrations due to the misalignment defect.

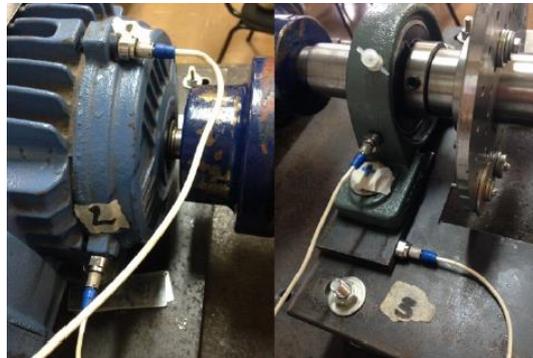
Figure 5 - Accelerometers for misalignment detection

The positioning chosen to measure these vibrations, axial and radial, are shown in the Fig. 5.

In figures 12 and 13 it is shown, respectively, the measured frequency response function for the axial and radial directions, according to the Fig. 5. The peaks represent the critical frequencies of the system, i.e., the natural frequencies.

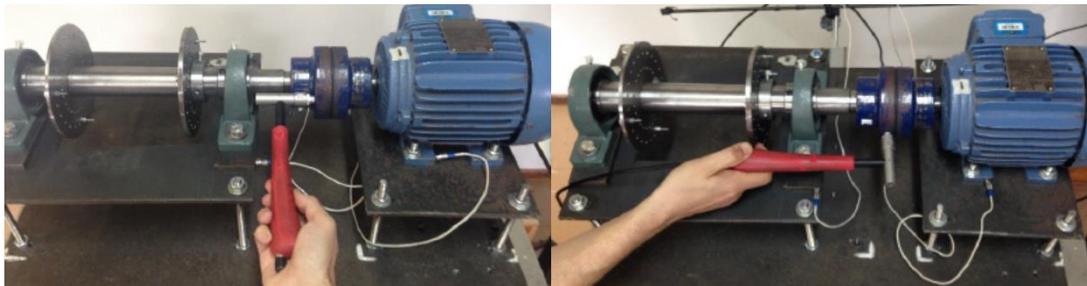
Figure 6 - Impact test, axial and radial directions

This test is important because it can foresee which system will have higher levels of vibration in a vibration range. Both systems were tested with an ENDEVCO impact hammer and two 256-100 ENDEVCO accelerometers, these were positioned in the axial and radial directions as shown in Fig. 6.

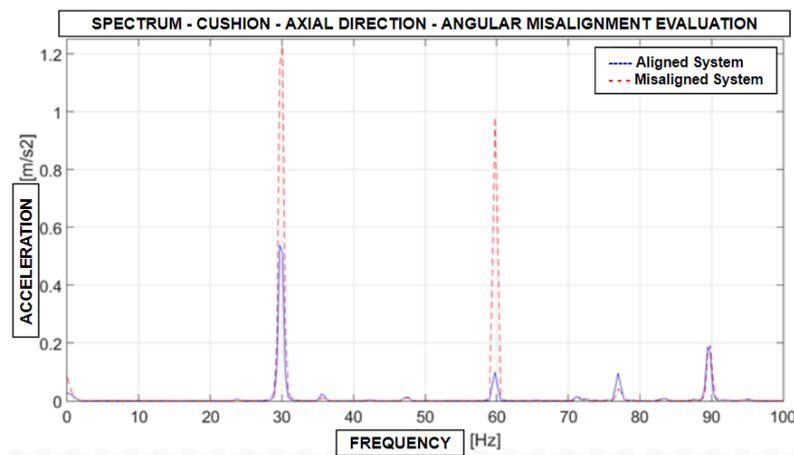
Figure 7 – Results for angular misalignment identification

For this type of defect, it was not possible to effectively identify the angular misalignment for the equipment assembled with threaded bars. However, for the cushion assembly, according to SCHEFFER AND GIRDHAR, P.94, the results indicate an angular misalignment defect with the increase of the vibration level at 1x rpm (30 Hz in this case) in one of the bearings, as demonstrated in Fig. 7 below.

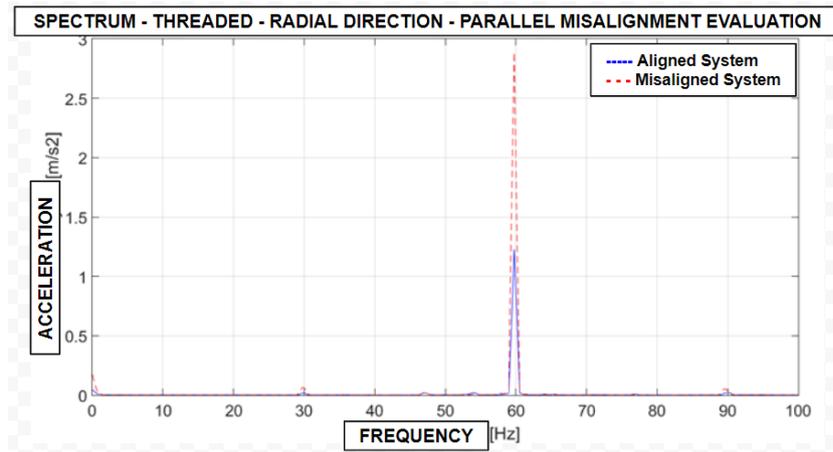
Figure 8 – Results for parallel misalignment identification - Threaded Bars

Different from the previous defect, it was possible to identify the parallel misalignment for both systems, assembled with threaded bars and cushions. According to SCHEFFER AND GIRDHAR, P. 96, the identification of this type of defect relies on the rise of the radial vibration level at 2x rpm or 60 Hz. The results for the threaded bars assembly are presented in Fig. 8, a sharp rise in the vibration level is indicated at 60 Hz.

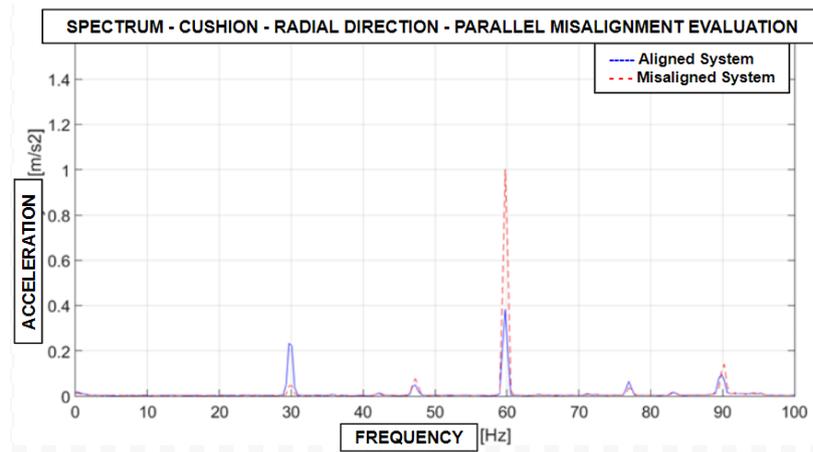
Figure 9 – Results for parallel misalignment identification - Cushions

The results for the cushion assembly are presented in Fig. 9, an increase in the vibration level is indicated at 60 Hz, this represents a parallel misalignment defect. It is important to note that the net frequency is equivalent to 2x rpm or 60 Hz. This might have influenced in the results by increasing the readings at 60 Hz.

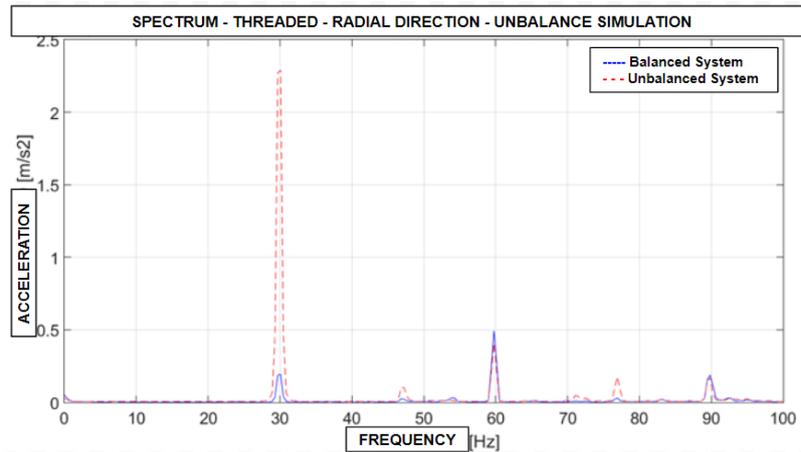
Figure 10 – Results for unbalance identification – Threaded Bars

The results show that it was possible to detect unbalance defects in both systems. According to SCHEFFER AND GIRDHAR, p.90, the vibration level at 1x rpm or 30 Hz should sharply increase for an unbalance defect. It is presented in Fig. 10 the result of the experiment that simulated an unbalance situation.

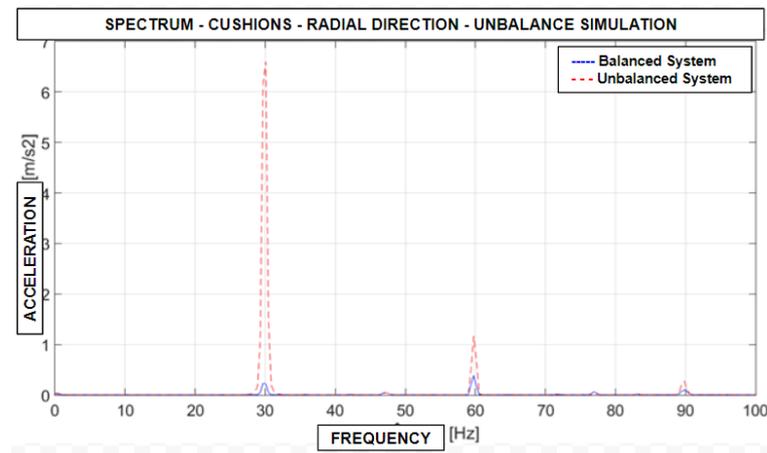
Figure 11 – Results for unbalance identification – Cushions

It is presented in Fig. 11 the result of the experiment for the system assembled with cushions. The sharp rise at 1x rpm indicates the unbalance defect according to the authors cited above.

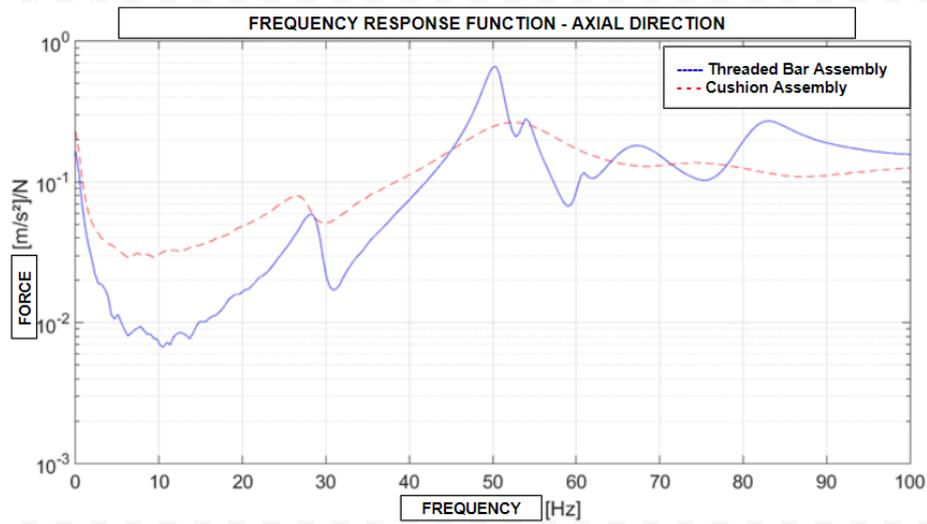
Figure 12 - Frequency response function - Axial comparison

It can be seen that, for the cushion system, the response in the frequencies 1x and 2x (30 Hz and 60 Hz) is greater than that for the threaded system. This agrees with the data previously shown where the actual level of vibration is higher for the cushions assembled system than for the threaded bars.

The shape of the graphs also represents the difference between the damping capacity of the studied materials. Comparing the frequency response functions, it is possible to see that the cushion system response shows a higher damping level, that is, smoother peaks. This tends to give higher amplitudes at the anti-resonances and lower at resonant frequencies.

It is suggested for further studies the effects of a frequency inverter acting in the system, the Figures 11 and 12 demonstrate the critic frequencies. Once the frequency inverter is set to these frequency it is possible for the academic community to study the effects of resonance in the system.
