25<sup>th</sup> ABCM International Congress of Mechanical Engineering  
October 20-25, 2019, Uberlândia, MG, Brazil

## COB-2019-1925

# PREDICTIVE MAINTENANCE USING INFRARED THERMOGRAPHIC CAMERA IN AGRICULTURAL MACHINES

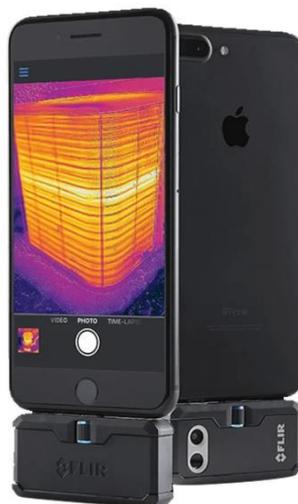
Figure 2. Exemple of camera Flir One Pro-3<sup>a</sup> coupled into a smartphone.

This camera permits measure temperature at  $-20^{\circ}\text{C}$  to  $120^{\circ}$  (out of this range the camera loss precision) with  $0,1^{\circ}\text{C}$  resolution and  $3^{\circ}\text{C}$  precision approximated. The camera produces a two-dimensional matrix while the software transforms numeric data in an image, as exemplified in Fig. 3. Technician then selects the region of image for which software will delivers average, maximum and minimum temperatures. This information is compared with usual operational parameters and must stay within a range (stipulated by the manufacturer). Any deviations will lead to further detailed inspection. The usual values are determined according to service provider and database information. Two types of sugar cane harvesters (A and B) and two tractors (C and D) was inspected. Points that was analyzed was gears, hydraulic pumps and electrical components.

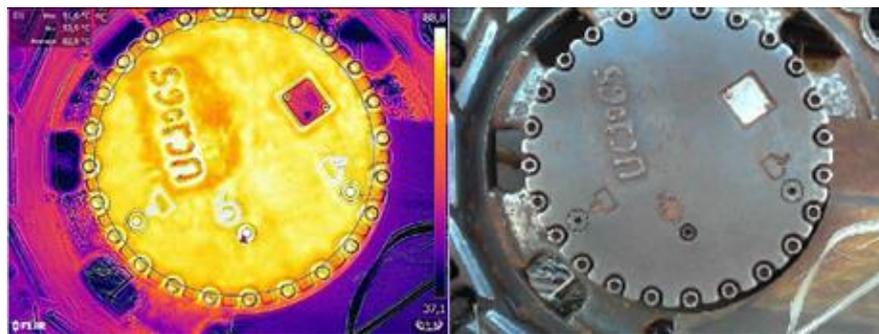
Thermographic analysis performed on parts of the sugar cane harvester A revealed abnormalities in temperature range of roller 7, roller 8 and final direct reduction (Fig. 4) of treadmill where the operation temperature was 131% higher above to the ideal. Two possible causes were suggested. First one was lack of lubrication in the system, since it would lead to more severe contact and thus increase friction, consequently leading to higher temperature. Another hypothesis is that lubricating oil used in the system was out of date or contaminated, since it would also lead to poor lubrication and more severe contact. Table 1 indicates the ideal operating temperatures of each agricultural machinery and the out-of-range temperatures found through the thermographic analysis.

Figure 4. Thermographic analysis in final right reduction of roller conveyor from sugar cane harvester where the average temperature was 46,2°C.

After presenting the results of the thermographic analyzes, the sector responsible for the maintenance of the agricultural machinery began an inspection work that verified the failures indicated by the excessive temperature in the compartments of the machines. In the cane harvester A, it was confirmed that the excessive temperature originated from the friction in poorly lubricated gears. The lubricating oil level was below the recommended level due to a leak in a retainer. The worn gear particles contaminated the fluid and consequently the wear and tear tended to get worse. Thanks to predictive maintenance, the problem was solved at an early stage, emphasizing the advantage of the agility of the thermographic analysis that allows quick inspections and in short periods (in relation to a reference of hours worked by the machine).

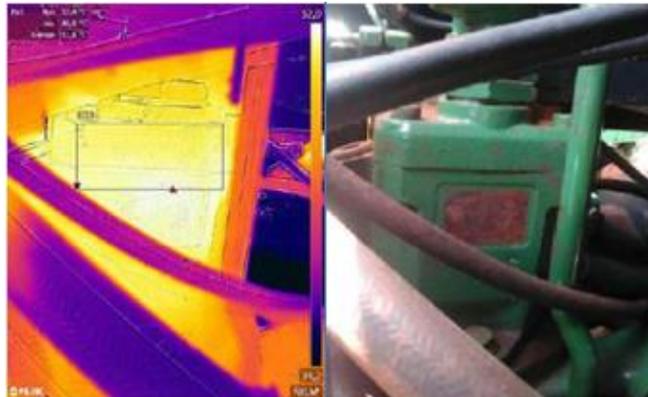
In the tractor D, through thermographic analysis a temperature increase in the hydraulic pump was detected. Fig. 7 shows a thermography performed on the hydraulic pump operating at a temperature above the ideal with average of 68,2 °C, while in Fig. 8 shows a hydraulic pump operating under normal conditions with a average temperature of 41,9 °C.

Figure 7- Thermography of a hydraulic pump operating at an above ideal temperature.

From the temperature differences recorded by the thermographic analyzes, an average discrepancy of 25°C is observed when compared to the hydraulic pump subjected to high temperatures with a hydraulic pump operating under normal conditions. This was due to an oil leak in the tractor's hydraulic system. There was reduction in the amount of oil and contamination of the remaining oil. As a result, the hydraulic pump operated under non-ideal conditions, leading to increased friction and consequently generated an increase in its temperature. In hydraulic systems, hydraulic oil also has a secondary function of lubricating the system.

The tractor D presented, as well as the cane harvester B, an elevation of the temperature in one of its hydraulic pumps. However, unlike case B where the origin consisted of excess hydraulic oil, in case D a lack of hydraulic oil was diagnosed. Hydraulic oil has the secondary function of lubricating the hydraulic pumps, and their level below the ideal makes it difficult to work the pump. The leakage point found was at a point of low pressure, and in this condition, there is the possibility of particles entering (dust, due to the working condition of an agricultural machine). This particles had a confirmed presence in a fluid analysis done in parallel with the thermographic analysis. Dust in the working environment of the agricultural machine contains silicon (coming from soil) oxides, which are abrasive and wear down the entire hydraulic system.
