25<sup>th</sup> ABCM International Congress of Mechanical Engineering  
October 20-25, 2019, Uberlândia, MG, Brazil

## COB-2019-2066

# MULTIPARAMETER MONITORING OF THE SPEED ADJUSTMENT SYSTEM OF A 390 MW FRANCIS TURBINE

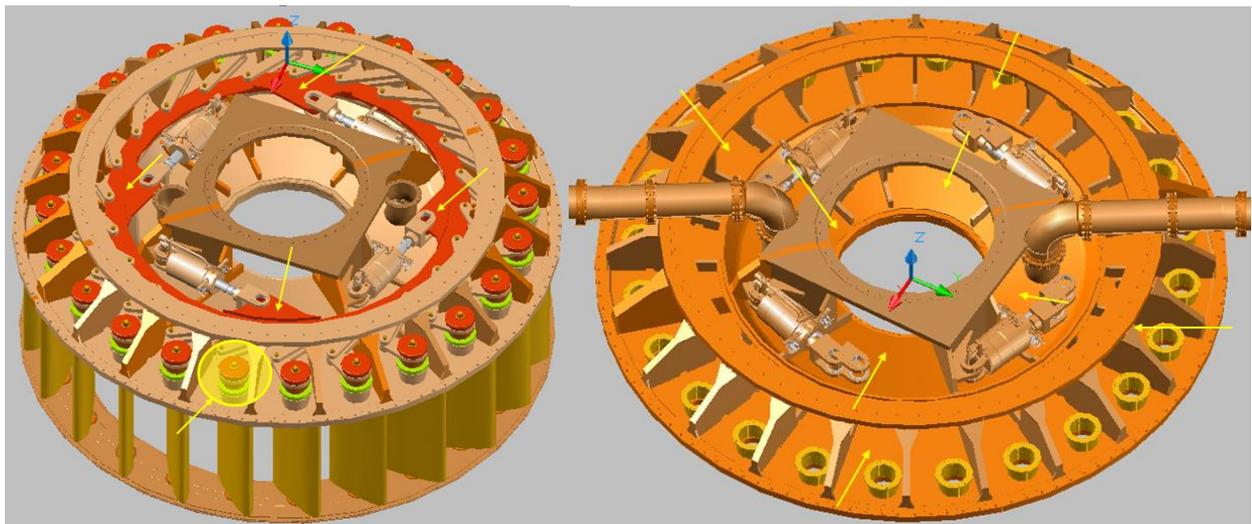
Figure 1. 390 MW hydraulic turbine distributor system and location of the strain gages.

The Francis turbine speed control system of unit 13 of Tucuruí Hydroelectric Power Plant has twenty four (24) sets of wicket gates with upper lower connecting rods, cranks, trunnions and guide vanes and four (4) servomotors with a force capacity of 1450 kN, to opening, closing and control operations of the speed governor system. These components are shown in figure 1. The maximum operating pressure of the hydraulic system is 64 Bar.

The positioning of strain gages is a critical step in the microstrain data acquisition process. However, only with its correct positioning can the measurement results be analyzed comparatively with a reference data in Project or in FEM (Finite Element Method) and detect the presence of faults and abnormalities. The yellow aims in the figure 1 shows the selected location of the sensors.

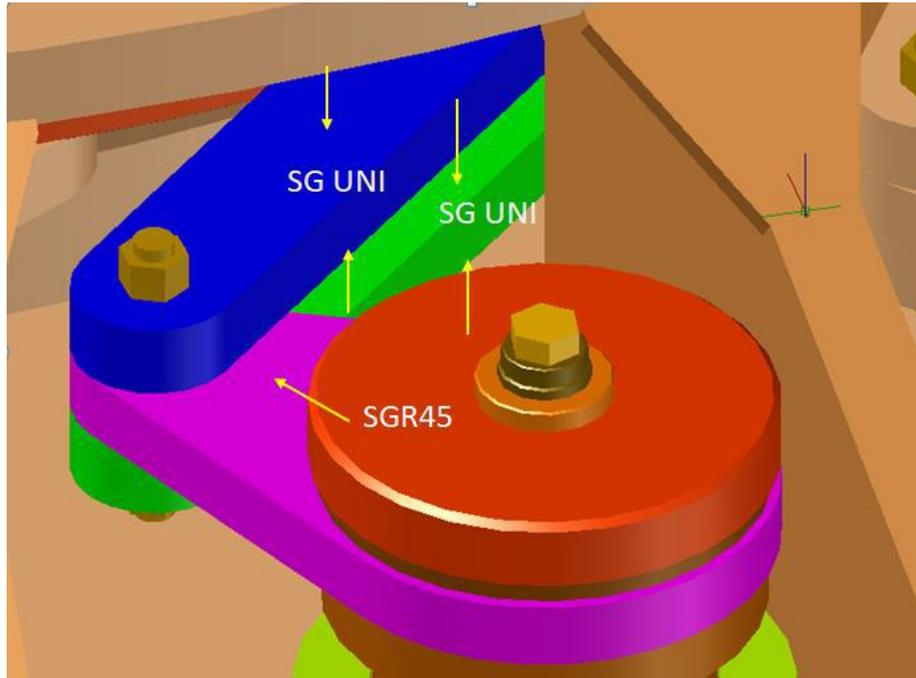
Figure 2. Chosen location of the strain gages in the cranks and trunnions of speed governor mechanism.

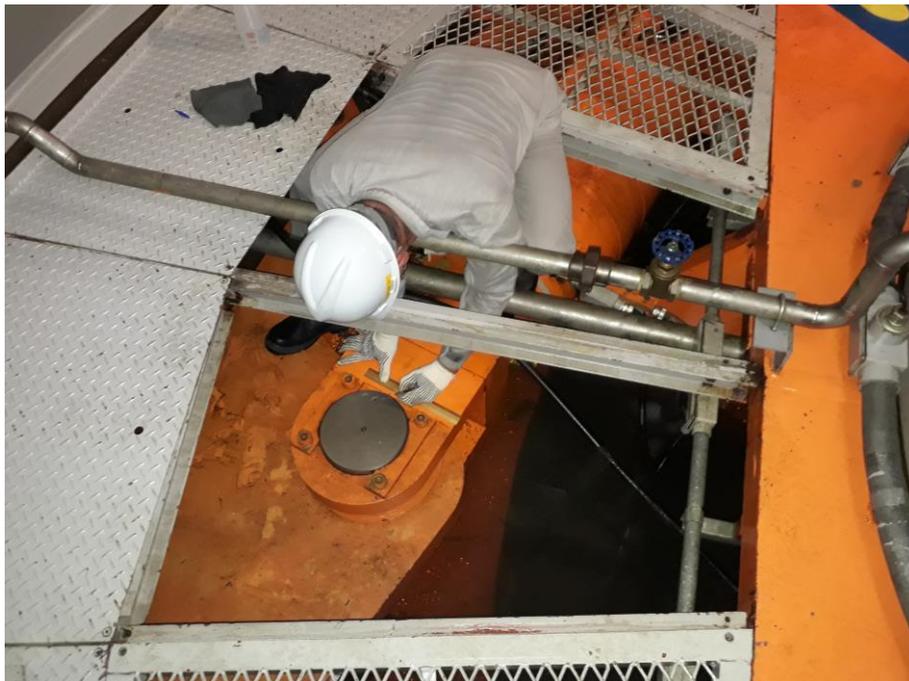
Figure 3. Installation of the strain gage in the fork of linkage of servomotor 1 with synchronism ring

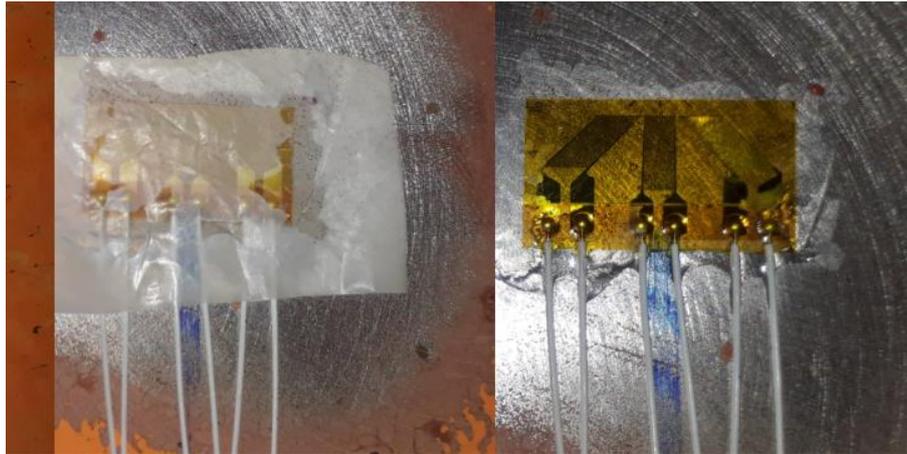
Figure 4. Fitting the 45° rosette type sensors of the distributor mechanism timing ring with Loctite® 496.

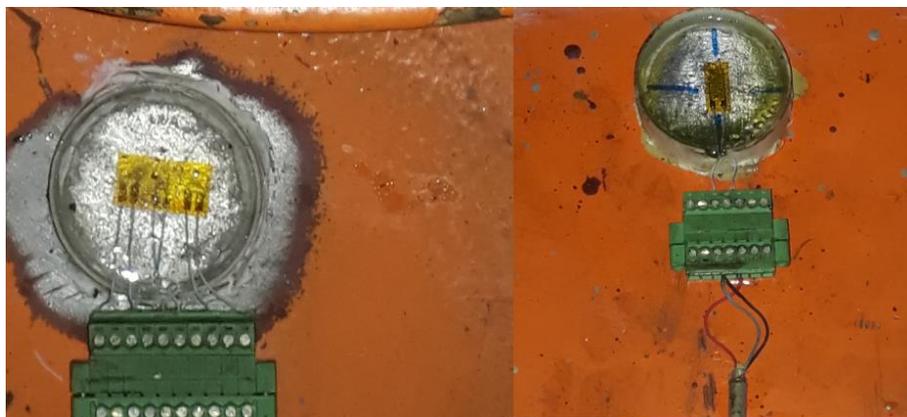
Figure 5. Mechanical and chemical protection of strain gauges using epoxy resin

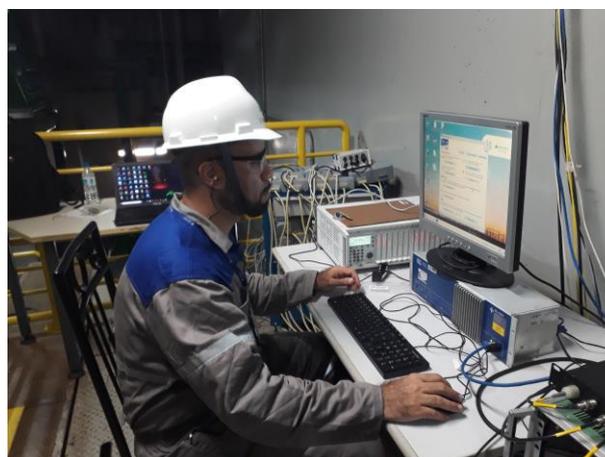
Figure 6. Operation of the data acquisition system during the multi parameter tests in the 390 MW Francis Turbine 13 of Tucuruí Power Plant.

The HBM MGC Plus data collector was used, combined with the CATMAN version 3.1.3 software to perform the microdeformations test. The parameters adopted for experimental stress analysis were: modulus of elasticity of 206 GPa and Poisson coefficient of 0.3 of ASTM A36 steel, that is the material of mechanical components of speed governor mechanism.

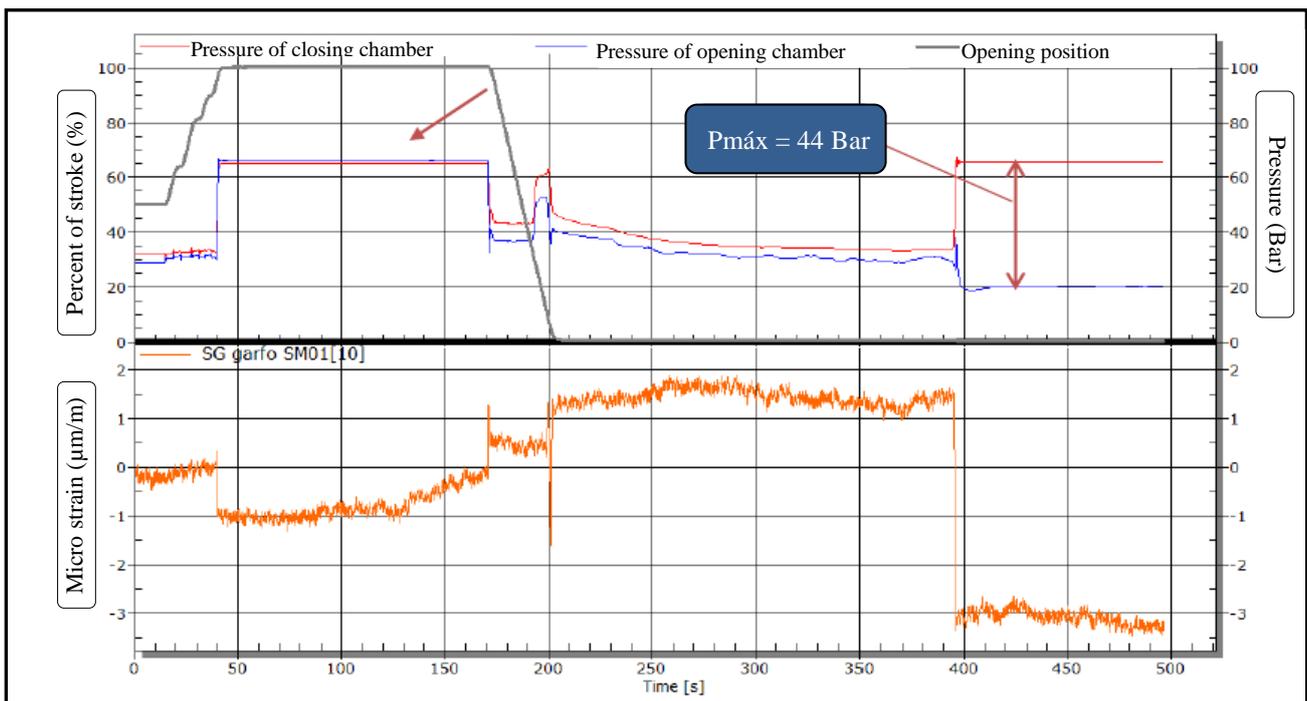
Figure 7. Pressure in the chambers and micro strain of the fork of servomotor 1.

The results in the figure 7, shows that servomotor 1 presented nonconformities in the distribution of pressures in the total closure and in the total opening. The maximum pressure in closing position was 44 Bar (instead 64 Bar), denoting Losses of 20 bar by leakage through the opening chamber, in the fully retracted position. Also, it could be seen equalization of pressures in the fully distended position. In the intermediate positions of the stroke, the servomotor presented regular behavior. In the crushing of the wicket gates, the fork of the servomotor presents compression loads instead of traction, denoting poor position adjustment of the servomotors forks for pre-compression adjustment of the guide vanes.

The graphs of the results of the micro strain and pressure of servomotor 1 test results are shown in figure 6. These results were recorded in "dead water" operations (turbine without water flow) with the HBM MGCplus data acquisition chain. The graphs were taken from Catman software, in order to measure the mean coefficient of friction of the mechanism and pressure distribution of the chambers inside the servomotors.

Some notes about the expected behavior of the components are important to analyze the results. The strain signal expected for the fork of the servomotor (linkage between servomotor and synchronous ring) is compression loads in total opening, once the servomotor is totally extend in this position. In total closure the traction loads is expected in the fork, once the synchronous ring is totally closed before the servomotor reach the total retracted position. It's calling crushing effect of the wicket gates and it's necessary to guarantee the maximum sealing of the speed governor when it's closed.

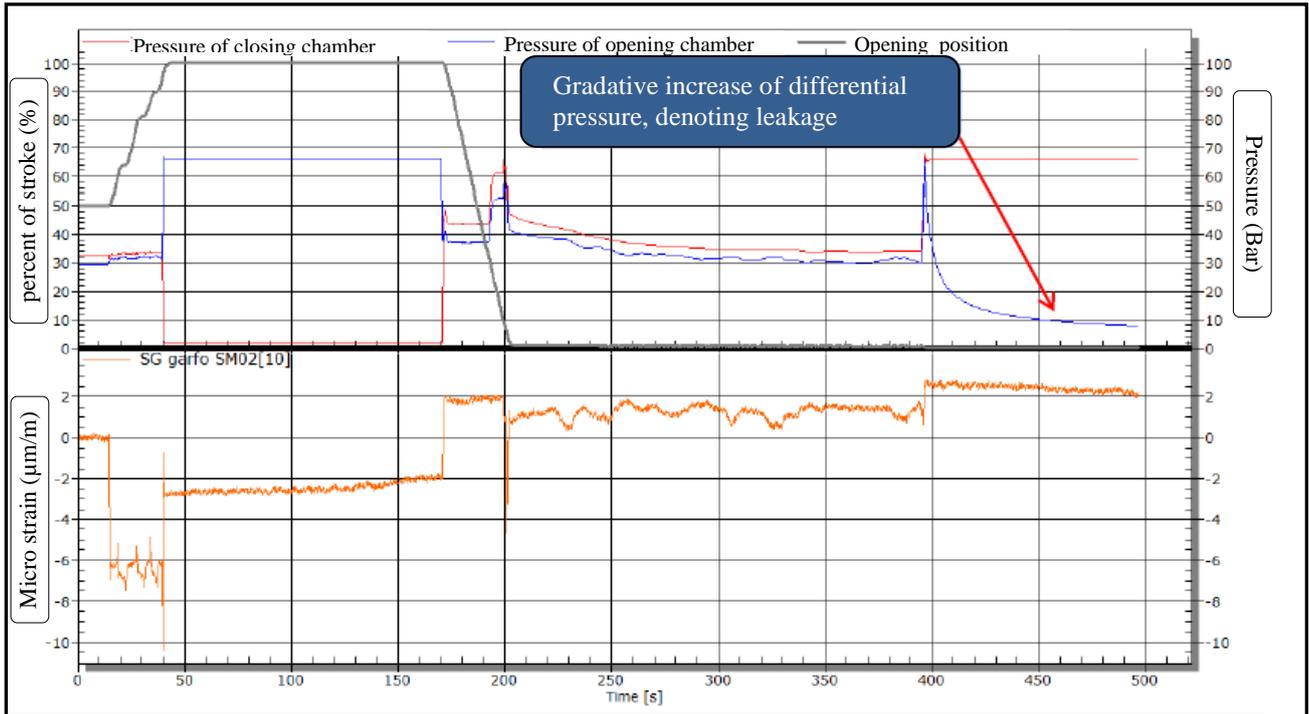
Figure 8. Pressure in the chambers and micro strain of the fork of servomotor 2.

In the figure 8, we can see that servomotor 2 presented regular pressure distribution at the intermediate position of the stroke. In the crushing of the wicket gates (total closure), the fork of servomotor presented traction load of coupling with the adjustment ring, as required in the in the assembly specification. The gradual reduction of the differential pressure in the crushing denotes internal leakage of other servomotors, reinforcing the diagnosis of leakage in the servomotor, in the fully collapsed position.

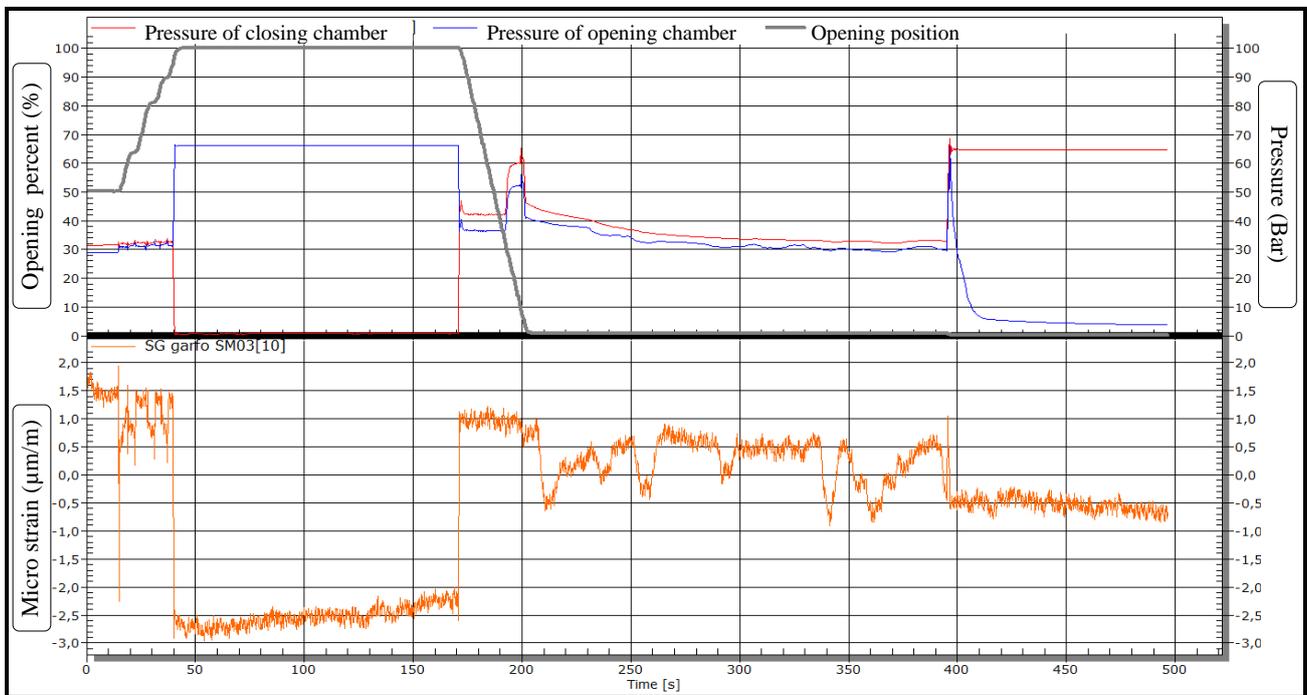
Figure 9. Pressure in the chambers and micro strain of the fork of servomotor 3.

The servomotor 3 presented a standard pressure distribution of the chambers and strain of the fork (linkage between servo and synchronous ring) in the opening, closing and in intermediate stroke. In the crushing of the wicket gates it

presented neutral load in the fork of coupling with the adjustment ring, denoting bad adjustment of position of the fork of coupling of the regulating ring.

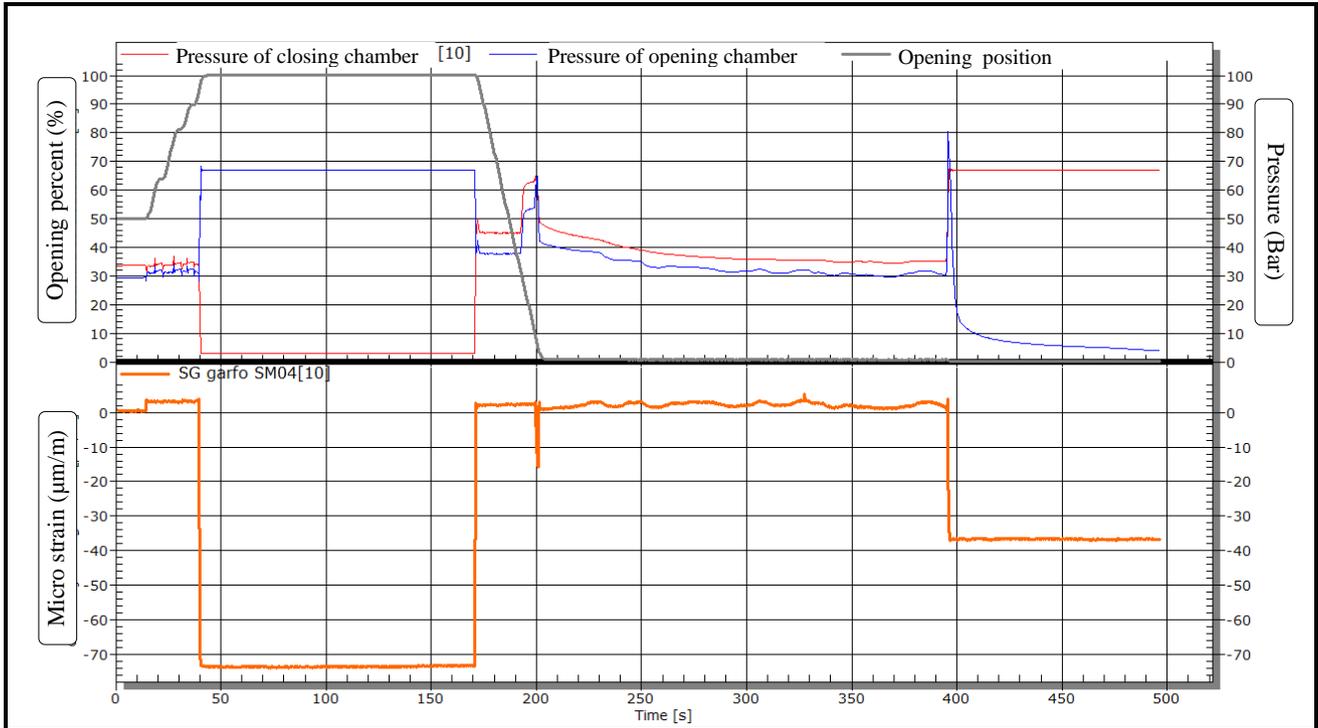
Figure 10. Pressure in the chambers and micro strain of the fork of servomotor 4.

The servomotor 4 presented a regular behavior of the pressure distribution along the stroke. In the crushing, it presented compression load in the fork of coupling with the regulating ring, denoting bad regulation of position of the fork. Pressure differential with gradual pressure reduction of the opening chamber, denotes the internal leakage of the adjacent servomotor, n<sup>o</sup>.1.

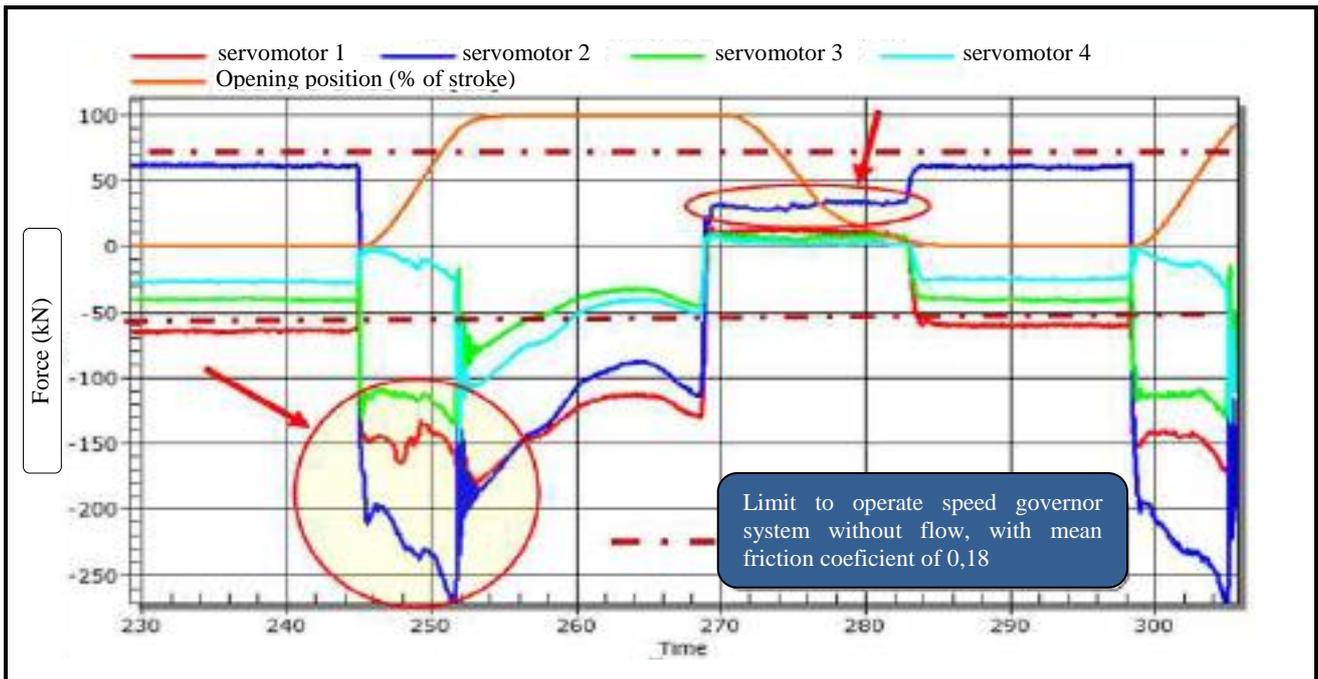
Figure 11. Drive force of the servomotors before change of the material of guide vanes journal bearing by PTFEE. Detail of the load reference value for the maximum coefficient of friction predicted in the design.

The analysis of loads in the speed governor mechanism show a significant overload in opening operation mechanism, without flow of water, that demonstrate a higher degradation of self-lubricate components in the mechanism of speed governor. Another important observation is the difference between the loads of the opening and closing operation and non linear loads in opening operation. In the test of *dead water*, is expected a constant load once there's no torque resistance generate by flow of water. Also in a standard operation this loads must be equal (opening and close). We conclude that there were another elements in mechanism that causes a non-linearity phenomena in the loads of opening. After maintenance, and complete disassembly of the mechanism, becomes clear that screws of the self-lubricate bearings were dropped out by the vibration in the cover of the turbine. This dropped screws, creating an aggressive interface between synchronous ring and steel guide in the cover of turbine (see fig.12). In fact these elements reached a point of fusion along the guides, causes an higher increases of loads in the mechanism. The overall strategy to correct the loads of the mechanism was change the material of self-lubricate components of the mechanism by PTFEE and reduces the friction coefficient.

The graph below, demonstrate the results of force applied by the servomotors before the five-year maintenance:

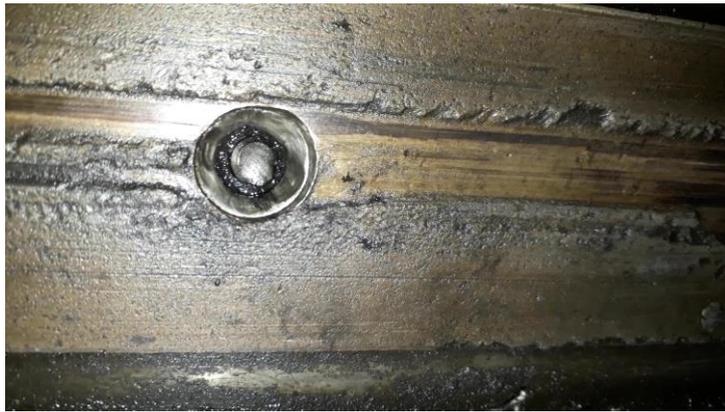
Figure 12. Degradation of self-lubricate guide of the synchronous ring.

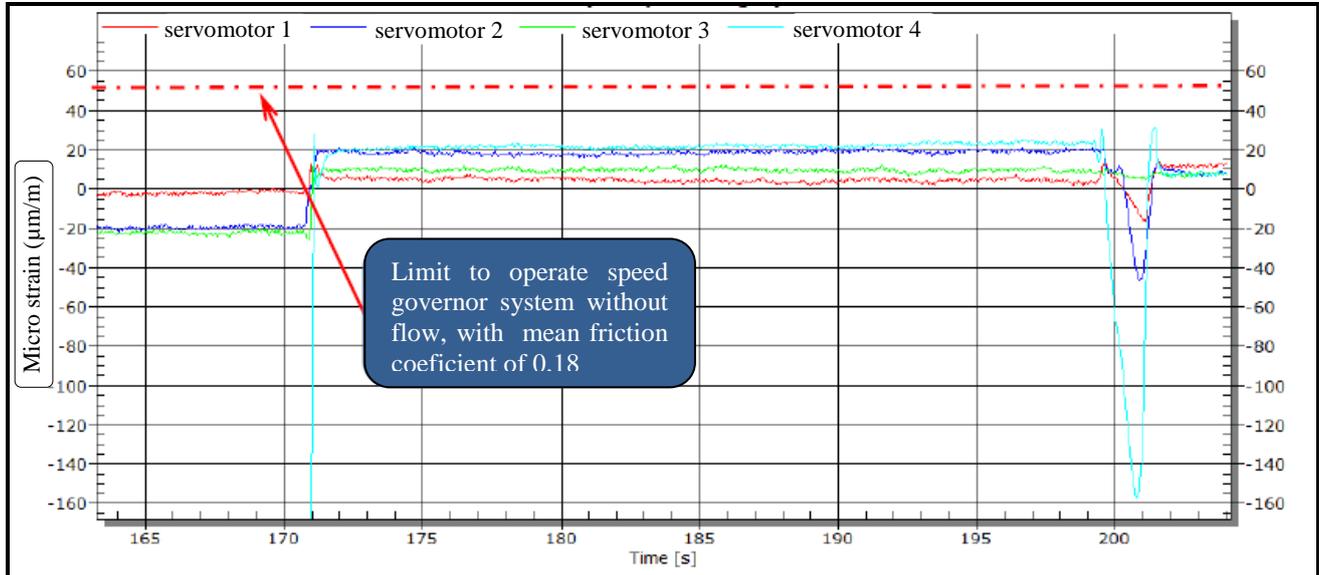
Figure 13. Drive force of the servomotors in opening operation after change of the self-lubricate material of the journal bearings by PTFEE.

As can see in figure 13, after the maintenance, was a significant reduction of the average friction coefficient of the mechanism after the replacement of the bushings with PTFE material (improvement implemented by the maintenance), and improvement of the heel sectors of the vane guidelines with increased contact area. The mean coefficient of friction of the mechanism after maintenance fell from 0.42 to 0.05.

- Significant reduction of the average friction coefficient of the distributor mechanism. From 0.42 (before maintenance) to 0.05 (after maintenance).

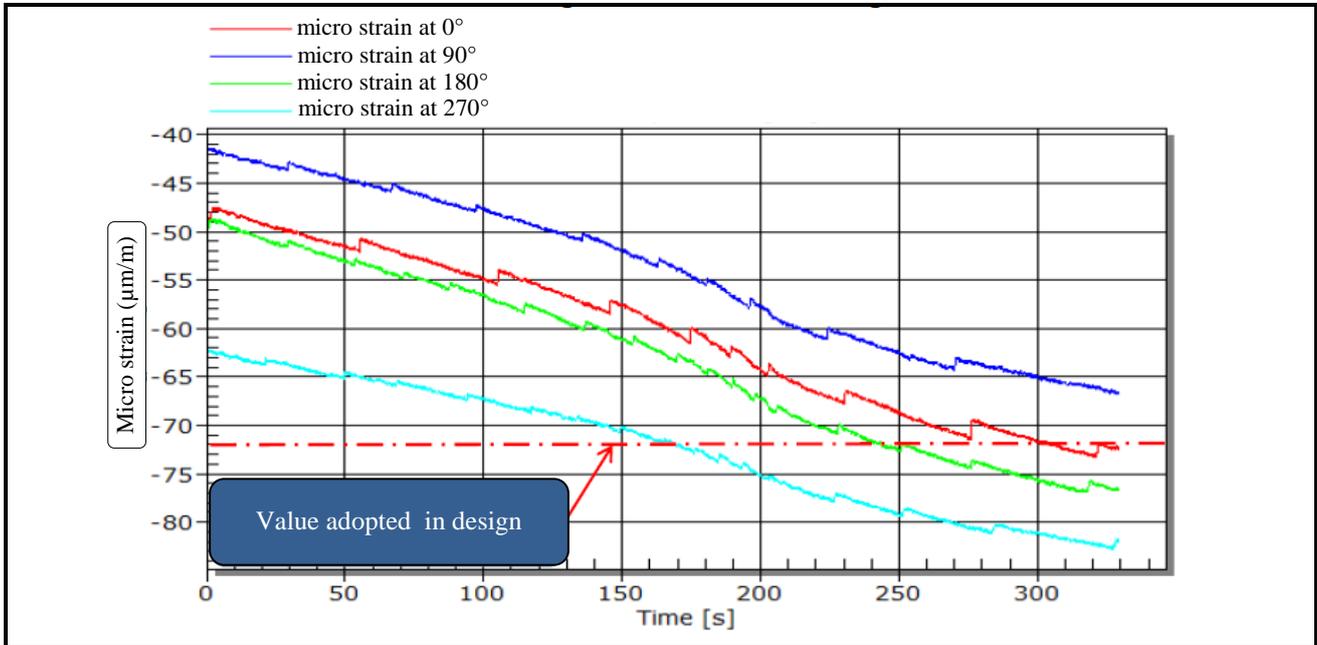
Figure 14. Radial microstrain of the turbine cap (orthogonal arrangement) during the pipe filling. Detail of the limit value, considered in design.

The deformation of the turbine cap during the filling of the penstock, extrapolated the design reference values. The turbine cap exhibited a lower axial stiffness resulting in increased drive torque of the guide vanes due to increased radial load on the journal bearings. These excessive torque values, combined with wear and increased friction of the old bearings, culminated in the recurrence of shear pin failures.

The figure 14 below show the micro strain of the turbine cap when subjected to the filling loading of the pipe (forced conduit). The angular position is referred to the pipe direction. 0° is aligned to the entrance of the spiral case.
