25<sup>th</sup> ABCM International Congress of Mechanical Engineering  
October 20-25, 2019, Uberlândia, MG, Brazil

## COB-2019-0130 FAILURE DETECTION IN GEAR TEST RIG

Instituto Tecnológico de Aeronáutica – ITA/CCM

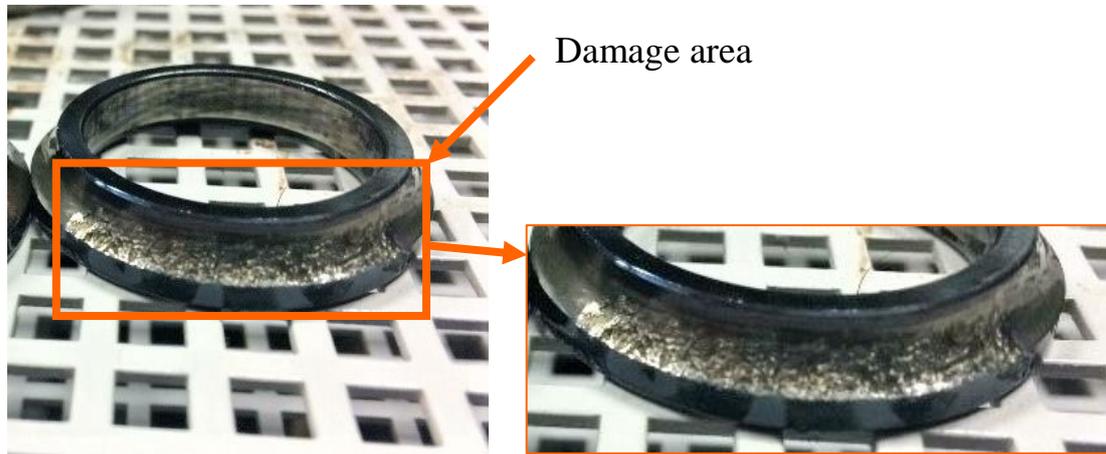
After the formation, the crack propagates until the material removal occurs. This material removal from the surface characterizes the condition of contact fatigue failure in bearings. Figure 3 shows the inner race of the bearing on the shaft of line 1 of the test rig.

Figure 3. Inner race bearing failure observed after inspection

In the damage area, it was possible to identify the surface cracks, characterizing the failure as contact fatigue.

While running, some micro-slips occur on the contact faces of the bearings. This occurs mostly due to distinct elastic properties of the contact surfaces and the different radius of curvature between them. This combination of rolling and sliding potentiates the contact fatigue failure, promoting the crack formation in the subsurface of the contact area (Campanha, 2008).
