25th ABCM International Congress of Mechanical Engineering
October 20-25, 2019, Uberlândia, MG, Brazil

COB-2019-2401 HARDNESS AND MICROSTRUCTURE EFFECTS ON SAE 1045 STEEL WEAR

Amália Mayrhofer
Ney Francisco Ferreira
Patric Daniel Neis
Daniel Rech Corrêa
Jean Carlos Poletto
Liur Barros

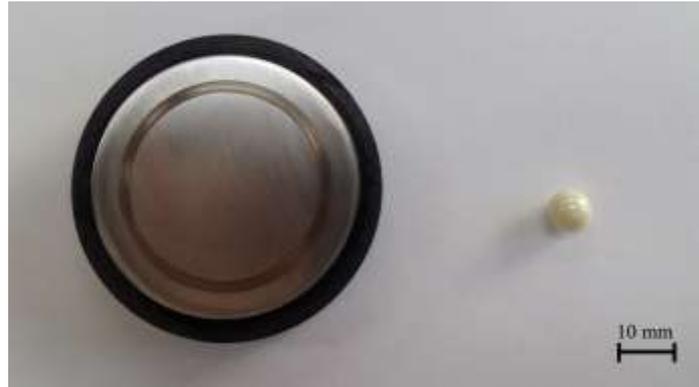
Six 1045 steel discs with 15 mm thickness and 55 mm diameter went through the following heat treatments: quenching (discs 1A, 1B and 1C) and normalization (discs 2A, 2B and 2C). The counterparts in the pin-on-disc tests were zirconium oxide balls (ZrO₂) with 8 mm diameter. Figure 1 shows a disc after test and a ball.

Figure 1. Materials used in the tribometer tests.
