25th ABCM International Congress of Mechanical Engineering
October 20-25, 2019, Uberlândia, MG, Brazil

PERFORMANCE OF THE TOOL FOR TAPPING WITH AND WITHOUT TRIBOLOGICAL COATING IN MACHINING OF CRANKSHAFT

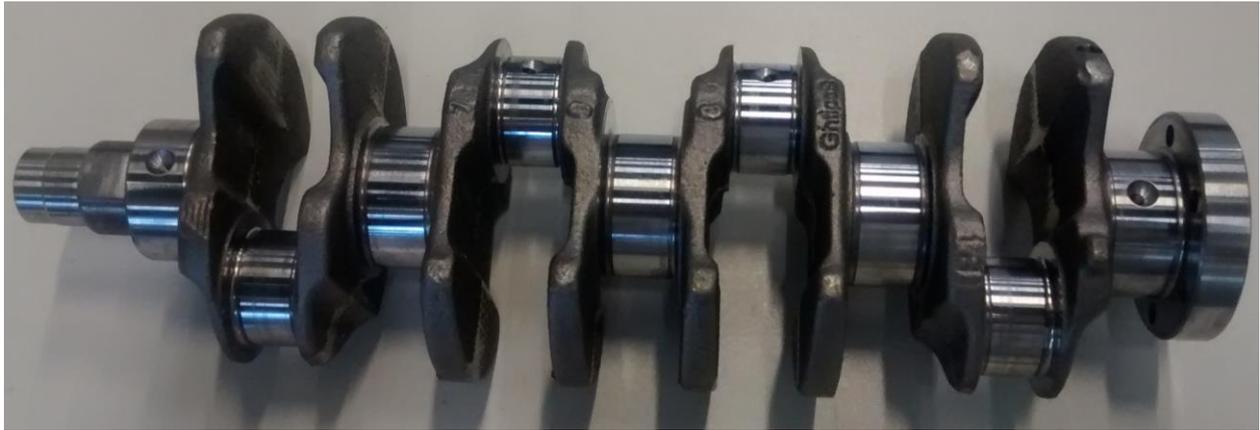
The crankshaft showed in "Fig. 1" of nodular cast iron / GH-Type B, hardness of 240-290 HB, was manufactured by gravity foundry and it is necessary to undergo some procedures of machining to achieve final dimensions of assembly.

Figure 1. Crankshaft used in the study

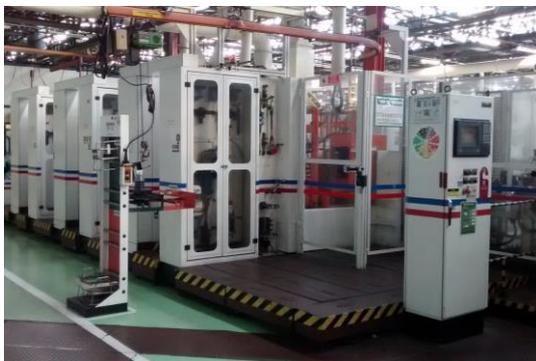
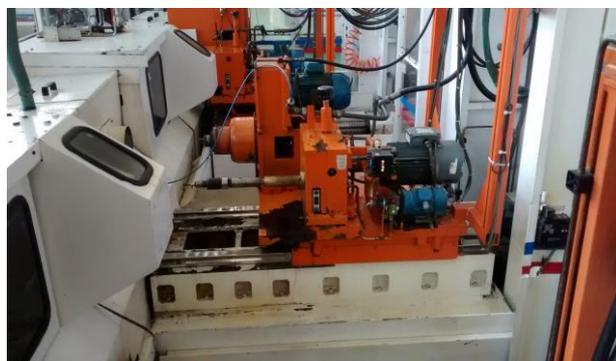
Currently, the holes tapping process are realized in an equipment called “Transfer Huller” as in “Fig. 2”. This machine allows the production of the thread in a sequential way, in which each cabin has a function, such as making the hole in the nodular cast iron of 11.04 x 31.5mm diameter before making the thread, widen the hole until it reaches the manufacturing cabin of the thread with the tool studied here. After that, they were liable to the fixation of crankshafts to engine gear. This process occurs in this way to increase productivity, so after 27 seconds one new threaded part was finalized.

Figure 2. (a) Equipment used in thread production of crankshaft; (b) the same equipment, highlighting the cabin of making threads.

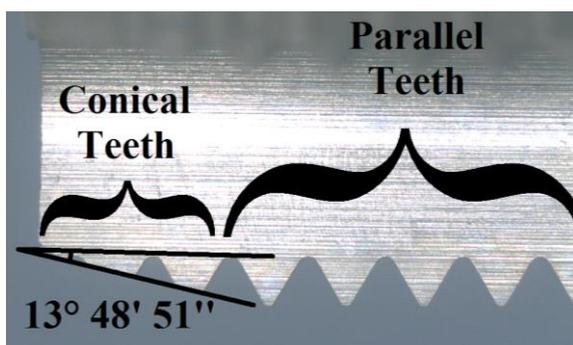
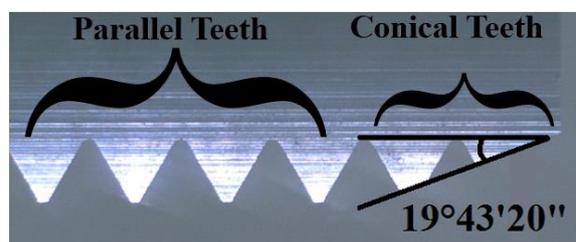
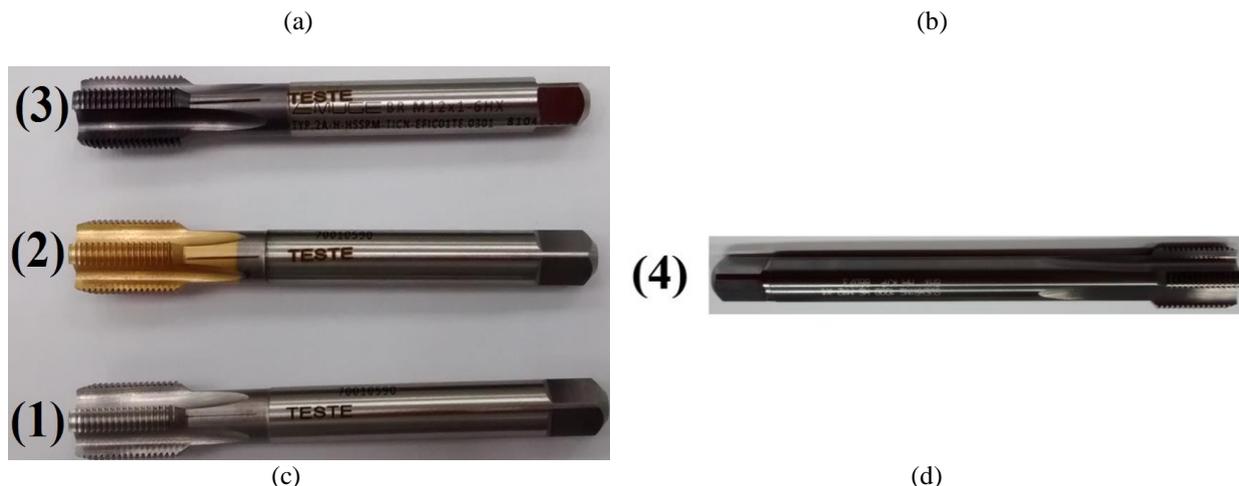
The tapping was made using two different types of geometry of threads with three and two conic taps and fifteen and fourteen parallels respectively as “Fig. 3”.

Figure 3. (a) HSS-PM tap geometry; (b) WC tap geometry; (c) Thread of (1) HSS-PM without coating, (2) HSS-PM TiN, (3) HSS-PM TiCN; (d) Thread of (4) WC-Co

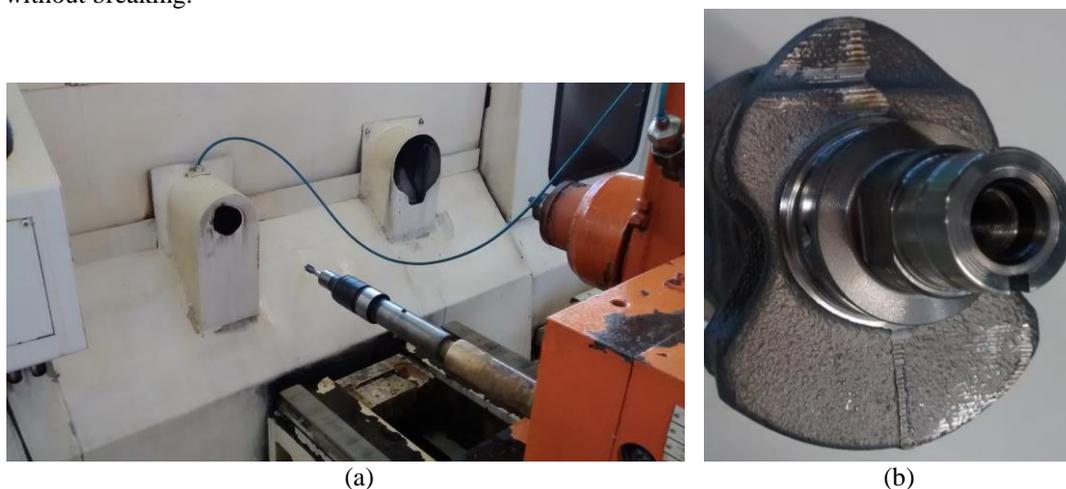
The “Fig. 4(a)” shows the cores utilized in tests HSS-PM without coating, HSS-PM TiN, HSS-PM TiCN and WC-Co. They were fixed with a floating head because if there was some discordance of concentricity, the tool could finish the process without breaking.

Figure 4. (a) Cores used to make the threads; (b) Crankshafts used in tests, highlighting the blind hole which the thread will be performed.

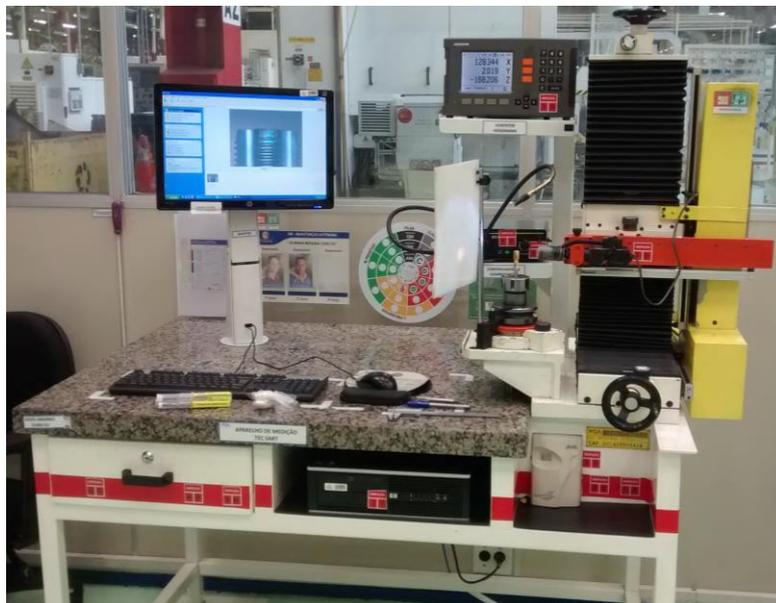
To follow the wear of each tool was used a machine with a high-resolution camera as “Fig. 6” that allowed to do an area analysis in the first three fillets, so that each period can be compared which fillet of which tool was most worn.

Figure 6. Machine that allowed measure the wear (Tecsart)

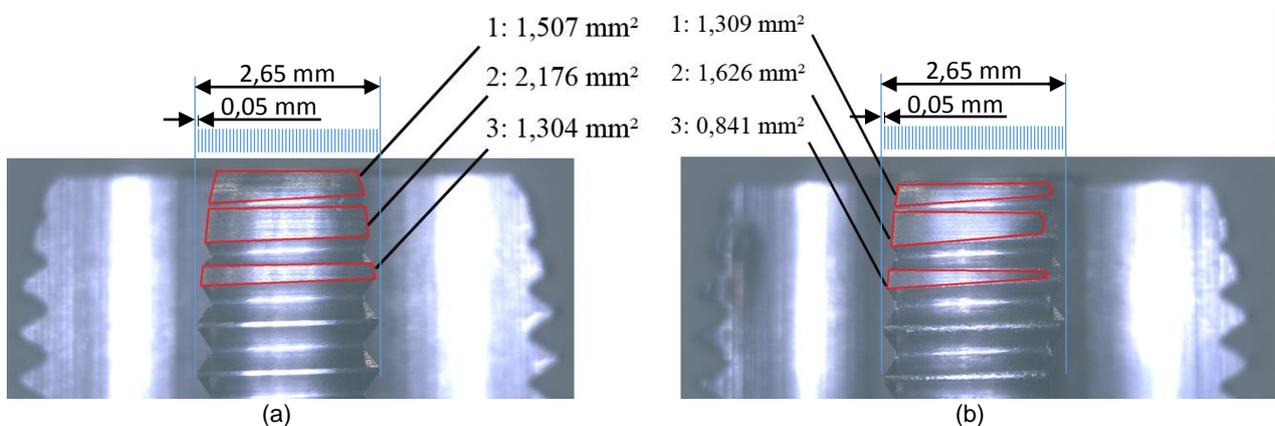
Figure 7. Examples of how the wear acts on the tool. (a) New HSS-PM without coating tap (b) HSS-PM without coating tap after 2100 parts.

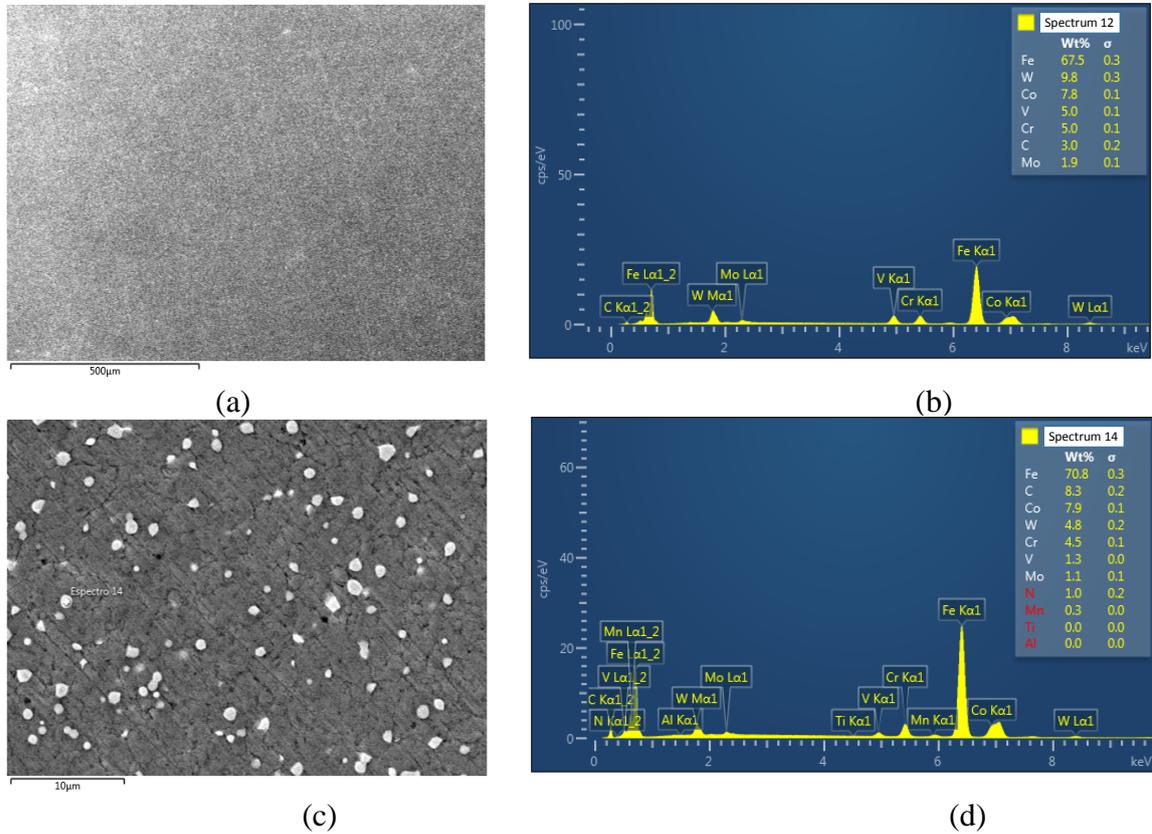
The “Fig. 8 (a-d)” shows the images of HSS steel tap. It was a high speed steel, tempering and quenched with some elements as W, V, Cr and Co shown in EDS analisys.

Figure 8. (a) View of HSS-PM; (b)EDS of HSS-PM; (c) View of HSS-PM particles; (d)EDS of HSS-PM particles

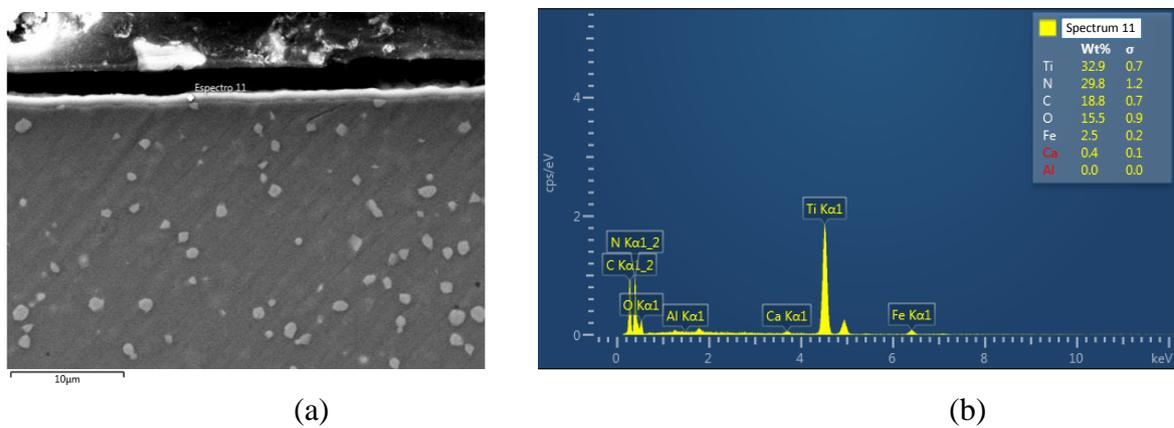
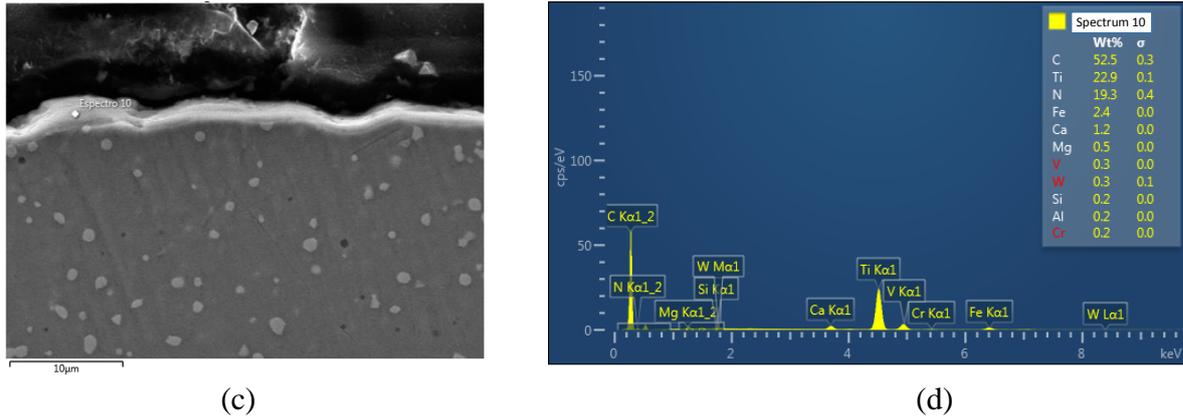
The “Fig. 9 (a-d)” shows the images of TiN and TiCN coatings with thickness close to 0,3 µm.

Figure 9. (a) View of HSS-PM TiN (b) EDS of HSS-PM TiN (c) View of HSS-PM TiCN (d) EDS of HSS-PM TiCN

It could be observed the chemistry composition of the substrate is the same in all taps with and without coating and coating has thickness approximately of 3µm showing PVD process. During the tapping process, this coating has been worn in the rake and flank surface with adhesion of nodular cast iron particles on the tools. This superficial layer aims to reduce the wear and improve the number of the crankshaft produced. It means that the useful tool lifetime increase, which leads to a reduction in production costs.

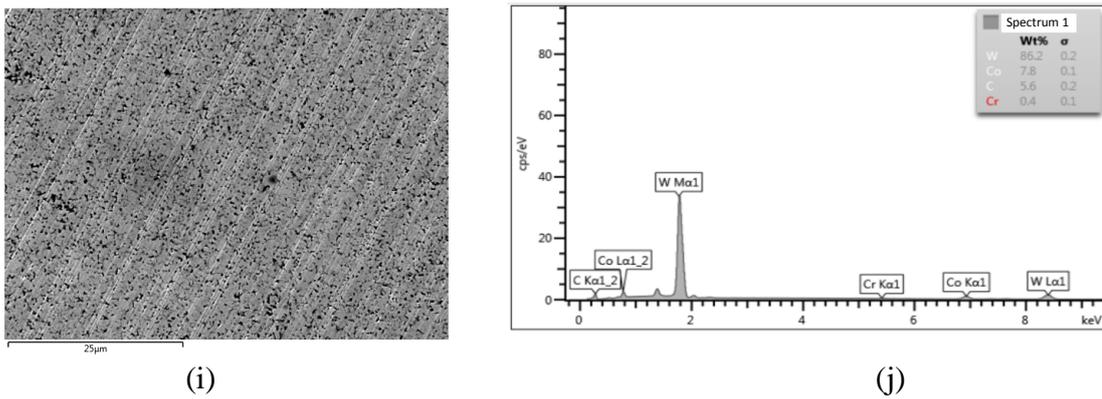
The “Fig. 10 (a-b)” shows the images of hard metal with WC and CrC particles in matrix Co.

Figure 10. (a) View of WC-Co (b) EDS of WC-Co

Before the test, it was received taps with first and second tip of hard metal. It was produced another conical teeth in the production area (third tip).

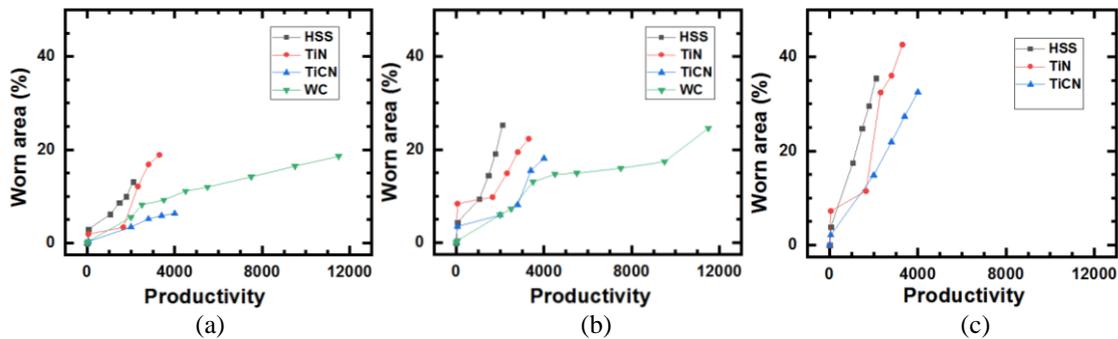
It was found that the malfunctions and wear of the cores that arose during the tapping operation occur in a greater degree on the edges of the conical region of the cores, i.e., the first three fillets, because this is the first portion of the core to perform the actions of cut, as verified by Dos Santos, Josué Olímpio et al. 2017. However, the analysis of the wear on the tools without and with coating happened gradually with the mechanism predominantly for "attrition". The wear was studied along the threading process considering the wear of the first, second and third conical threads. It was analyzed the worn out area for the three firsts taps because they are the firsts to contact to the nodular cast iron, suffering the greatest impacts of wear. It was analyzed with the number of crankshafts produced. This is an extremely decisive parameter, since it indicates where the tool is being more requested and therefore the useful life of the tool can be predictable. It can be better compared through graphs showing the wear area along with the quantity of crankshafts produced, such as "Fig. 11".

Figure 11. Evaluation of the (a) first; (b) second; (c) third fillet wear. Due to the WC not having the third conical fillet, the analysis of the third conical fillet was only made with the other three tools.

However, the best result is for WC tool, that exceeded the results of all other tools used in the study making more than double the considered second best tool and resisting much more time the were. WC tool with third tip produced in the area production has observed the best result with 18000 approved threads inspected by go/no go gages.

It was noted that for the same number of threads produced, the wear of the first, second and third threads were consistently higher for the HSS core, in spite of the expectation for the greater wear would be in the WC, due the recommendation of manufacturer for not use WC tool with low cutting speeds.

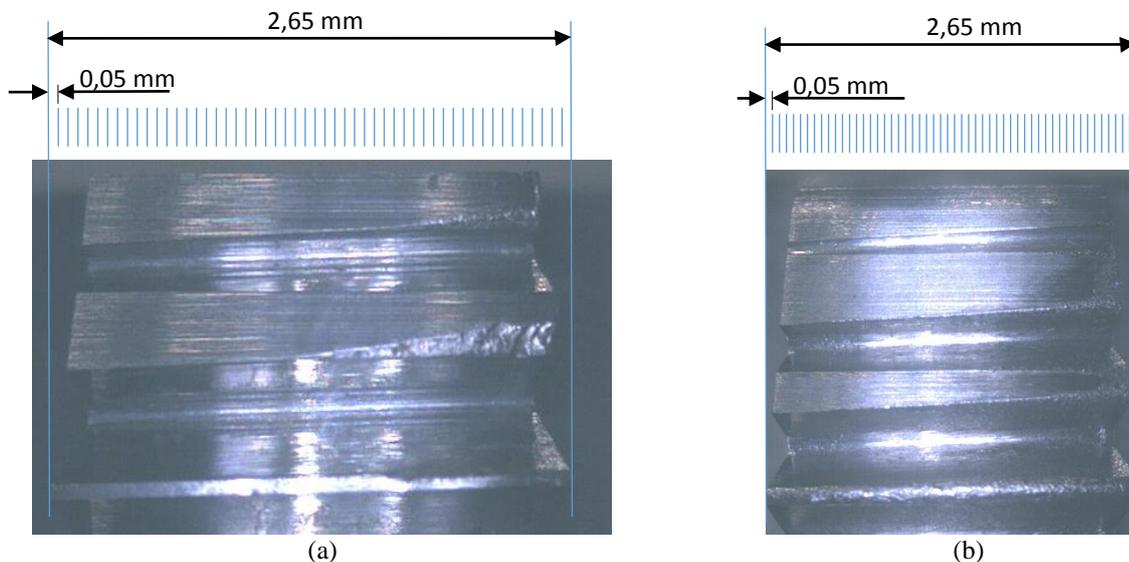
The WC tool has a peculiarity, while the other tools wear out during the process (abrasive wear "Fig. 12 (b)"), the WC splits at once such as "Fig. 12 (a)".

Figure 12. (a) WC-Co tap chipped; (b) HSS-PM without coating tap worn out

The mechanism wear in WC tool was “chipping”, while PM steel with or without coating was abrasive wear.
