25th ABCM International Congress of Mechanical Engineering
October 20-25, 2019, Uberlândia, MG, Brazil

COB-2019-2276 AISI 4140 X H13 STEEL SLIDING WEAR BEHAVIOR

Abstract. *This paper aims to present to the analysis about the resistance to wear by dry a steel x steel pair when normal force variation occurs. The method used to perform the sliding wear tests was the pin-on-disk test, keeping the pin and disk hardness constant (340 and 380 HV, respectively), with 05 tests for each pin-to-disk pair, as a function of 02 (two) normal load values (35 N and 70 N). To perform the tests were used ABNT 4140 steel pins with 5 mm diameter for 15 mm in length and ABNT H13 steel discs measuring 76 mm in diameter by 4 mm in thickness. The study showed that with the increase of normal force the analyzed factors also presented growth, the pins, mainly, with the applied load of 70 N suffered a very high increase reaching a difference of 120% in the level of hardening when compared with the material before the test.*

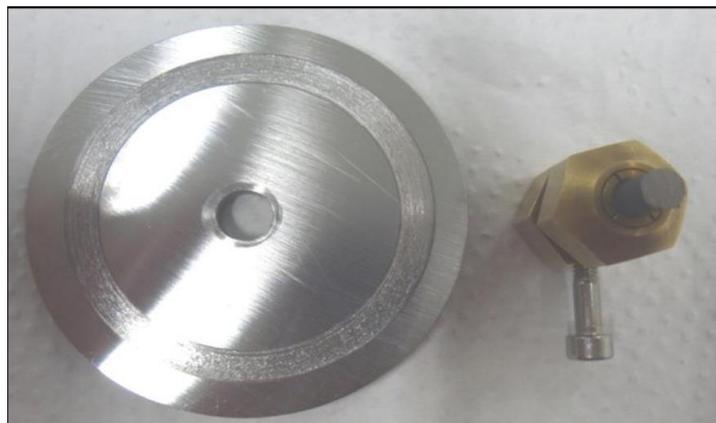
Figure 1. Pin and disc used for the test. Source: GPEMAT GROUP.

The pins used in the tests, acquired in the temperate condition (with hardness around 440 HV), were standardized to obtain the average hardness of 340 HV, with 5 mm diameter by 15 mm long proposed by ABNT 4140 high grade steel screws. resistance. for the tests. The discs used in the tests were obtained from an ABNT H13 round steel bar (tool steel), measuring 76 mm in diameter by 4 mm in thickness, which were heat treated to obtain hardness (380 HV). Figure 1 shows a pin and a disc after the test.

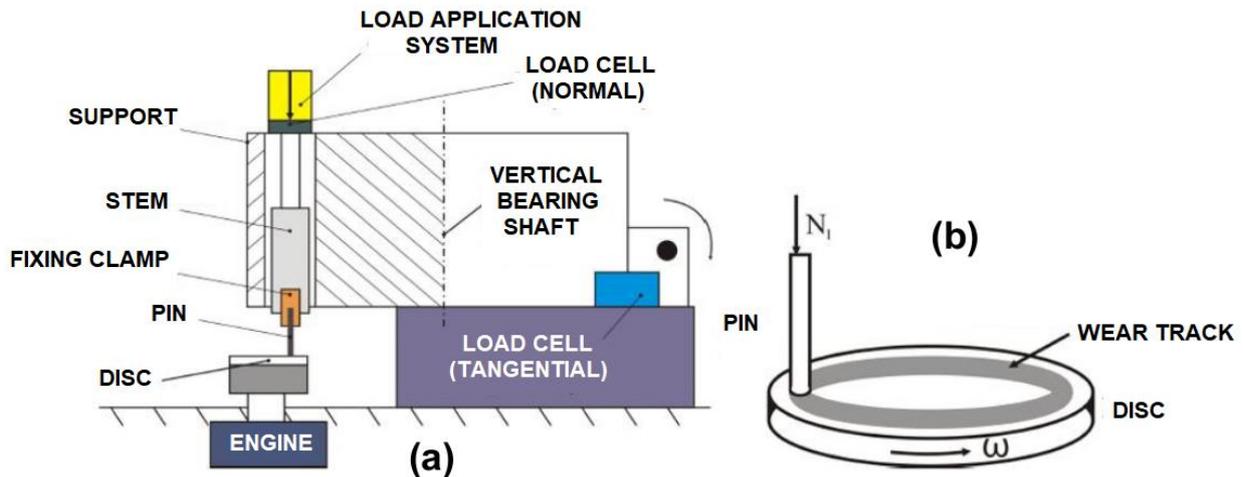
Figure 2 shows a schematic illustration of the pin on disk assay. The equipment works by a shaft coupled to a geared motor that provides an induced rotary motion in a disk that has. The machine, developed by the group, has a lever arm for fixing the pin, which can be placed in contact with the rotating disc, which rotates at a constant rotation of 40 rpm and a constant tangential speed of 0.1 m / s. It also has the functionality of applying the normal load on the pin by means of the lever arm, either by circular plates or deadweight. Finally, the equipment features load cells to measure normal load

Figure 2. a) Illustrated equipment and contact diagram and b) Disc pin test. Source: VIÁFARA, 2010.

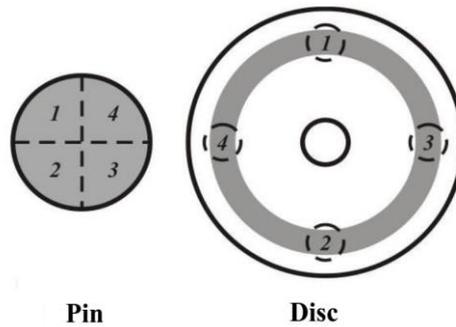
Figure 4. shows a schematic of the four regions where microhardness measurements will be made on the pins and discs.

Figure 4. Illustrative scheme of microhardness measurement regions. Source: VIÁFARA, 2010.

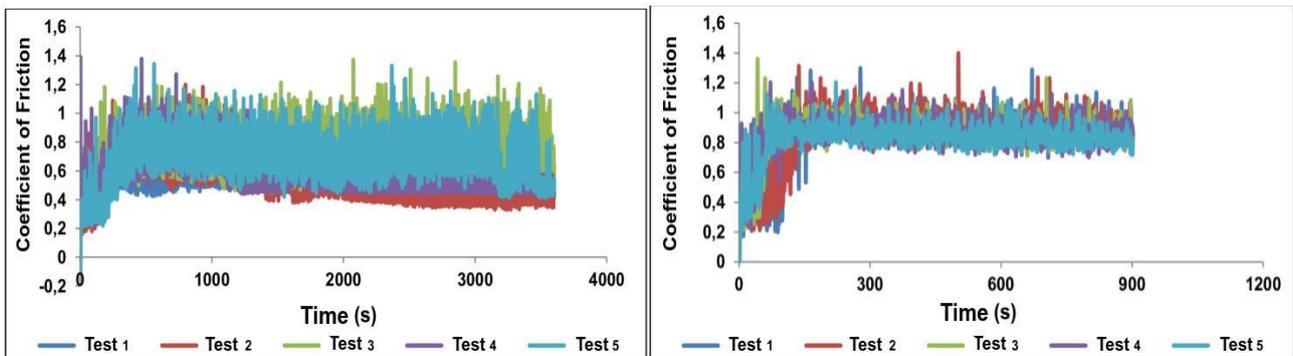
The running-in periods are observed at the beginning of the interaction between two surfaces, and a permanent friction regime, in which the coefficient of friction tends to be constant. The figure 5 the graph shows all the friction coefficient curves as a function of slip time (3600 s) for the normal load of 35 N and disc and pin hardness of 380 HV and 340 HV, respectively.

It can also be observed that the running-in periods, which happens at the beginning of the interaction between two surfaces, which occurs in the first 400s in the graph and the permanent friction regime, characteristic of the slip wear tests. The running-in period was considered to mark the beginning of the stagnation of the increasing coefficient of friction behavior. The figure 5 also shows friction coefficient curves versus slip time (900 s) for the normal 70 N load.

Figure 5. Friction coefficient curves as a function of slip time under a normal load of 35 and 70 N, respectively.
 Source: GPEMAT GROUP.

The decrease in slip time for the 70 N load compared to the 35 N load was due to the high pin wear rate during the test, thus avoiding the total loss of the tested pin.

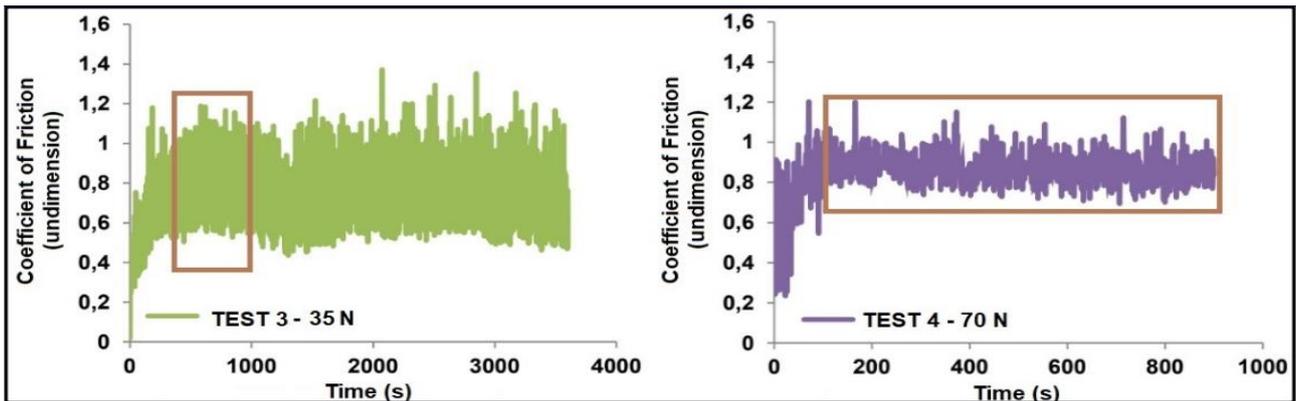
For a more detailed analysis only one test will be referenced for each load. Figure 6 shows that with the increase in applied load, from 35 N to 70 N, the softening period becomes shorter, the permanent friction regime presents higher values of coefficient and presents less variation. It is also observed that the amplitude of the friction coefficient becomes smaller with the increase of the applied load, as shown by a marked region, in the figure below.

Figure 6. Friction coefficient values for the tests 3 and 4 as a function of the slip time under a normal load of 35 N and 70 N respectively. Source: GPEMAT GROUP.

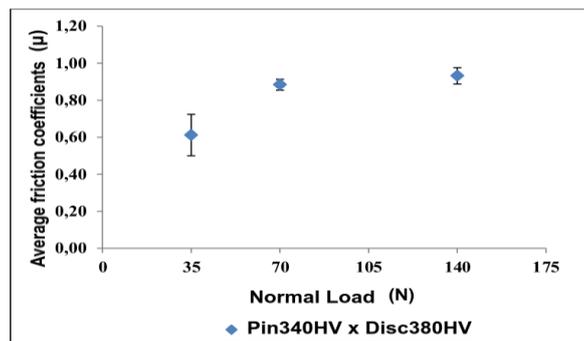
Figure 7. Comparison of the mean steady state friction coefficients for each essay studied. Source: GPEMAT GROUP.

Table 1 summarizes the calculated steady state friction coefficient values for each test, as well as the mean and standard deviation, then Fig. 7 presents a graph comparing these values.

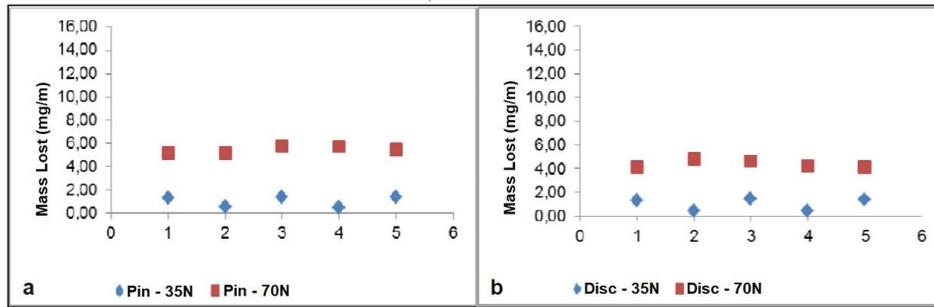
The graphs in Fig. 8 show the results of average mass loss (in mg / m) for the pins and discs, after five repetitions of slip tests, for the two normal loads applied. It is observed that the graphs show similar behavior, the loss of mass for the pins is greater than in the discs. With the force of 70 N the loss of mass of the pin begins to get larger values with respect to the disk.

Figure 8. Results of loss of mass of the pins (a) and disks (b) after the five sliding wear tests, with a hardness of 380 HV. Source: GPEMAT GROUP.

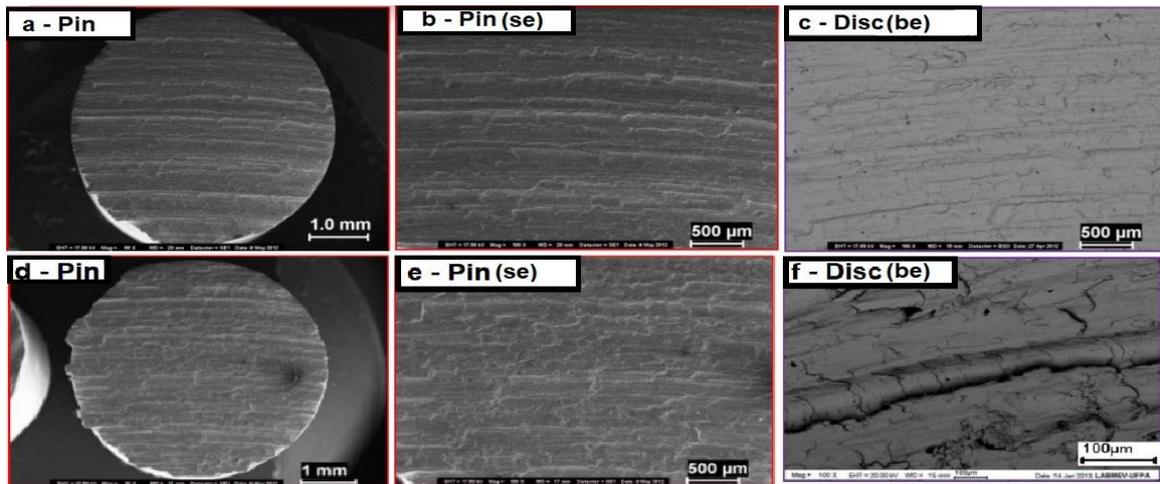
Figure 9 shows images of the SEM of a pin-to-disk pair, it can be seen in the images of the pins the plastic deformation marks that are better evidenced (a) in the image, in the increase of the load the image (b) shows besides the plastic deformation also formation of lateral edges (c) and (d) removed in the secondary electron mode (se) shows larger expansions of the wear region with the variation of the applied load.

The surface of the disk (e) shows the presence of particles removed from the (softer) pin together with plastic deformation marks, less evident than on the surface of the pin. With normal force growth the disk surface (f) shows much more pronounced adhesion and plastic deformation marks.

Figure 9. SEM images of the worn surfaces of a 340 pin x 380 HV disk pair, normal load of 35 N and 70 N, (a) and (b) pin surfaces at different loads. Images of the pin on secondary electrons in (c) and (d). Images of the disk in backscattered electrons (f) and (g). Source: GPEMAT GROUP.

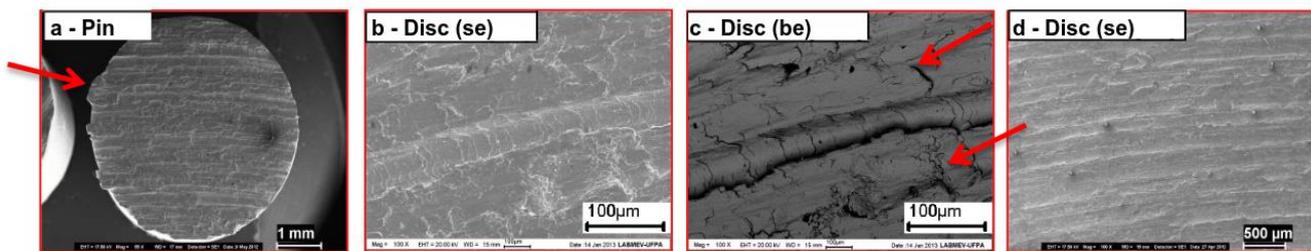
Figure 10. Comparison of SEM micrographs of worn surfaces. (a) 70 N load tested pin; (b) 70 N load-tested disc (secondary electron mode); (c) Test disc with a normal load of 70 N (backscattered electron mode); (g) 35 N load-tested disc (secondary electron mode). Source: GPEMAT GROUP.

Analyzing Fig. 10 Clearly observe it is the main differences in the micrographs. Micrographs “a” and “b” have a pin and a disc, respectively, from the same assay. There are strong marks of plastic deformation, typical of a severe wear mechanism, creating edges on the sides of the pin (red arrow) and marked wear marks on the disc. Other important features are shown in micrograph “c”. This is a backscattered electron mode disk image, in which it is possible to perceive cracks in the micrograph of deformation (red arrow), probably caused by the continuous metallic contact between the pin and the disk, at a high normal load (70 N). The micrograph “d” is from a standard 35 N load-tested disc where plastic deformation marks and small adhesion particles can be observed.

For briefly show how wear affects slip on the tested surfaces, a comparative table was constructed in Fig. 10 SEM micrographs highlighting the main differences between the wear mechanisms acting on the pins and discs.

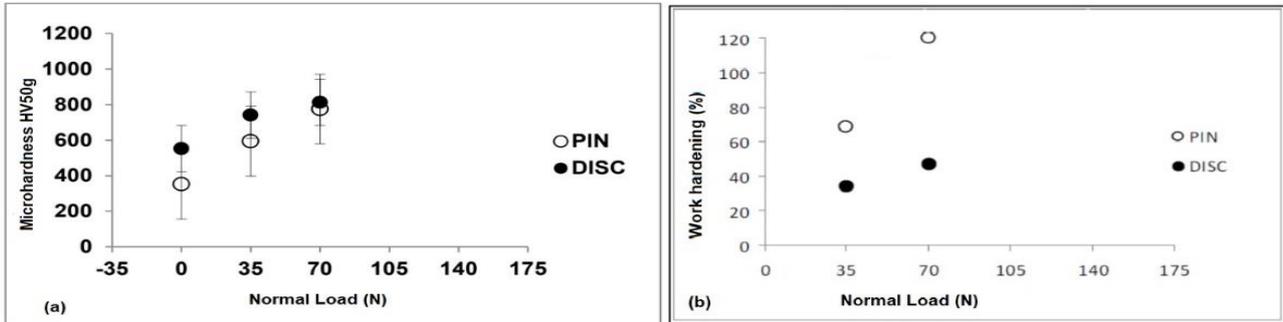
The worn surfaces were characterized by microhardness measurements on the wear tracks. Fig. 11 (a) shows a microhardness plot as a function of the applied normal load. The microhardness values for the normal load 0 N correspond to the values in the regions of the specimens that did not undergo the tests, so that if it were possible to compare how much the hardness was modified after the wear.

The graph of Fig. 11 (a) shows that the microhardness values of the pins are close to those of the disks and that they have increased with normal increasing load applied. This increase in hardness may be related to a cold plastic deformation.

Figure 11 (b) shows the graphic of the pin and disk hardening plot for each normal load applied on the 380 HV hard disk, the results were calculated by measuring the hardness before and after the test, the hardness variation is the work hardening. It is believed that the pin presents a greater hardness variation when compared to the disc because it was excessively bent during its test cycles, being exposed beyond its design parameters.

Figure 11. Microhardness graph of the surfaces of the pin 340 HV x 380 HV disk as a function of the normal load (a) and variation of the hull on the surfaces of the pin 340 HV x 380 HV disk as a function of the normal load (b). Source: GPEMAT GROUP.

In order to make a comparison of the magnitude of the hardening on the worn surfaces, it was stipulated the increment of the microhardness in percentage terms. The results showed that the disc had a microhardness higher than that of the pin in the two normal loads applied, although the pin had more hardening (average of 101%) than the disc (average of 45%) in all applied loads. In addition, it is observed that the pins have a greater hardness variation than the discs for the normal loads applied.
