COB-2019-0395

EFFECT OF TOE GRINDING ON FATIGUE PERFORMANCE OF CRUCIFORM WELDED JOINTS IN A NAVAL STEEL

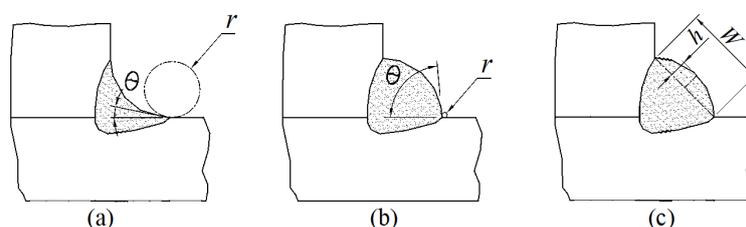
Figure 1. Geometrical aspects of the reinforcement: a) concave shape, b) convex shape and c) width and height.

Another important issue is the joint geometry, which, in its turn, can be divided in two branches: global and localized configuration. Both are very important for the flux of loads, but the global configuration frequently cannot be modified in an assessment procedure, because changing the joints usually implies modifying the whole aspect of the structure. Nevertheless, if possible, global configuration of the joint shall be as smooth as possible (a butt-joint is better than a lap-joint, for example). However, localized geometry is a very important, sometimes easily manageable, but frequently neglected aspect. As a notch effect is associated with the weld toe, providing a better reinforcement shape indeed promotes a fatigue life increase. Figure 1 shows two geometrical parameters, the weld toe angle θ and radius r , which are used for indirect notch effect evaluation (Caccese et al., 2016; Skriko et al., 2017). Both parameters are not easily measured in field, so frequently the height-to-width ratio of the reinforcement (h/W) is adopted.

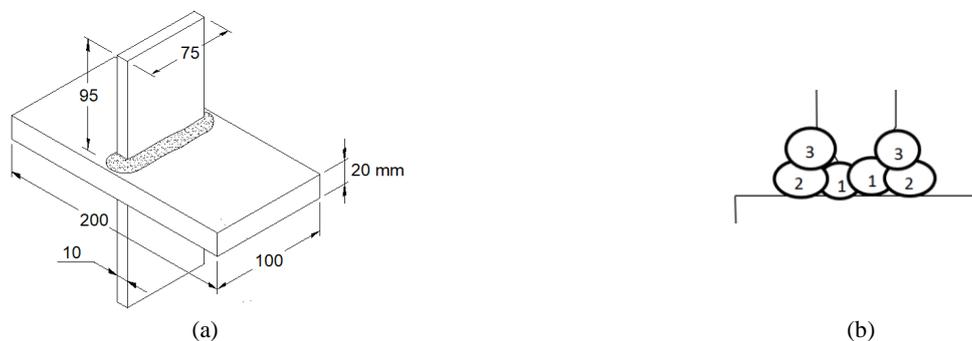
Figure 2. Aspects related to the welded plates: a) after welding configuration and b) sequence of welding passes.

In the preliminary study, a plate of ASTM A131 AH36 steel (yielding strength of 362 MPa and ultimate strength of 520 MPa) with thickness of 10 mm was firstly cut in parts with 95 mm x 75 mm, while a 20 mm plate was cut in parts of 100 mm x 200 mm. The biggest dimensions had been aligned to rolling direction. The initial decision of employing an intermediate plate with greater values of thickness and width was adopted in order to enable a better flux of heat along the welding process, as well as enough space for posterior ultrasound inspection. Figure 2 shows the aspect of original plates joined in the cruciform configuration and the sequence of the passes.

As shown in Fig. 2(b), the first pass at the root had to be back-gouged to remove the slag before applying the opposed pass. However, the gouging process generates a very deep and narrow groove that, in its turn, hinders penetration, and generates lack of fusion. Unfortunately, such a problem is very common in complete penetration joints.

Finally, the horizontal position adopted for welding the joints naturally propitiates undercut at the weld toe in the rib (in the third pass depicted in Fig 2-b). The undercut can be observed in Fig. 8. The existence of such an irregular geometry in the rib toe, which is expected to occur in any welding position except the plane one, also justifies the application of a grinding procedure.

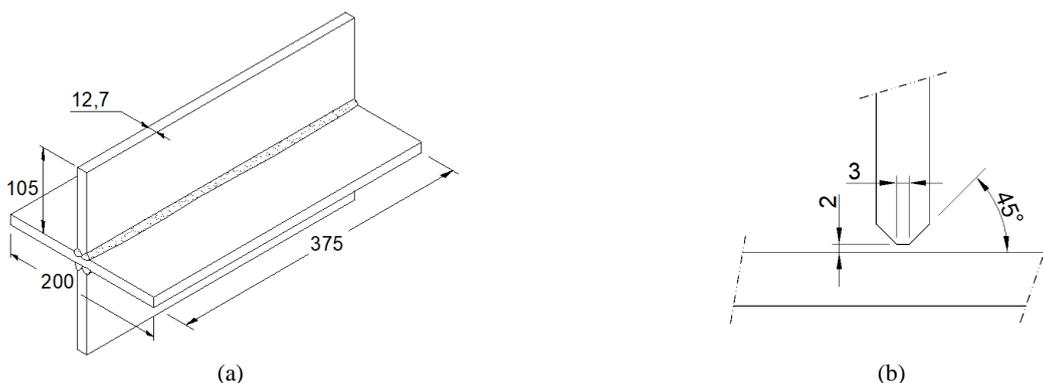
Figure 3. Plate dimensions: a) global view and b) joint preparation [dimensions in mm].

For the second set of specimens a plate of ASTM A131 AH36 steel with thickness of 12.7 mm (1/2 in) was used in both rib and intermediate parts. Initially, parts with 105x375 mm and 200x375 mm had been cut. Welding was implemented in order to obtain the configuration shown in Fig. 3(a). Joint preparation is shown in Fig. 3(b).

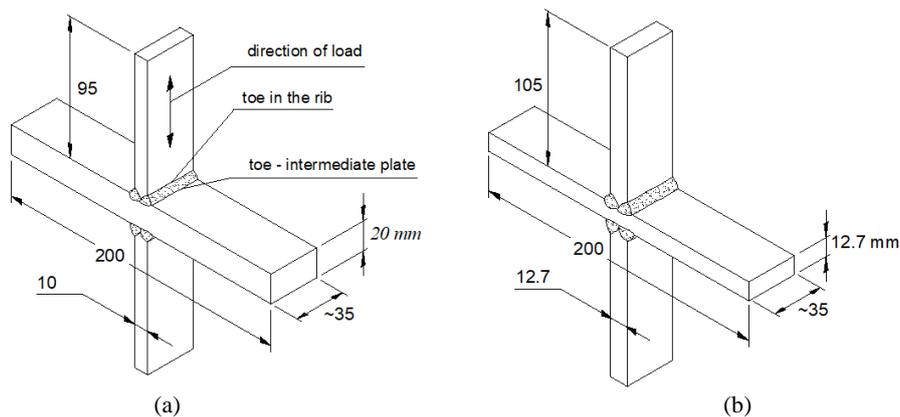
Figure 4. Final aspect of the specimen after cutting and machining: a) preliminary study and b) second set of specimens.

Finally, lateral faces were machined by a milling procedure. Figure 4 shows the final aspect of the specimens.

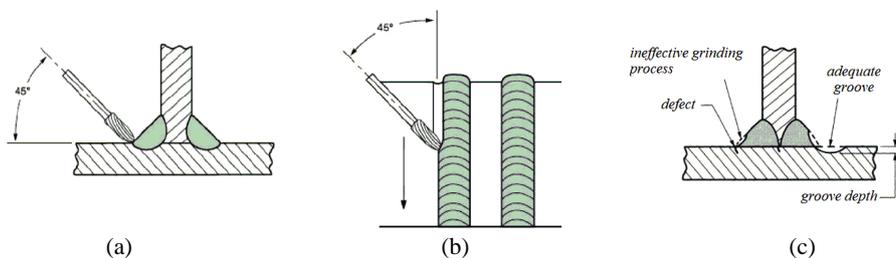
Figure 5. Toe-grinding parameters: a) work angle, b) travel angle and c) orientations for effectiveness of the toe grinding procedure (AWS, 2010).

The grinding process, in its turn, was applied at the toe in the ribs (see Fig. 4) with the positional angles described in Fig. 5(a) and 5(b). Figure 5(c), inserted to outline some important procedure-related aspects, shows an ineffective groove in the left toe and, oppositely, the correct groove configuration in the right. A crack in the weld root is purposely shown in the image, in order to evidence that the grinding procedure is not able to efface such a defect.

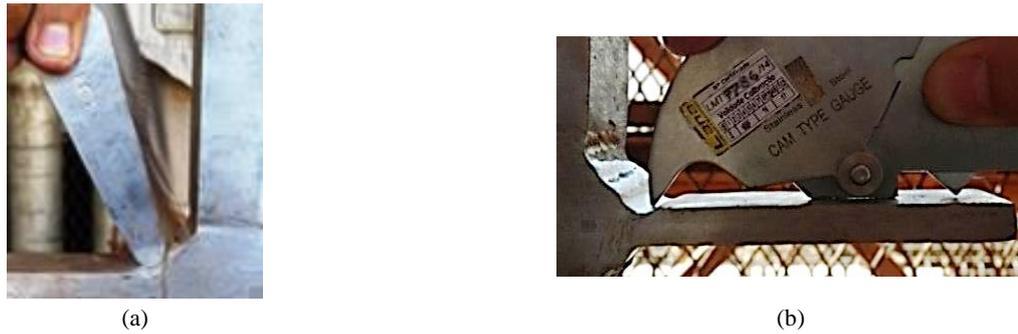
Figure 6. Groove geometry inspection: a) radius gauge and b) depth measuring caliper.

A groove radius of 5 mm and a depth value in the range of 0.5 to 1 mm were employed. The depth of the groove was near the minimum limit of the range advised by the Recommendations of IIW (Hobbacher, 2008). However, greater values could propitiate an important decrease in the resistance area, conducting to adverse results in terms of fatigue life. Figure 6 shows the inspection procedures adopted for groove radius and depth verification.

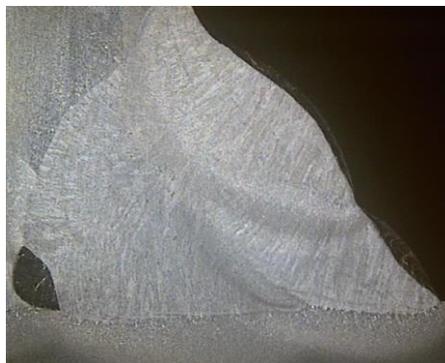
Figure 7. Transversal section of the weld bead evidencing the lack of penetration and slag in the root.

Before presenting final results, an unexpected problem related to final bead integrity shall be reported. In the specimens assigned to the exploratory study, after cutting the welded plates, an important defect located in the root of the beads became evident. Such a defect is shown in Fig. 7.

Surprisingly, such longitudinal cavity in the root, full of slag, was not detected in the ultrasound inspection. Even though, fatigue tests were applied, although there was the possibility of failure in the weld root, instead of the toe.

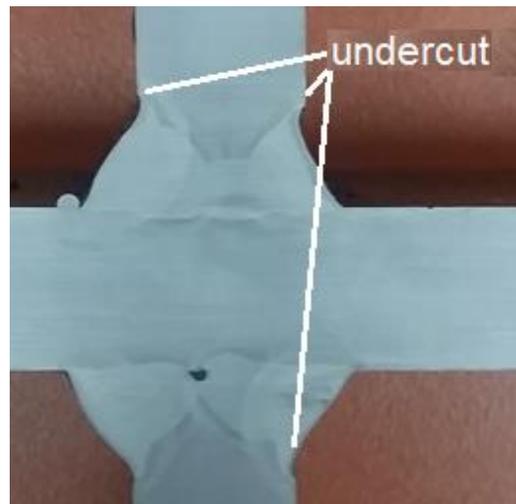
Figure 8. Undercut at the weld toe in the rib.

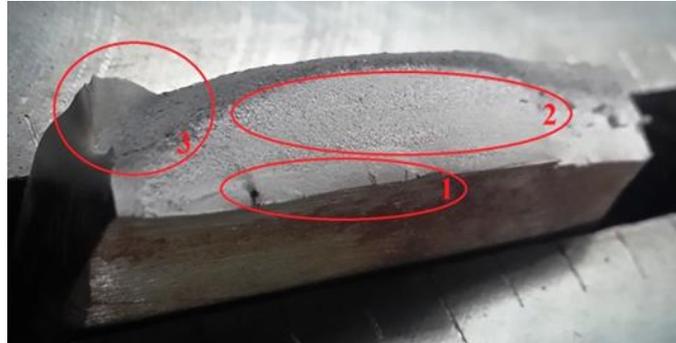
Figure 9. Image of the fracture surface of specimen 1. Outlined regions correspond to: 1) nucleation and encounter of initial cracks, 2) crack propagation region and 3) final fracture region, clearly evidencing the ductile behavior.

As observed, all specimens which had not underwent the grinding process presented crack initiation at the weld toe. However, a considerable difference in attained life was observed in specimen 1 in relation to specimens 2 and 3. So, in order to figure out the reasons of such a difference, a careful examination of the fracture surfaces was implemented. It was observed that, as shown in Fig. 9, specimen 1 apparently presented several crack initiation sites and, along the test, the encounter of these cracks has produced a sole and important crack.

These previous crack-like defects, resulting from the welding process and called intrusions, are responsible for the suppression of nucleation period of fatigue phenomenon. In the other sense, both specimens 2 and 3 presented a commonly observed fracture surface, resulting from the propagation of a crack initiated at the encounter of a weld toe with one of the corners of the resistance section. Such differences in life results as well as in the aspect of fracture surface clearly outline the importance of the intrusions. Consequently, parts with similar characteristics of specimen 1 evidently represent the lower bound of the scatter range attained in fatigue life results.

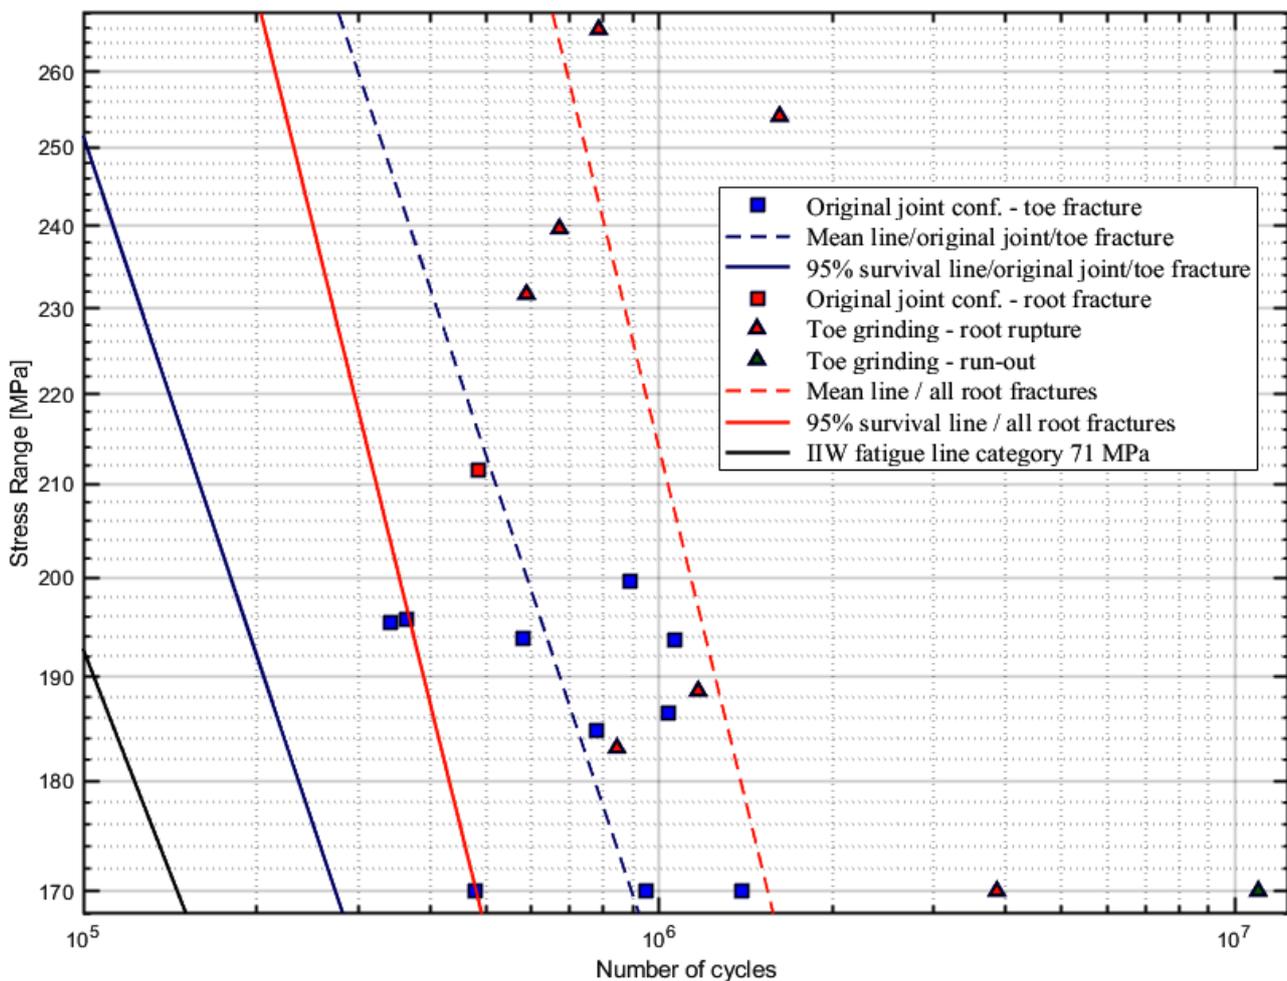
Figure 10. Obtained S-N diagrams.

Figure 10 shows the resulting S-N diagrams obtained. The stress range adopted had been corrected by the amplification factor yet described. As the fracture process in the root represents a distinct case itself, independent of the weld toe condition, the mean and 95% survival lines were implemented considering all root rupture specimens.

Finally, both S-N diagrams presented in Fig. 10, corresponding to weld toe and weld root fractures, represented a superior performance in relation to the IIW 71MPa Fatigue Category. This fact indicates that the tests implemented to obtain the SN diagrams by standard codes probably adopted specimens with real, maybe extremely unfavorable conditions. On the other sense, it also means that the assessment of cruciform and T welded joints, widely employed in engineering structures, shall be the focus of future investigations, in order to figure a less conservative approach.
