25<sup>th</sup> ABCM International Congress of Mechanical Engineering  
October 20-25, 2019, Uberlândia, MG, Brazil

## COB-2019-1441

# ALUMINUM ALLOY CONDUCTOR CABLE: FATIGUE AND FAILURE ANALYSIS

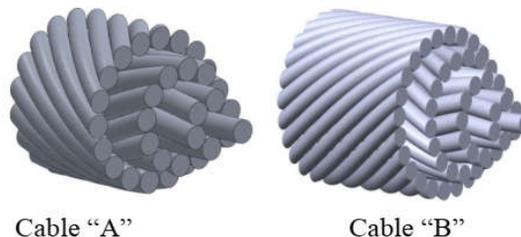
AAAC (All Aluminum Alloy Conductor) conductors were tested in the present study. These consist of three (cable “A”) and four (cable “B”) concentric alternating strands of 6201-T81 aluminum wires, wound helically in opposite directions around a central wire. The schematic diagram of the arrangement of the strands in cables “A” and “B” is presented in Fig. 3.

Figure 3. Schematic drawing with strands and wire orientation of the cables.

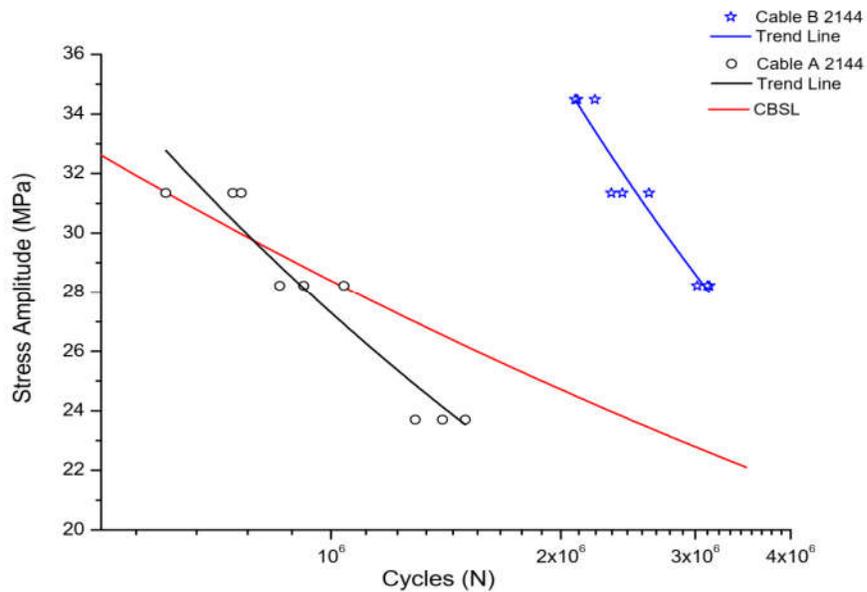
Figure 4 shows the  $\sigma$ -N curves with fatigue test results of both cables (“A” and “B”) submitted to the 2144 H/w ratio, in addition to the CIGRE Safe Border Line (CSBL) curve.

Figure 4.  $\sigma$ -N Curves of cables “A” and “B” tested under fatigue and the Curve Safe Border Line (CSBL).

Despite being manufactured with the same alloy (Table 1), and theoretically submitted to identical heat treatments, cables “A” and “B” obtained different results in the fatigue tests. These results demonstrate that the difference in fatigue behavior between the two cables is not related to the H/w ratio used in the tests, but rather the different mechanical properties in each of the conductor cables, resulting in distinct microstructures depending on the methodology used in the manufacture of these cables.

- The fatigue life of cable “A” was around three times shorter than that observed for cable “B”, in some cases below the safety curve proposed by CIGRE (CSBL).

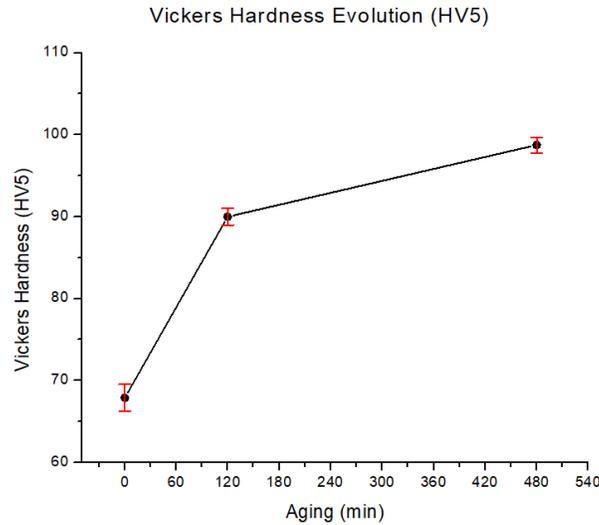
The mechanical properties of aluminum are influenced by several factors, such as fine precipitates formed during aging treatment, which promote alloy hardness and impurities that can reduce mechanical properties, among others (Polmear ,1995). In order to determine the influence of heat treatment on the hardness of the alloy used to manufacture the cables, aluminum wires were removed from cable “A” and submitted to new heat treatments (solution at 520 0C and artificial aging at different times) and Vickers hardness tests. Average Vickers hardness values after three aging treatments are presented in Fig. 5.

Figure 5. Evolution of Vickers hardness x aging time from cable “A” wires.

The results shown in Fig. 5 shows that solution treatment at the temperature of 520 °C of cable “A” wire with no subsequent aging caused a decline in the hardness of this 90 HV5 wire, as received, to 65 HV5. This result was expected, since solution promoted the dissolution of hardening elements in the matrix, leading to a solid solution with low hardness. The process requires temperatures slightly below the liquidus line and sufficient treatment time to completely dissolve the phases present in order to obtain a homogeneous solid solution. Adequate temperature selection is related to the composition of the alloy and the melting point of the intermetallic phases (ASM Handbook v.4, 1991) (Imam, Rahman and Khan, 2015).

Aging this wire for 480 minutes resulted in a considerable increase in hardness, reaching 98 HV, higher than its initial hardness value. This effect is related to the formation of the Mg-Si intermetallic compounds homogeneously distributed in the aluminum matrix, blocking dislocation motion and substantially increasing the hardness and tensile strength of the material. Earlier studies from (Imam, Rahman and Khan, 2015), (May et al., 2010), (Abreu et al., 2011) and (Ding, Biermann and Hartmann, 2002) established a correlation between an increase in hardness and the fatigue life of aluminum alloys.

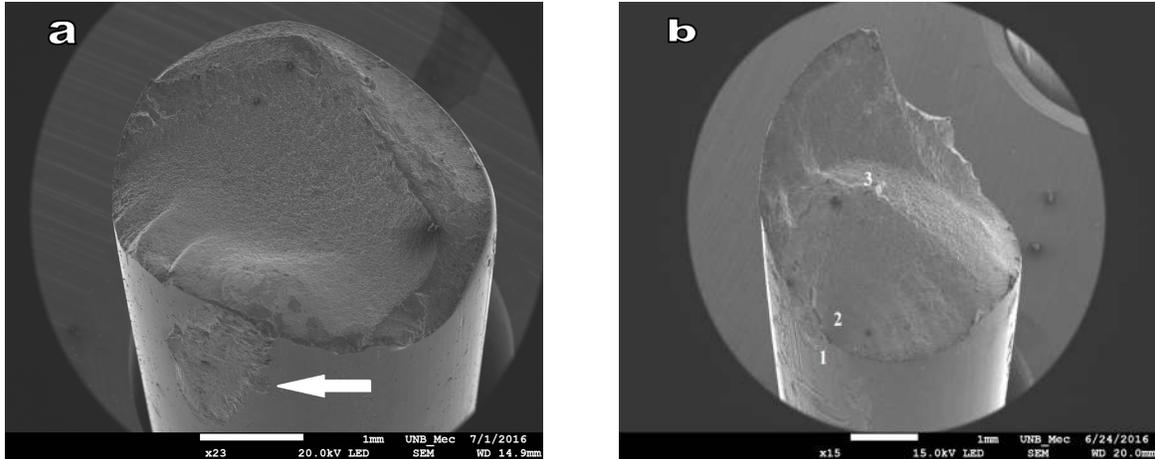
In both cables wire failures started in the wire-wire contact regions, causing fretting marks during oscillatory movement over the course of the fatigue test, as shown in Fig. 6a. Figure 6b shows the fracture surface of aluminum wire from cable A, with the fracture initiation (1), beach marks (2) and the ductile final fracture (3).

Figure 6. SEM image of fretting fatigue crack origin of conductor “B”, indicated by the arrow (left) and fracture surface of aluminum wire of cable “A” showing fatigue fracture regions (right).

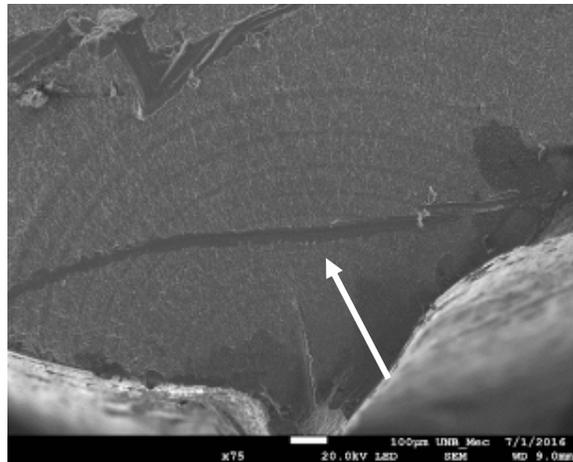
Fretting fatigue marks cause cracks to spread to an area transverse to the longitudinal axis of the applied load (ASM Handbook v.11, 2002). This crack mechanism can be seen, and confirmed, by the beach marks (pointed by the white arrow), which is observed in the fractured wire sample from cable “A” (Fig. 7).

Figure 7. Surface fracture detail from a cable “A” wire.

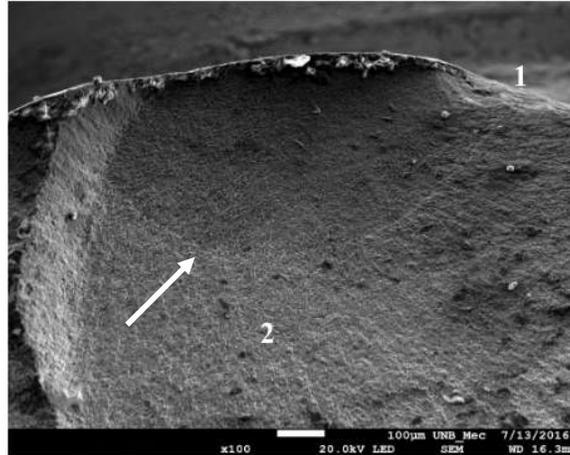
Figure 8 shows the fracture of the aluminum cable “B” wire and, as seen for cable “A” wires, the 3 fatigue characteristics regions can be identified. The crack initiation (1), followed by the fatigue propagation (2). Some beach marks can be seen, white arrow.

Figure 8. Fracture surface from cable “B” wire showing crack origin (1) and fatigue propagation (2).

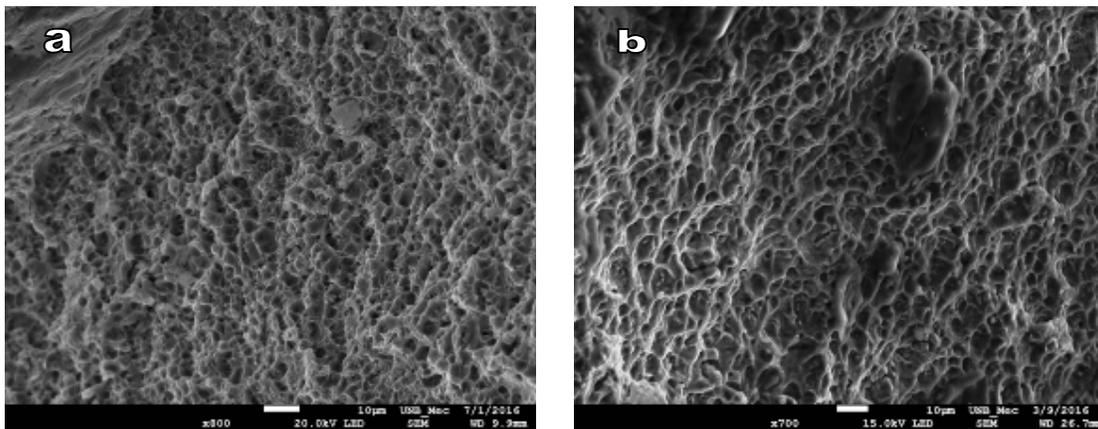
The wire’s final fracture regions exhibited dimples, which is a characteristic of the ductile fracture mechanism (Fig. 9).

Figure 9. Final Region of fracture surface showing equiaxial dimples. (a) Cable “A” wire and (b) cable “B” wire.
