COB-2021-2116

INVESTIGATION OF THE INFLUENCE OF LOADING ON THE WEAR OF A PERLITIC RAIL

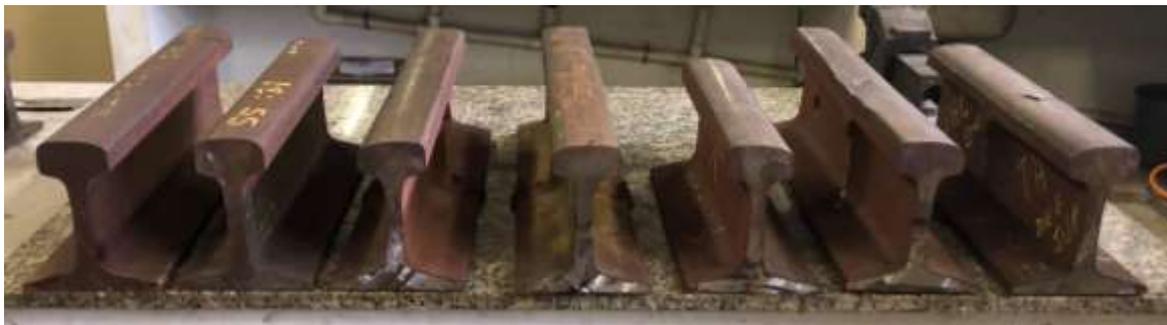
The TR68 rails used in this work were provided by a company that operates railroads and are classified as heavy haul. The components came cut lengthwise, however, the part of the rail to be analyzed is the billet. Figure 1 shows the rails as received and used.

Figure 1. Rail as received. Source: Author

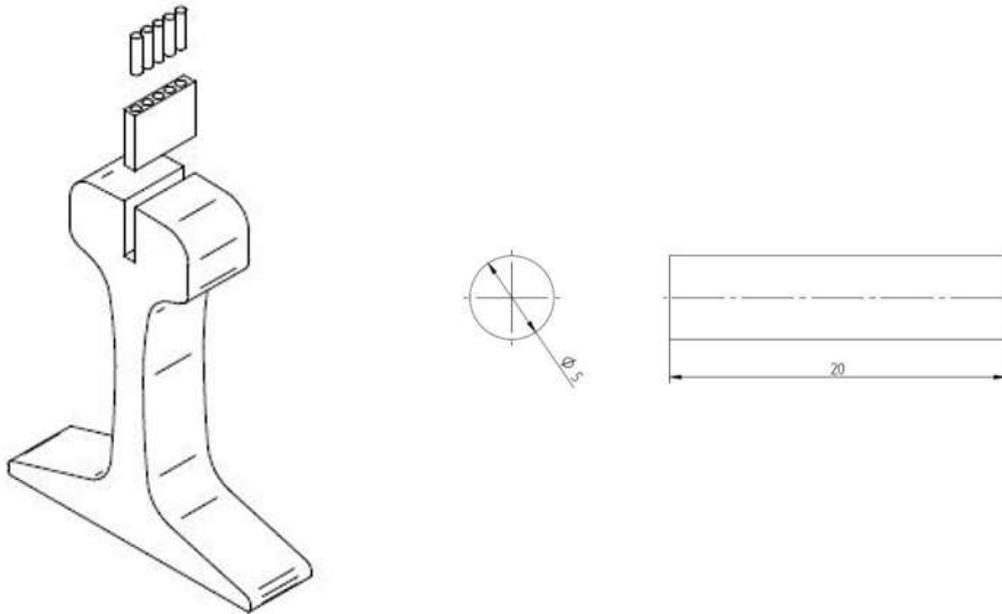
The pins are 20 mm long and 5 mm in diameter. The scheme for the removal of the pins, as well as more details regarding its geometry, is shown in Fig. 2. In order to guarantee replicability, three (3) pins were removed for each load used in the pin-on-disk tests. In addition, at least two (2) pins obtained were used to obtain samples, by successive cuts via cut off.

Figure 2. Arrangement and dimensions of the removed pins in drawing without scale and dimensions in mm. Source: Author. Adapted from (Almeida *et al.*, 2019).

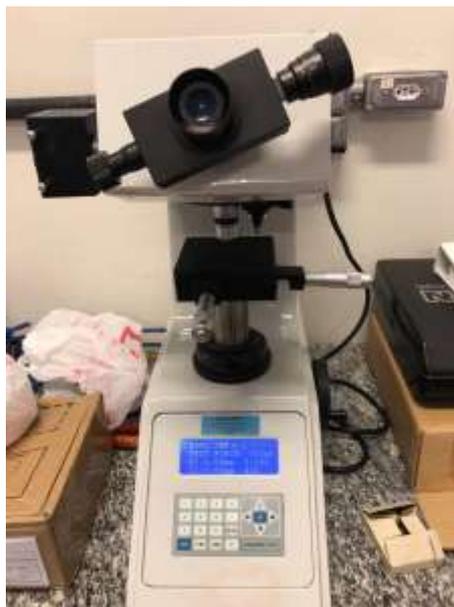
The microhardness was obtained using the HV-1000B digital microhardness meter, shown in Figure 3. To measure this property, a quantity of 120 indentations was performed, with 30 indentations, in each quadrant with a load of 50g for a period of 30s. This practice is in compliance with the standard (AMERICAN SOCIETY FOR TESTING AND MATERIALS, 2005a).

Figure 3. Digital Microdurometer. Source: Author.

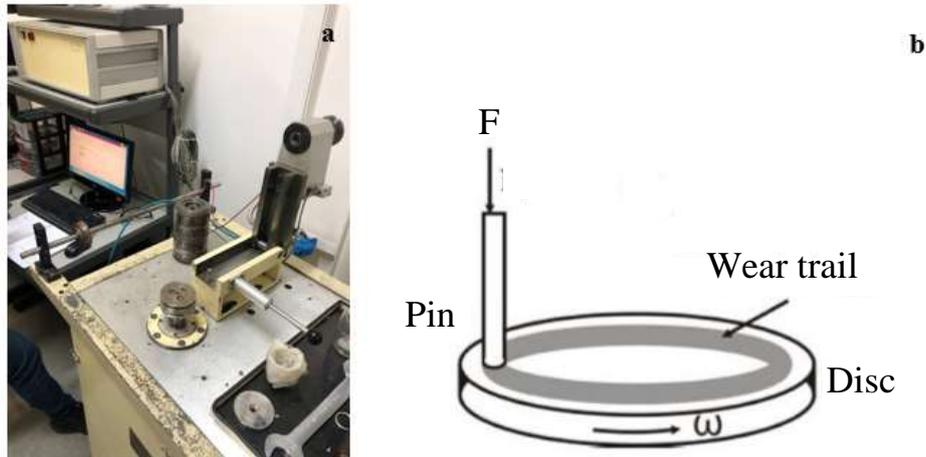
The pin-to-disk test was conducted, considering the ASTM G99-05 standard (AMERICAN SOCIETY FOR TESTING AND MATERIALS, 2005b), making use of pins and disks. The pin-on-disk tests were carried out in a TE67 Tribometer – PLINT, Fig. 4a. The loads adopted to carry out the tests were 50, 100 N. Therefore, normal tensions of the order of 2.54, 5.09 MPa were reached. It is noteworthy that, for each load, 3 (three) pins were tested.

The other conditions adopted were similar to the literature (TRESSIA et al., 2020; MASOUMI et al., 2019). Therefore, the following parameters were adopted: the rotation speed was 75 rpm, the sliding track radius of 25 mm, the sliding speed reached is 0.2 m/s and the test time was 3600 seconds for each pin, so the distance slipped was equivalent to 720 m. The test scheme was similar to that shown in Fig. 4b.

Figure 4. Tribometer for carrying out the pin-under-disk test and test performance scheme. Source: (a) Author and (b) adapted from (SANTOS, 2013).

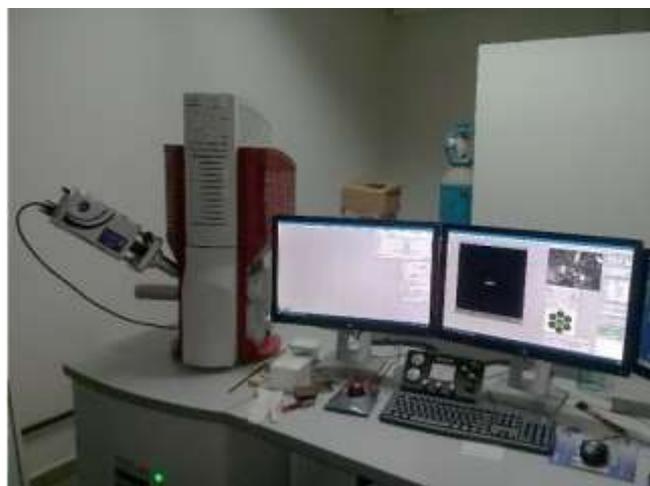
The acquisition of images and analysis via EDS was performed in a Scanning Electron Microscope (SEM), brand TESCAN, model Mira3, with electron gun type FEG and EDS, model PentaFet X-Act, manufactured by Oxford, belonging to the Laboratory of Electronic Microscopy of the Museu Paraense Emílio Goeldi. In this equipment, images were obtained for the investigation of worn surfaces. Figure 5 shows the equipment used to capture the images.

Figure 5. Scanning Electron Microscope. Source: Author.

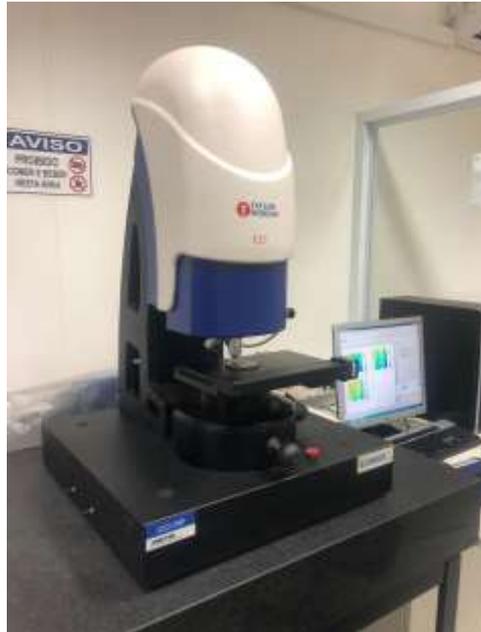
The surface topography of the samples (pins and discs) was analyzed by a 3D CCI profilometer manufactured by Taylor Hobson, that is, the 2D and 3D parameters were obtained. To analyze the surface roughness, digital images of the surface of the discs and pins were generated using the software Talymap® (Digitalsulf). The data obtained by the equipment were treated using the standards ISO 4287 (Geometrical Product Specifications) and ISO 25178 (Geometrical product specifications (GPS) – Surface texture: Areal). Figure 6 shows the equipment used to determine topographic characteristics.

Figure 6. CCI 3D profilometer. Source: Author

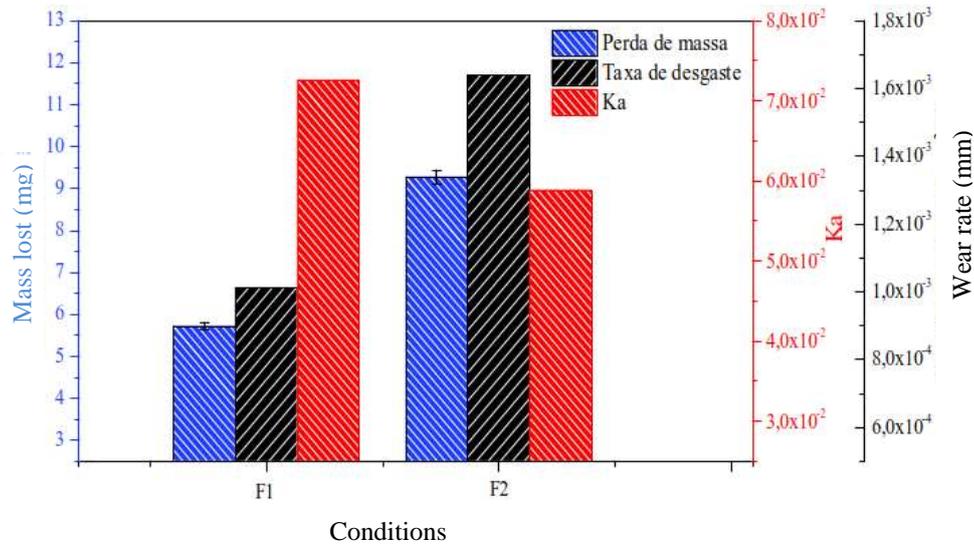
Regarding the pins, softer, the wear occurred in a moderate regime for all conditions. Figure 7 presents the behavior of the pin, regarding the relevant characteristics for a synthesized mode wear analysis.

Figure 7. Comparison of the wear parameters of F1 and F2 conditions. Source: Author.

By wear rate one can check the lost pin volume. In both F1 and F2 there was a decrease and, consequently, it can be determined what was the linear reduction in terms of height. Through this analysis, it can be seen that there was no significant reduction in the pin height.

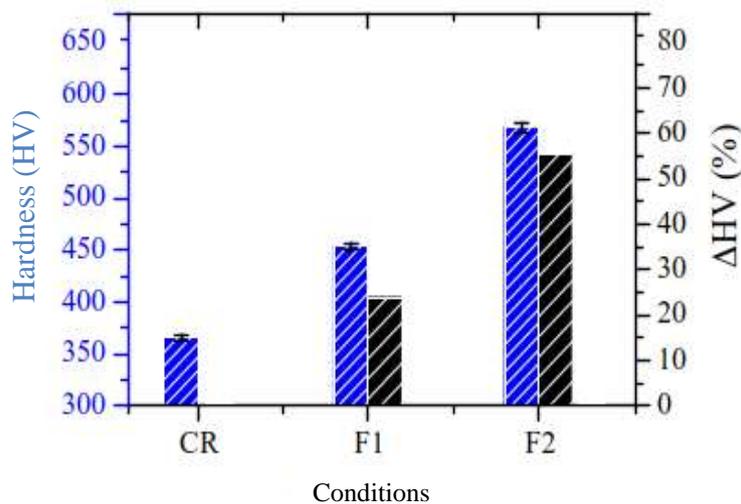
Figure 8 shows how the pins behaved when subjected to the two loading conditions. In the condition as received (CR), the rail presented hardness of 369 HV. As pointed out in the literature (Santos, 2013; Viáfara; Sinatora, 2009), with increasing loading, there is greater work hardening on the surface of the pins.

Comparing CR with conditions F1 and F2 it is noted that there was a variation in hardness of about 20% and 55% the hardness values achieved by the pins at the end of the wear tests were approximately, 453.49±3.72 HV and 568.34±4.26 HV. Figure 8 presents the hardness values measured, as well as the increase in strain hardening, with the standard rail hardness as reference.

Figure 8. Variation of the hardness and hardness of the pins. Source: Author.

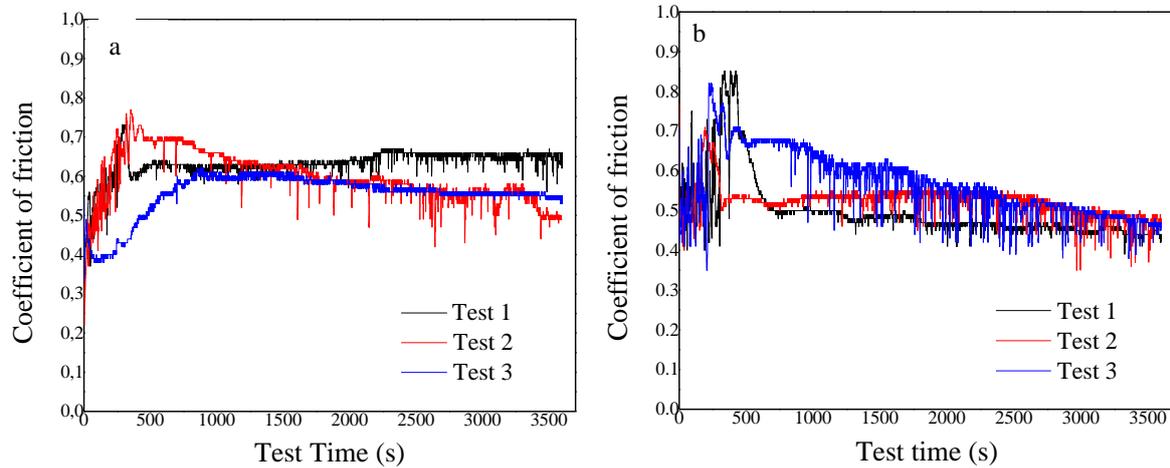
Next in Figure 9 are the variation curves, of coefficient of friction, for conditions F1 and F2. The test time and sliding distance were 3600 s and 720 m, respectively. The curves have the most typical behavior, since at the beginning of the contact, due to the surface roughness, the friction becomes increasing, creating a peak, until conformity and reduction of friction occurs. Thus it can be said that these characteristics are of lubricated or even non-lubricated sliding of metals, as

in the case of steel on steel pair, Viáfara (2005) points out that, in the case of the F2 condition in pins with pearlitic microstructure, the presence of oxides such as Fe_3O_4 and Fe_2O_3 can occur.

The latter is, has its formation characterized in most cases by high temperatures and/or loadings and acts preventing the metallic contact between the surfaces and, with this, inducing the moderate regime of oxidative wear. It is noted that in condition F1 the running-in period extends until approximately 500 s, after which a stage of stabilization of the friction coefficient begins, a fact that was also observed by Tressia *et al.*, (2020) in test conditions very similar to those adopted in this work.

Figure 9. Variation of friction coefficient with sliding distance for conditions (a) F1, (b) F2 N. Source: Author.

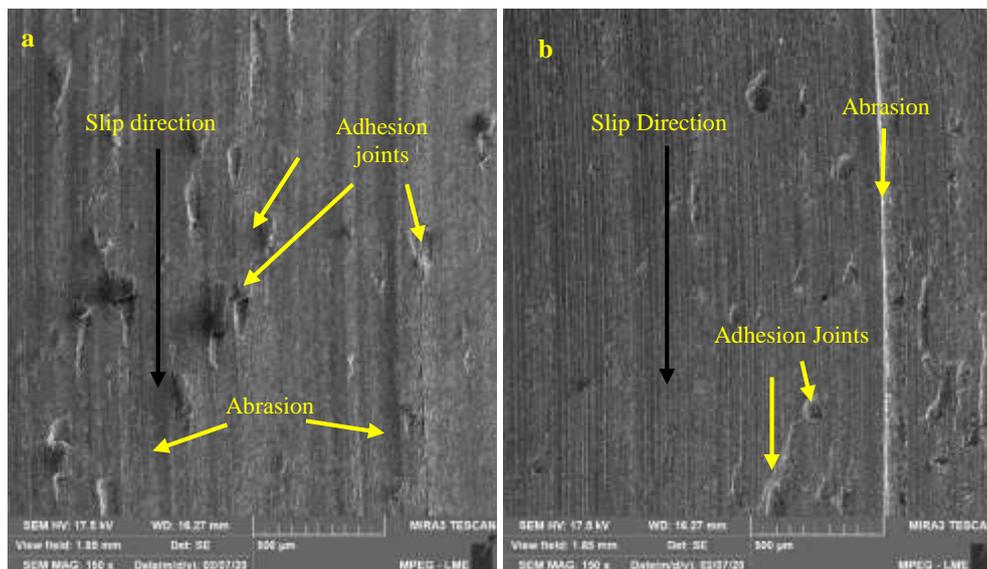
Figure 10 shows the scanning electron microscopy images of the wear tracks. Taking an overview, it can be seen that in condition F1 (50 N) and F2 (100 N), in addition to abrasion marks, adhesion points appear. The adhesion points were also verified in other literature (Viáfara, 2005; Tressia *et al.*, 2020) that performed sliding wear on pins with pearlitic structures.

Figure 10. Secondary electron scanning electron microscopy images of the worn surface tracks for (a) F1 and (b) F2 conditions. Source: Author.

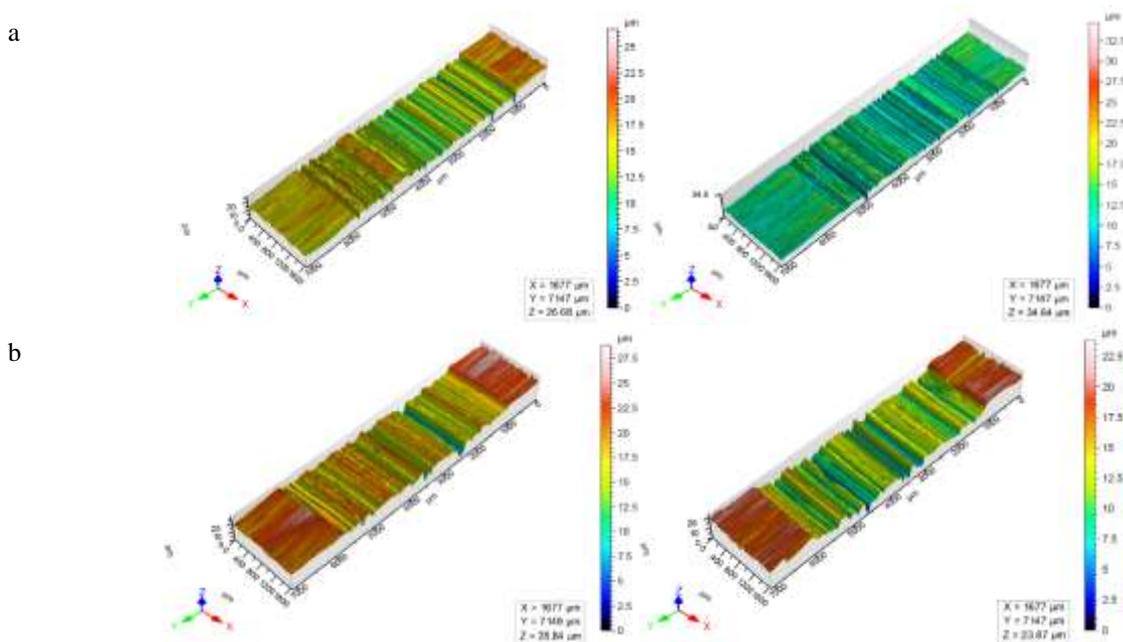
The topographical images, obtained by the 3D profilometer for 2 (two) quadrants of each disc tested in conditions F1 and F2, are exposed in Fig. 11. It can be seen that the effect of the variation of the load condition was notorious on the worn surfaces of the discs.

Figure 11. Images of the stitches of the quadrants measured for the disks in the (a) F1, (b) F2 conditions. Source: Author.

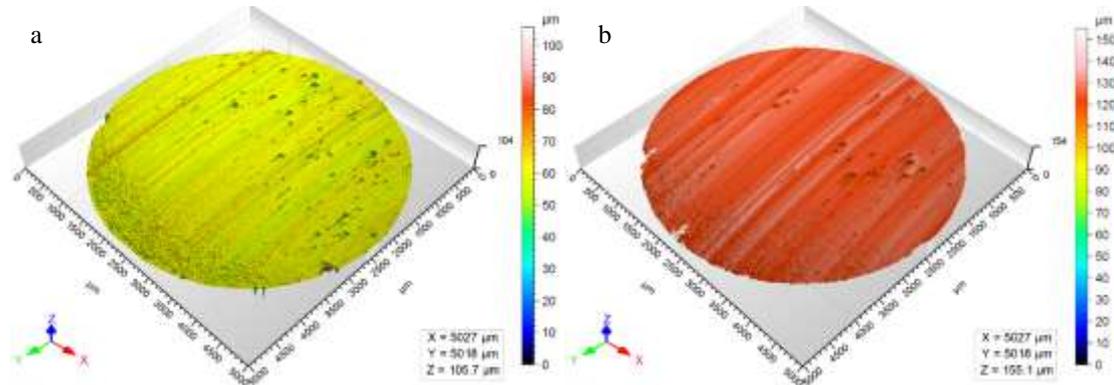
The images of the topographies of the 3D profiles, obtained by the 3D profilometer, for the worn pins are presented in Fig. 12, for conditions F1 and F2. The wear trail of the pins points out that for the conditions of this system, there are clear changes in the worn surface, which can be noticed with the trend of increasing roughness. Furthermore, it is

noticeable that the topographies indicate various appearances of adhesion marks, highlighted by their depth on the surfaces, as the forces change.

Figure 12. Images of the measured quadrant stitches for the pins in the (a) F1, (b) F2 conditions. Source: Author
