COB-2023-0302

FAULT DETECTION IN A THICK STRUCTURE BY USING THE ISHM TECHNIQUE

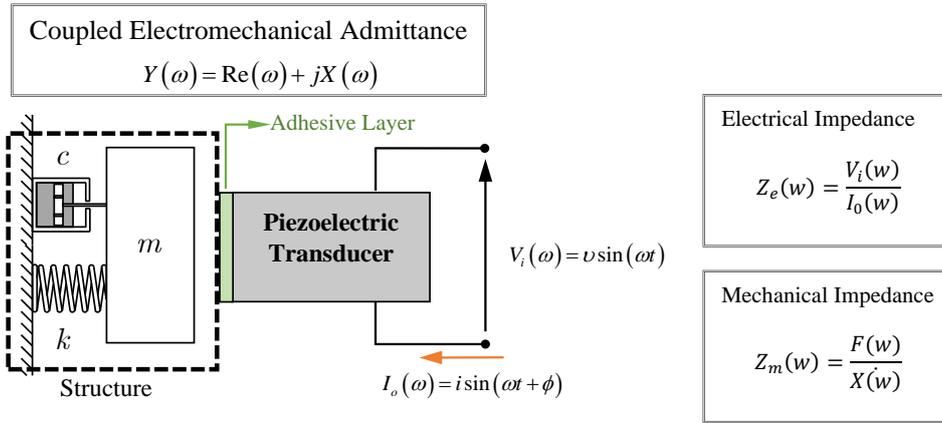
Figure 1. Classical single-degree-of-freedom system for the ISHM technique (Adapted Liang *et al.* (1993)).

From the proposed system and considering that the mechanical properties of the PZT patch do not vary with time, these authors demonstrated that the admittance $Y(w)$ of the PZT actuator could be written as a combined function of the mechanical impedance of the actuator itself Z_a and the structure Z_S (Eq. 1).

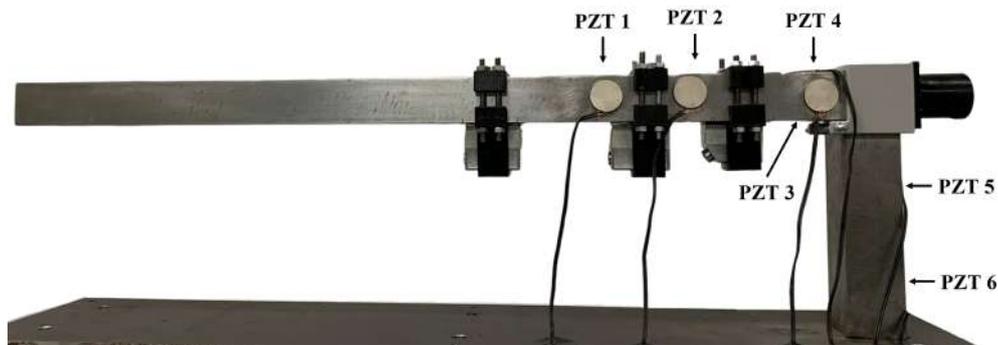
For the first impedance technique evaluation, a 1020 steel beam (44.45 mm thick, 850 mm long, and 50.8 mm wide) was used as the experimental setup, clamped at one of its ends as shown in Fig. 2. The beam was subjected to nine successive cuts using an angle grinder, starting from a V-notch present in the beam near the clamped end, as shown in Fig. 3(a). The first and last cuts performed are presented in Fig. 3(b) and 3(c). The cuts were named D1 (first cut) to D9 (last cut).

Figure 2. Structure analyzed for cut propagation.

Six piezoelectric transducers, measuring 30 mm in diameter and 2 mm in thickness, were attached along the structure of the beam. They numbered 1 to 6, as shown in Fig. 2. These PZTs were employed to assess the damage through impedance signature measurements. The signatures were acquired before each cut (baseline) and after each cut using the Agilent 4294A impedance analyzer, within the frequency range of 90 to 120 kHz, as depicted in Fig. 4.

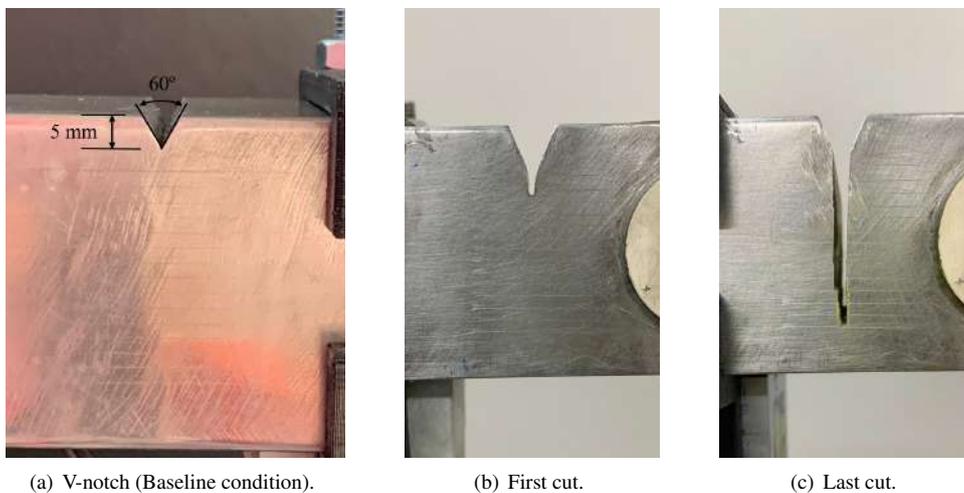
(a) V-notch (Baseline condition).

(b) First cut.

(c) Last cut.

Figure 3. Initial condition and damaged.

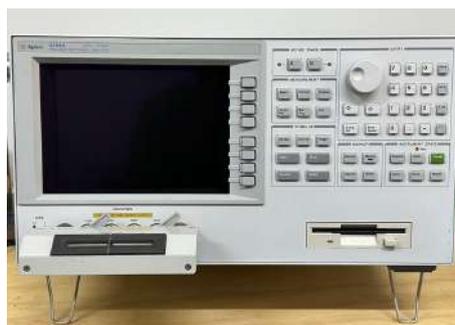
Figure 4. Agilent 4294A impedance analyzer.

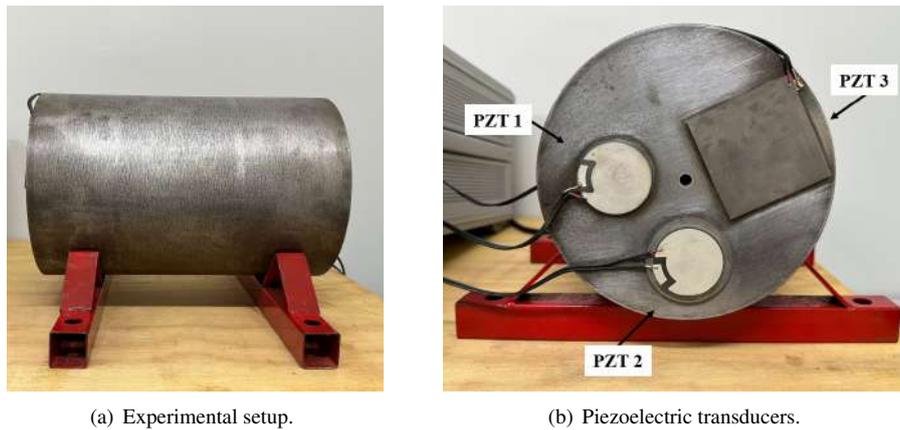
The second experimental setup consisted of a steel cylindrical bar measuring 300 mm long and 200 mm in diameter. It was supported by two square steel bases and four corner brackets, as shown in Fig. 5. The bar was instrumented with three piezoelectric transducers at one of its ends, PZT 1, PZT 2, and PZT 3, as illustrated in Fig. 5(b). However, only PZT 1 and PZT 2, with a diameter of 50 mm and thickness of 2.6 mm, were analyzed in this study. For the proposed analysis, PZT 1 was directly bonded to the bar, while PZT 2 was attached to the structure using a 3 mm thick stainless steel base. This configuration aimed to evaluate the influence of the base on the fault detection sensitivity in the experimental setup. In this study, adding mass on the opposite side of the PZTs' positioning was considered a fault.

Figure 5. Analyzed steel bar.

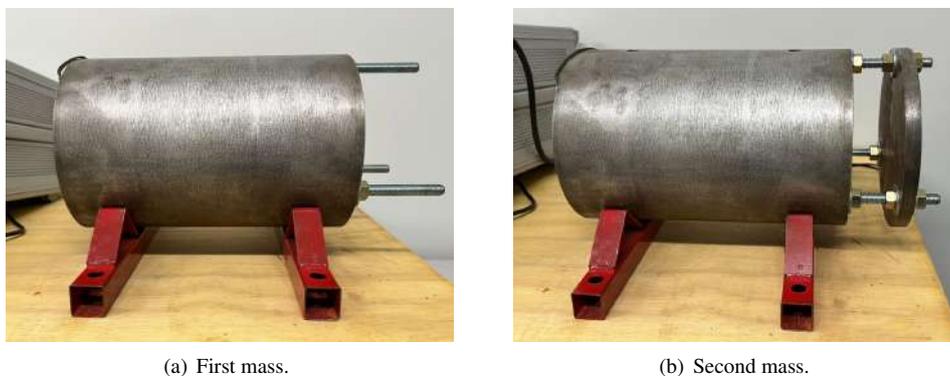
The first added mass (D1) corresponds to four threaded bars mounted on the bar using nuts and washers weighing 369.5 g, as shown in Fig. 6(a). As the second damage (D2), the nuts were tightened, and a steel disk was added to the bar, resulting in a total mass of 4163.5 g, as depicted in Fig. 6(b).

Figure 6. Masses added for failure simulation.

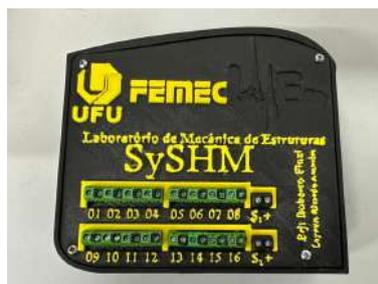
In this case, the impedance signatures were obtained using the SySHM impedance analyzer (Fig. 7), developed by researchers from LMEst. It is an innovative, low-cost, versatile technology with fast processing capabilities, operating in frequencies ranging from 0 to 400 kHz (Finzi *et al.*, 2010).

Figure 7. SySHM impedance analyzer.

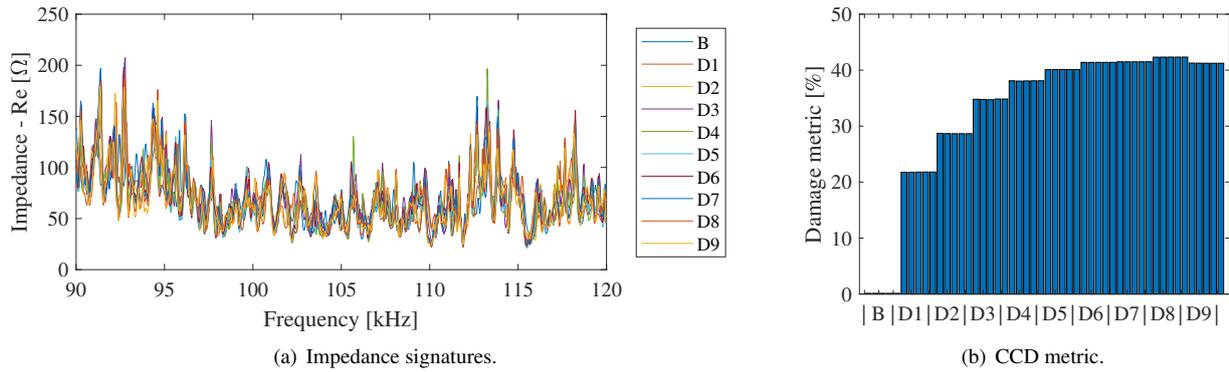
Figure 8. Piezoelectric transducer 1.

The impedance signatures and corresponding CCD metric values for all the analyzed piezoelectric transducers are shown in Figs. 8 to 13. It is evident from the impedance signatures presented in Figs. 8(a) to 13(a) that there were changes with increasing cut. The CCD damage metric highlights this change as its value increases with the growth of the cut.

Upon examining all the obtained results, it can be noted that minor changes were observed in the piezoelectric transducers labeled as PZT 5 and PZT 6, with CCD values below 15 %. These transducers were positioned farther from where the cut was made. On the other hand, the transducer set closest to the cut (PZT 3) exhibited a more significant variation in the damage metric, with a variation of around 70 %. This demonstrates that the ISHM technique could detect the cut’s propagation in the structure and that the PZT positioned closest to the flaw had higher sensitivity in this detection.

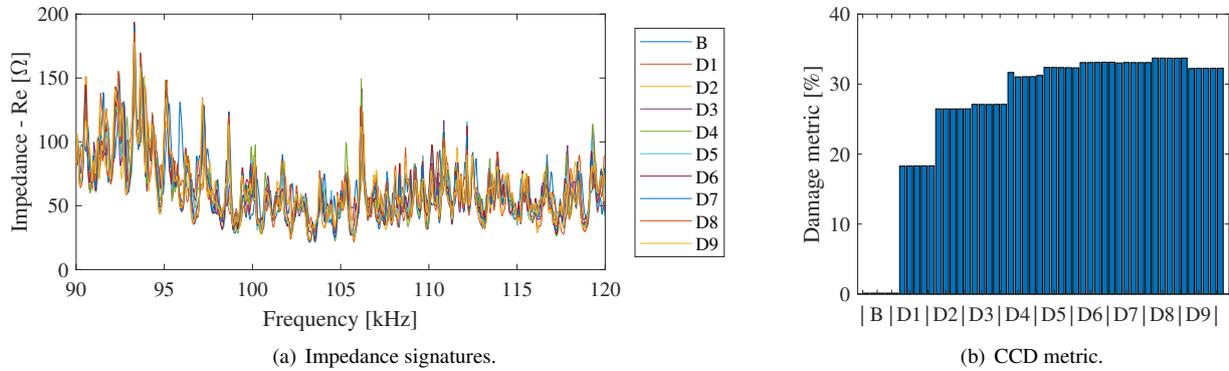
Figure 9. Piezoelectric transducer 2.

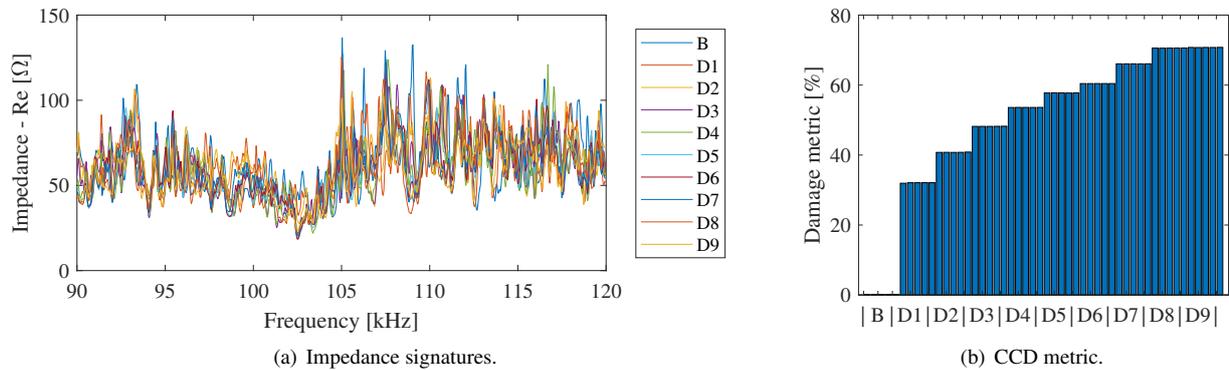
Figure 10. Piezoelectric transducer 3.

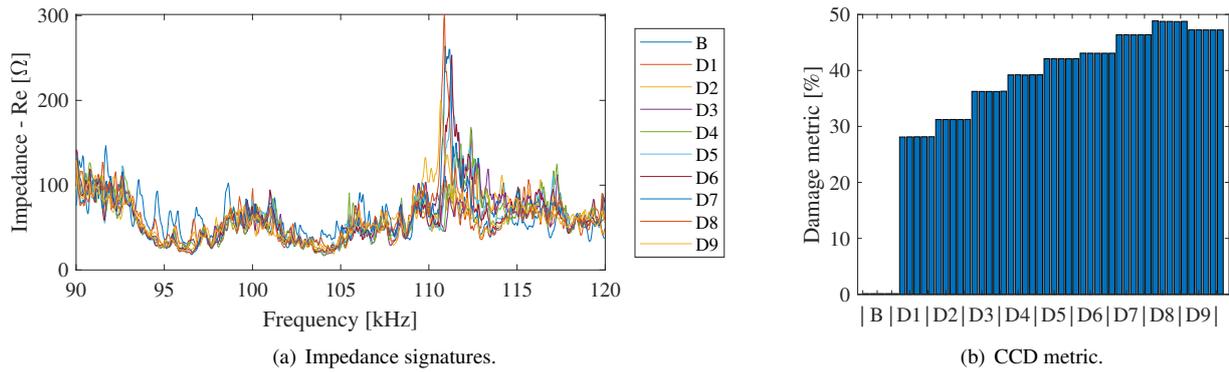
Figure 11. Piezoelectric transducer 4.

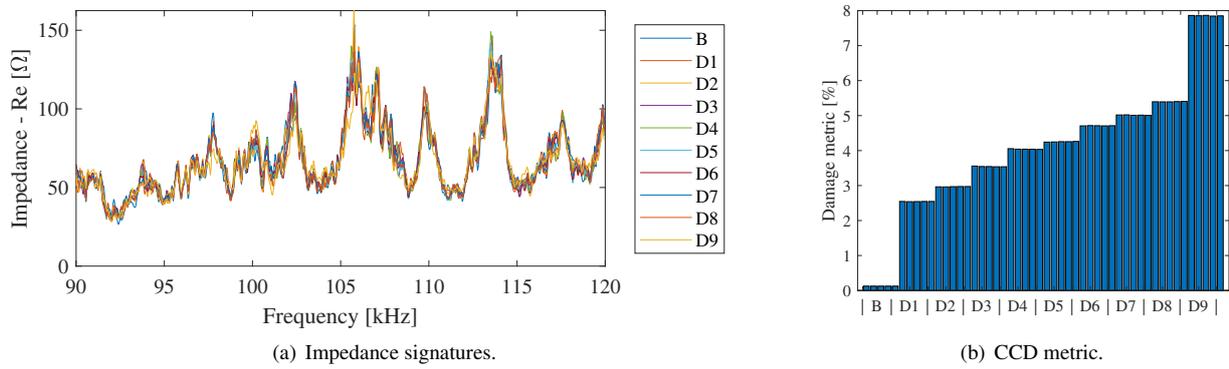
Figure 12. Piezoelectric transducer 5.

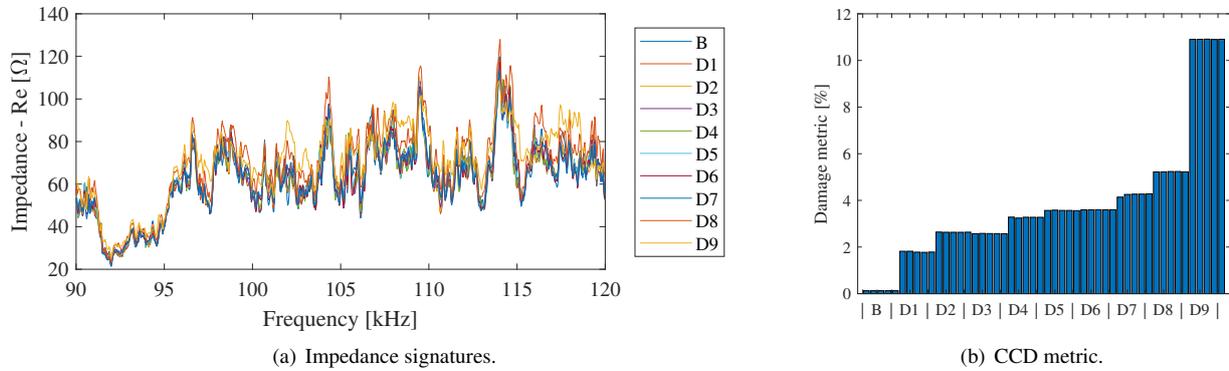
Figure 13. Piezoelectric transducer 6.

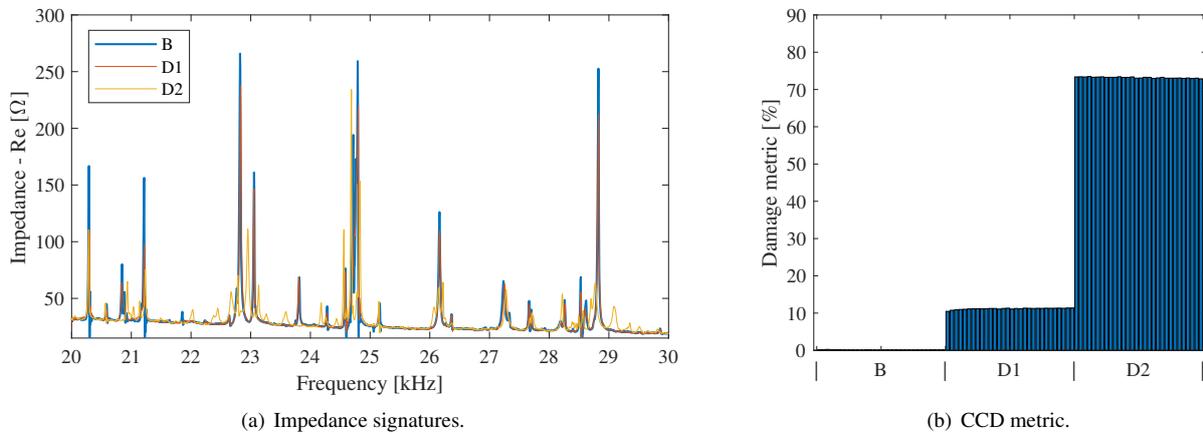
Figure 14. Piezoelectric transducer 1.

Similarly to the previous analyses, impedance signatures were also obtained for the bar. They were compared with baseline measurements, and the CCD damage metric was used to quantify the variation in the signatures. The impedance signatures obtained through PZT 1 and PZT 2, along with their respective CCD values, are shown in Figs. 14 and 15.

In this analysis, masses were added to the structure, and it can be observed that the impedance signatures also changed due to the non-destructive damage analyzed. Furthermore, it is observed that as the flaw increases, the CCD value also increases, indicating more significant differences compared to the reference measurement.

When evaluating the influence of the base on the sensitivity of flaw detection, it was found that PZT 2 exhibits more

minor alterations compared to the results obtained by PZT 1. However, even with the presence of the base, it was still possible to identify modifications in the impedance signatures.

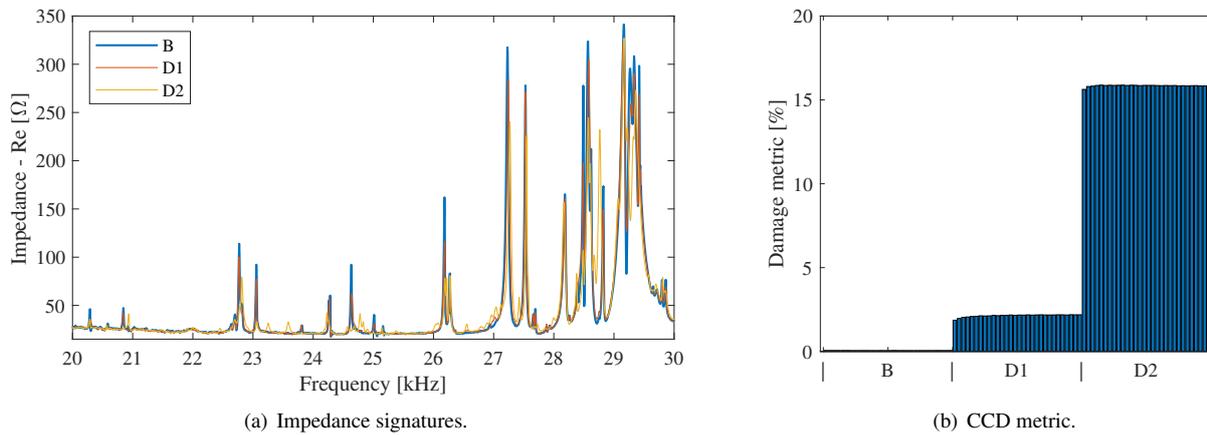
Figure 15. Piezoelectric transducer 2.
