COB-2023-XXXX

THE USE OF THERMOGRAPHY IN THE DETECTION OF BREAKAGE IN STEEL: FAILURE PREVENTION IN THE TENSION PROCESS

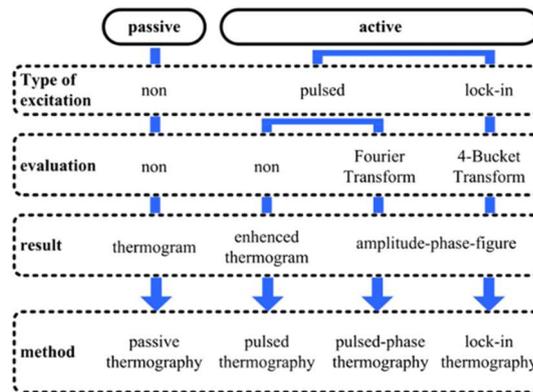
Figure 1– Classification of active thermography methods. Source: An et al (2012).

The NDT procedures nowadays is typically based on active thermography because of its many advantages, such as more reliable information on its results and insensitivity to the influence of environments, An et al (2012). Figure 1 shows a typical classification of common infrared thermography methods. For An et al (2012), among all these active thermography techniques, pulsed phase thermography (PPT) and lock-in thermography (LIT) are the most applied. Thus, the methods of detecting defects in sheet metal parts were focused on the PPT and LIT techniques.

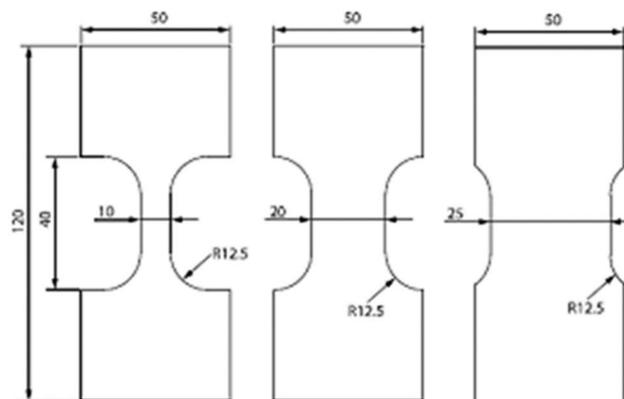
Figure 2 – Specimens - Source: The author – Nakazima test standard edition (2023).

For this study, 3 different sizes of specimens of different sizes were defined, as shown in Figure 2, and for each size 5 specimens were built. Specimens 1 and 5, from each Specimen of evidence, were used only for adjustments and tests outside the standard established for the tests. The specimens were manufactured using BH 220 steel sheets with a thickness of 1 mm.

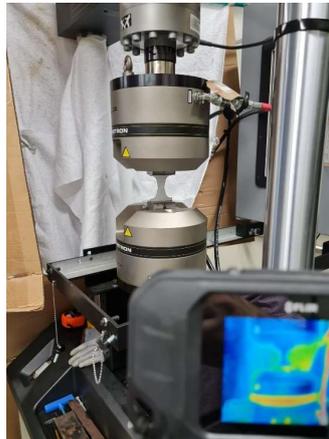
Figure 4 – Test environment. Source: The authors (2023).

Next to the test equipment, a thermal camera from the brand Flir®, model C2, was installed on a pedestal to capture the temperature in the specimen during the execution of the test. The camera was positioned as perpendicular as possible to the plane of the specimen in order to, when take a photo, obtain the best heat emission from the Specimen. To avoid interference from external thermal radiation, white cloths were arranged in the background, thus minimizing this influence. The assembly of the site can be seen as shown in Figure 4.

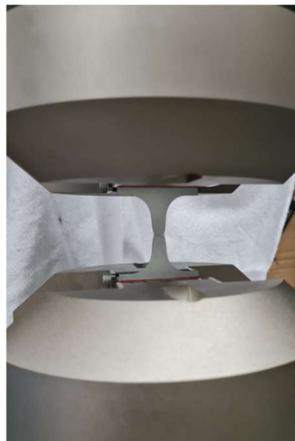
Figure 5 – S1 specimen after completion of the test Source: The authors (2023).

During this process, the equipment used in the test read the force (in Newtons - N) as well as the elongation of the specimen (in millimeters - mm) at a rate of 10 sample per second. The applied force is dynamic and its increments are based on the characteristics of the material to be tested. These results were saved in a CSV (Character-separated value) file. Figure 5 shows specimen Specimen S1 after fracture and Figure 6 shows specimen Specimen L1 after fracture.

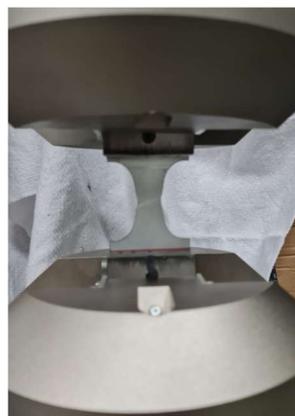
Figure 6 – Specimen L1 after completion of the test Source: The authors (2023).

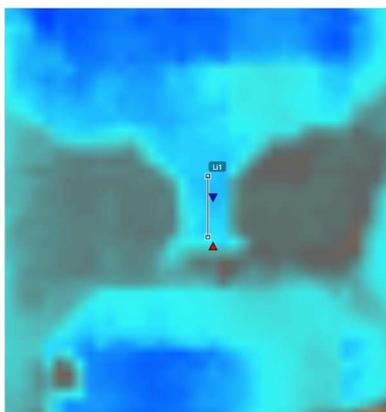
Figure 7 – Screenshot Treatment Image Line LI1 Source: The authors (2023).

Figure 7 shows a table with the line reference (Li1) and the maximum and minimum temperature indications on the line and its location on it.

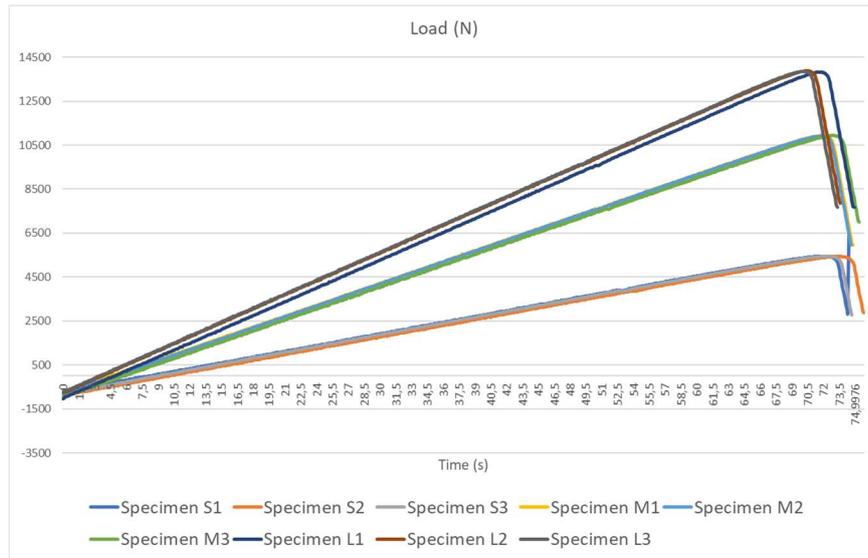
Figure 8 – Data collected Strength. Source: The authors (2023).

Figure 8 shows the results of force(N) under the various specimens, and it is possible to observe a relative similarity in the data obtained for each set of specimens.

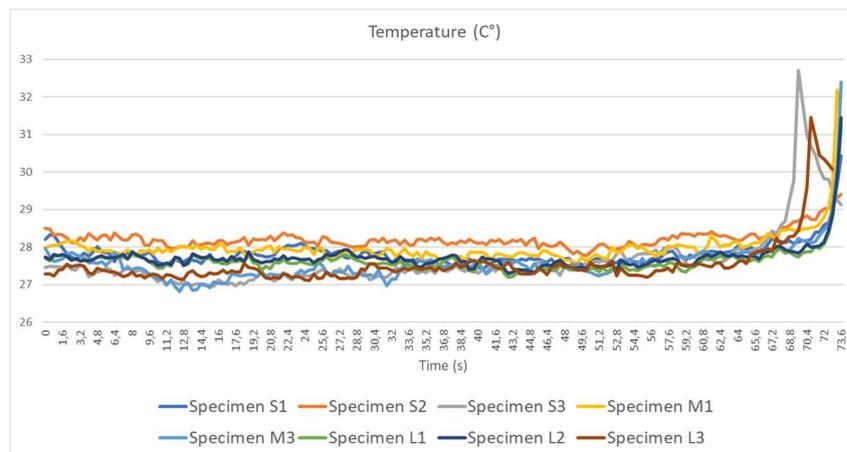
Figure 9 – Data Collected Temperature. Source: The authors (2023).

Figure 9 shows the results of the temperature in the specimens, obtained through the post-processing of the images obtained by the thermographic camera. In this graph, it is possible to verify a similarity in the data, but with an oscillation during the period of stable temperature and a slightly greater variation during the moments preceding the rupture. There are all cases, in the most stable period the variation did not exceed 2% of the average value.

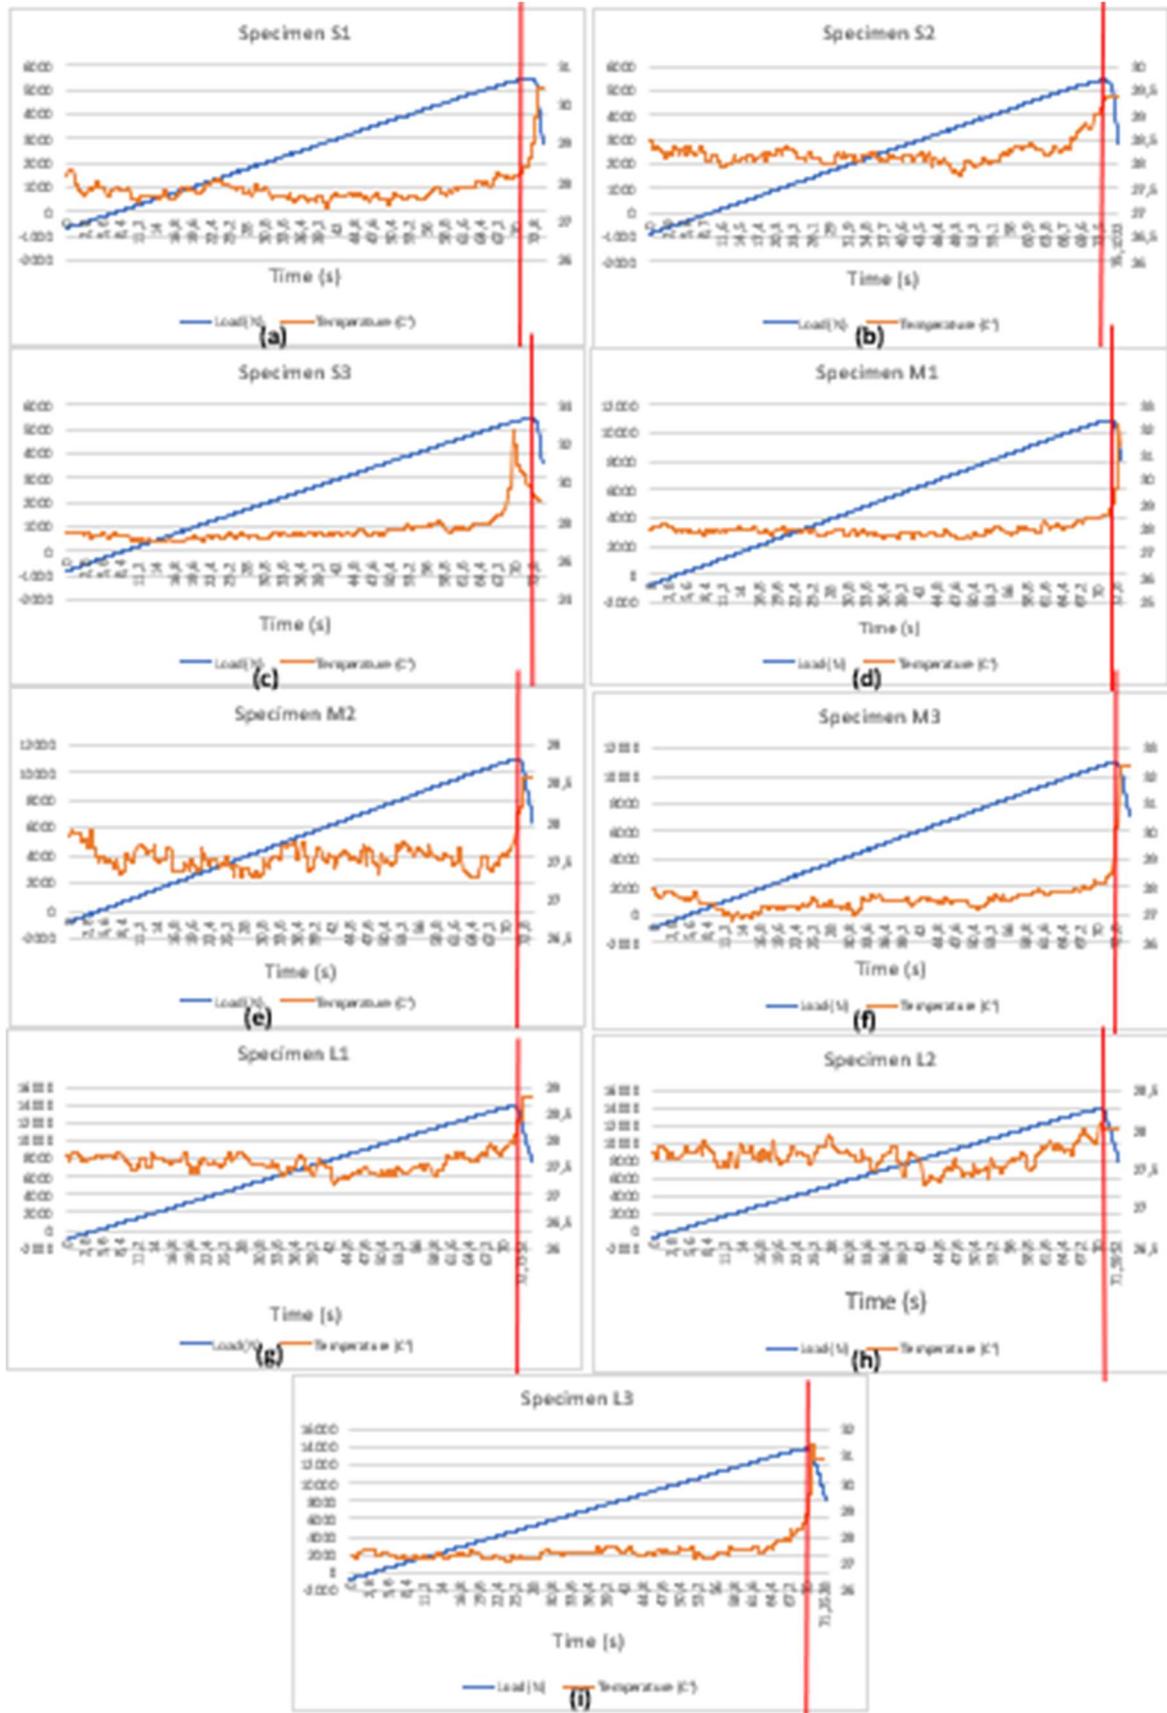
Figure 10 – Comparison of Strength and Temperatures / Time of Specimens. Source: The authors (2023).
 (a) Specimen S1;(b) Specimen S2; (c) Specimen S3; (d) Specimen M1; (e) Specimen M2; (f) Specimen M3; (g) Specimen L1; (h) Specimen L2; (i) Specimen L3

Figure 10 shows the comparative evolution of stress and temperature in the specimens.

It is possible to observe that, in general, the temperature increases abruptly almost simultaneously with the approach of the breaking point of the specimen. The red lines mark the point of maximum tensile force on the specimen. In Figure 11(c) the large lag between the maximum temperature and when the maximum stress occurs was caused by the miss of synchronism of both measuring process.

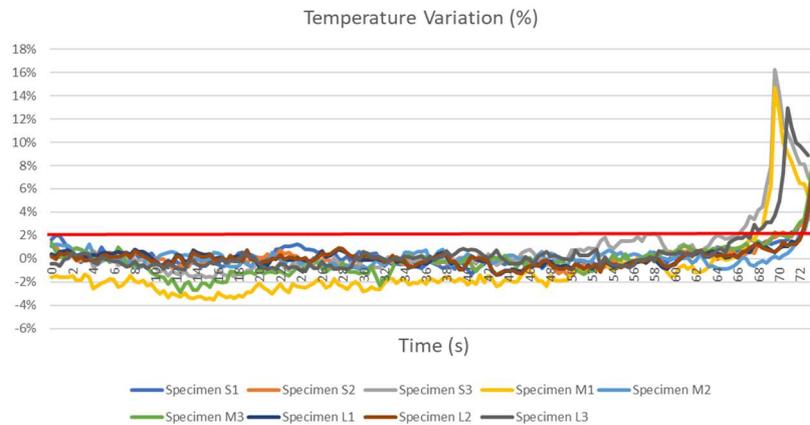
Figure 11 – Global analysis of percentage temperature variation in all specimens. Source: The authors (2023).

Figure 11 shows the result of percentage temperature variation in the various specimens during the tests. It is evident from the graph that, although there are oscillations during the initial phase of the tests, the temperature close to the rupture starts to increase when it exceeds 2% of the average variation and only decreases again after the rupture. The variation was calculated based on the total temperature average to all specimens' measures, relative to temperature at each time of the measurement. So the positive numbers occur when the local point temperature is high then the average and the negative and the temperature was below of the measure.
