COB-2023-1448

CHARACTERIZATION AND EXPERIMENTAL ANALYSIS OF STRESS CORROSION CRACKING AND ITS INFLUENCE ON THE STRUCTURAL INTEGRITY AND MECHANICAL PROPERTIES OF THE MAGNESIUM ALLOY WE43

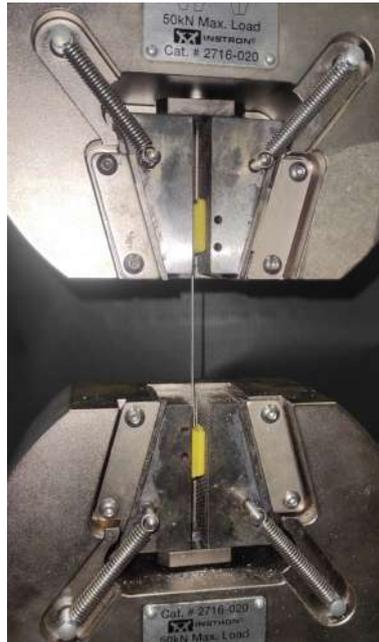
Initially, a uniaxial tension test is performed to verify the mechanical properties of the material and validate the subjection method in the stress corrosion tester, because there may be slippage or excessive force concentrations at the ends where the SP specimen is subjected, to mitigate these issues, it is proposed to attach polymeric clamps or tabs to the SP specimens, as illustrated in “Fig. 3”. “Figure 4” shows the stress-strain curve obtained from the tensile test conducted before and after two heat treatments.

Figure 3: Setting up the tensile test on the universal machine.

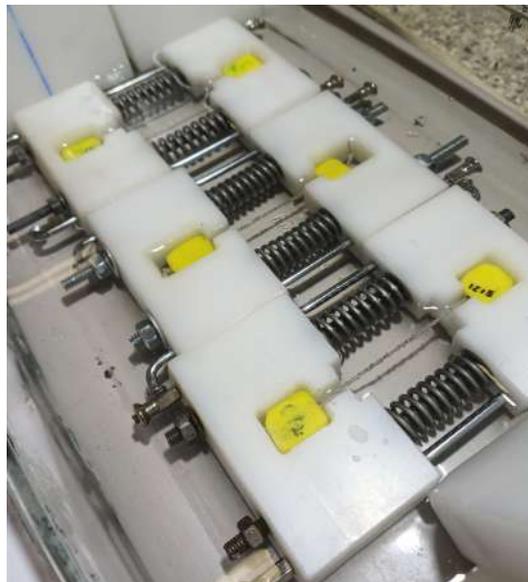
Tests were conducted with two different conditions while maintaining the assembly as depicted in the “Fig. 5”. In the first condition, 5 specimens underwent annealing heat treatment at 400°C for 15 minutes. For the second condition, a heat treatment at 500°C for 15 minutes was performed to 5 specimens.

Figure 5: Experimental setup.

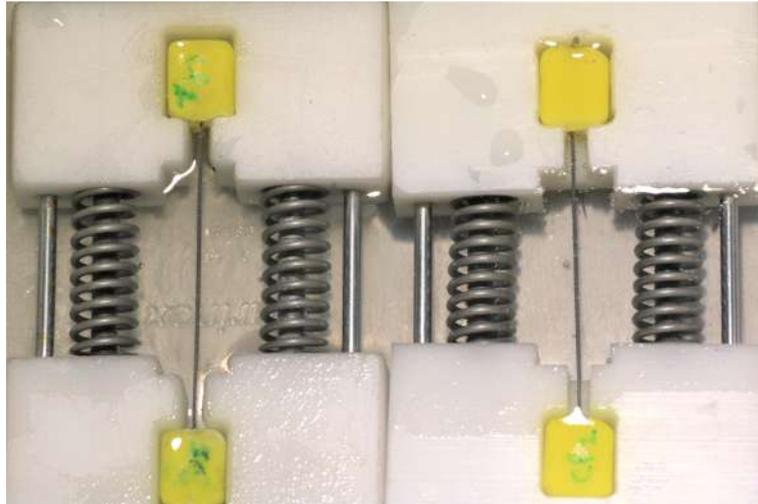
“Figure 6” illustrates two specimens immersed in the SBF (simulated body fluid) solution, and they are subjected to a constant load of 181.73MPa and 93.16MPa. These loads correspond to 80% and 40% of the yield strength of the magnesium alloy WE43, respectively. Both samples were simultaneously placed in the solution and underwent identical chemical cleaning and heat treatment procedures prior to testing.

Figure 6: SP1 and SP2 with 40% and 80% of yield strength respectively.

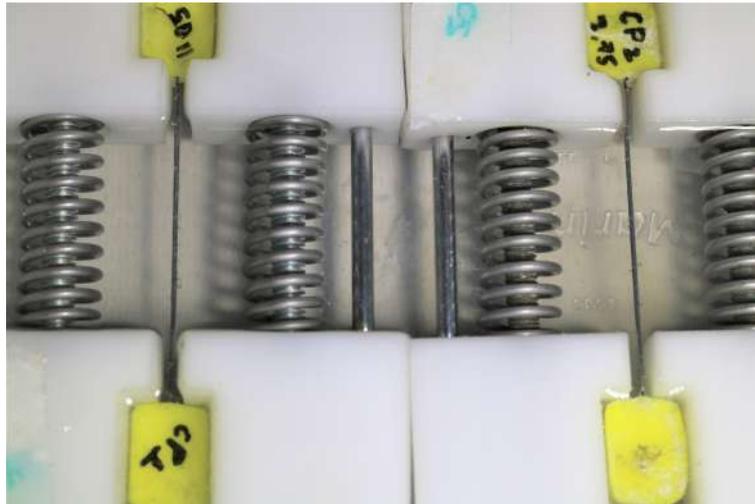
The tests were repeated for the second group of specimens, and in this case, they underwent annealing heat treatment at 500°C for 15 minutes. Similarly, 5 specimens were immersed in the SBF solution until failure, with stresses ranging between 40% and 70% of the material's yield strength. The "Figure 8" displays two specimens, SP1 with a stress of 83.85MPa and SP2 with a stress of 102.716MPa.

Figure 8: SP1 and SP2 with 40% and 50% of yield limit respectively.

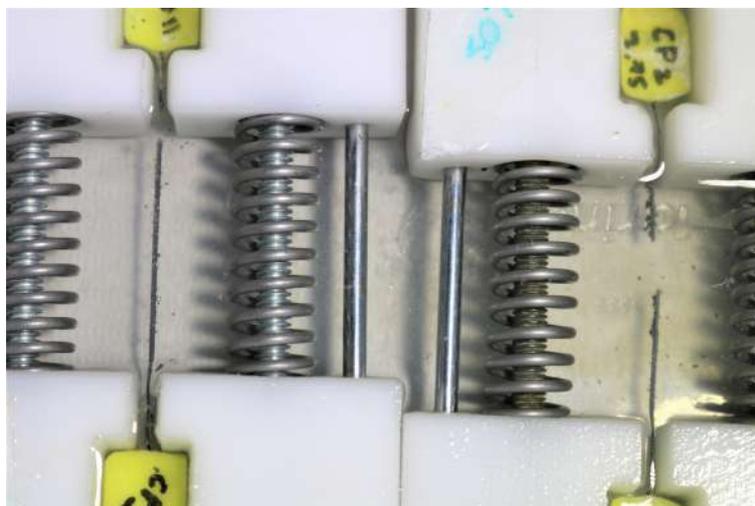
Additionally, the "Figure 9" presents the specimens at the time of fracture, with SP1 (left) breaking after 53 hours of testing, SP2 (right) after 51 hours, and SP3 after 40 hours of testing. The "Table 4" provides a summary of the main parameters used in the tests and the results obtained, including failure time and final mass.

Figure 9: SP1 and SP2 failure.
