## COB-2023-1599

# MECHANICAL ANALYSIS OF FIBERGLASS-REINFORCED POLYESTER COMPOSITES ARTIFICIALLY AND NATURALLY AGED

**Abstract.** *Fiberglass-reinforced polyester matrix composites are used in the Brazilian electricity sector. These composite materials can manufacture poles and crossarms for electricity distribution networks installed in a hard-to-reach locations. For its application in electrical networks, poles and crosses must be sized and manufactured according to specific standards. The Brazilian standard for this application is ABNT NBR 16989. Although available technical Standards consider the aging test performance in a weathering chamber on the material, there is no consensus in the technical community about the relationship between the aging test results degradation and durability of the structure. The present study aims to establish a relationship between natural aging and aging in a weathering chamber of composite samples of polyester reinforced with fiberglass. This relationship provides information on the structure life span after installation. This work was done in four stages to establish this relationship: tensile strength tests were made in three kinds of sampl

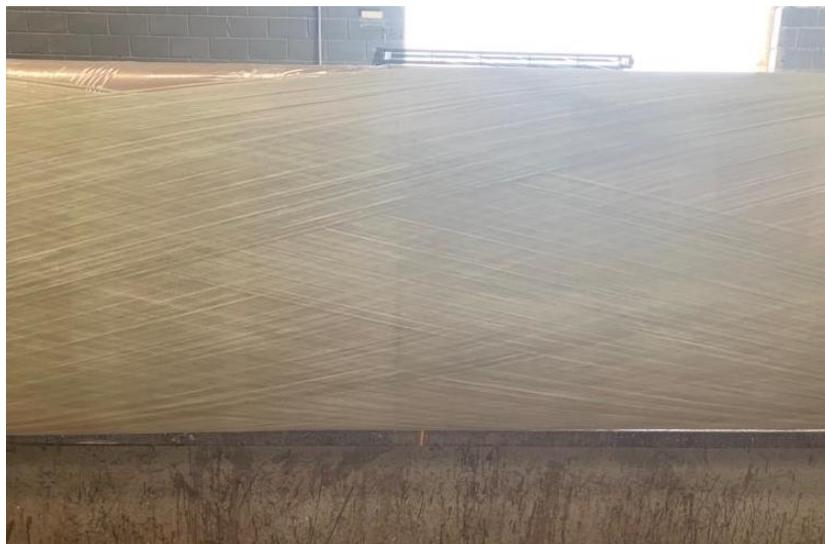
Figure 1. Filament winding pole production.

The naturally aged samples analyzed in this experiment were taken from poles that were produced through filament winding process using fiberglass and polyester resin. The most uniform parts of the product were chosen, however, as

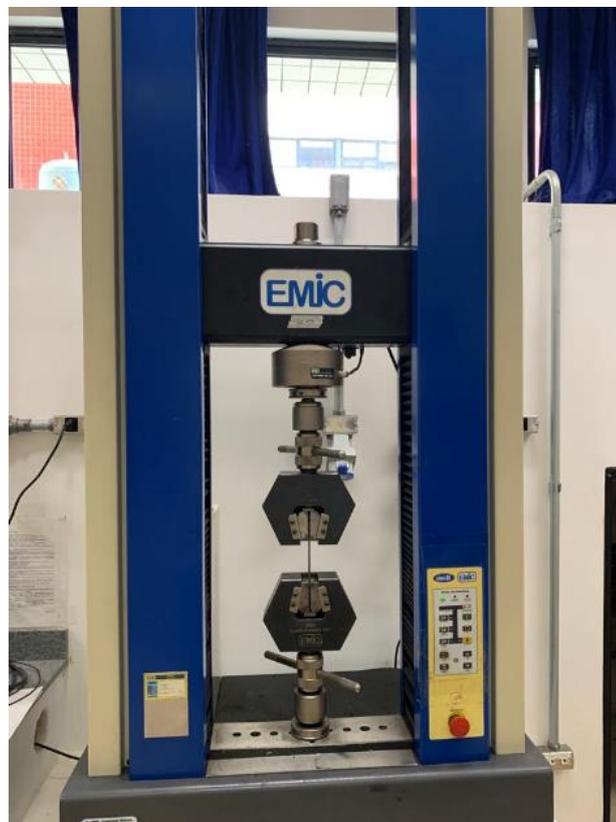
Figure 6. INSTRON universal testing machine, model 4467.

The used equipment was a INSTRON universal testing machine, model 4467. The load cells had capacity for 100,000 kgf. The speed of testing was  $5 \pm 25\%$  mm/min, according the table 1 of the standard.
