COB-2023-2383

HVOF-SPRAYED COATING AGAINST WEAR OF SLURRY PUMP ROTORS AND TAILINGS FOR THE COAL MINING INDUSTRY

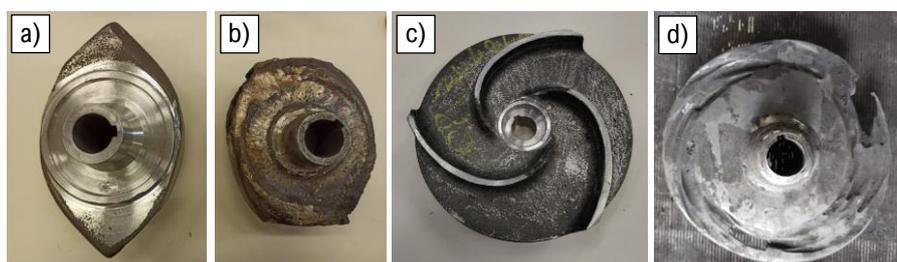
Figure 1. New and used pump rotors a) new slurry pump rotor recovering slurry pump rotor, b) maintenance slurry pump c) new tailings pump rotor, and d) severely worn tailings pump rotor.

The rotors are balanced and concentric when they are in operation. An electric induction motor, powered at 440 V, of 40 HP and a rotation speed of 1750 rpm, is used by slurry pump. An electric motor also induction with same characteristics, but with 100 HP, drives the tailings pump. In Figure 1, worn rotors are compared with new ones.

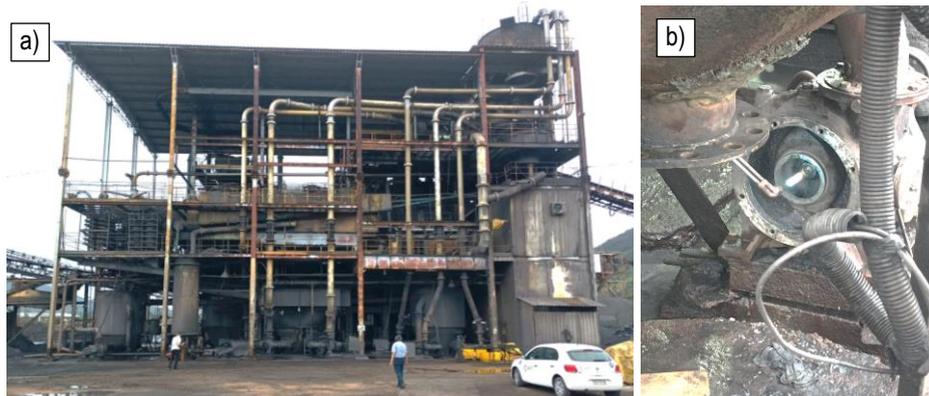
Figure 5. Location of field tests (a) beneficiation plant (b) slurry pump rotor undergoing maintenance.

In the field testing, WC-10Co4Cr and WC-10Ni-coated rotors were employed to investigate the wear characteristics brought on by the carbon pulp's interaction with them. These rotors were set up at the coal beneficiation run by Carbonífera Metropolitana SA company. For the slurry rotor and the tailings rotor, the test basically consisted of determining the mass loss after operating for 15 and 30 days, respectively. The setting where the test rotors were set up is seen in Figure 5.

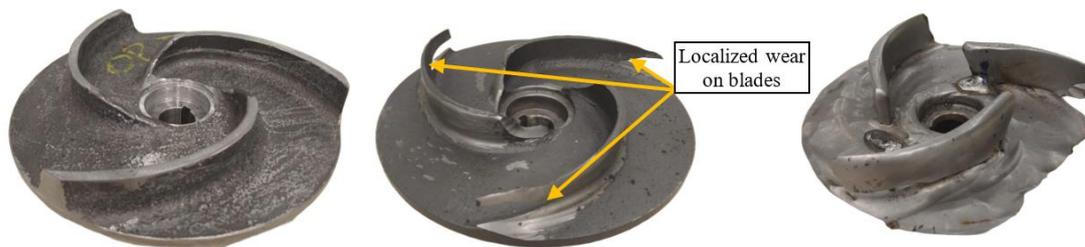
Figure 11. Comparison of tailings rotor a) new, b) used coated with WC-10Ni and c) used coated with SiC.

Another case study was with the tailing's rotor coated with WC-10Ni, and installed in the pump, as show Figure 11.

This rotor operated for 17 days and lost 386g of mass, while the one coated with SiC, operating for 15 days, had 1825g of material removed. Figure 11 compares the wear following testing. Figure 11a shows the rotor unused, whereas Figure 11b shows it coated with WC-10Ni. This rotor had significant localized wear at the ends of the blades, being little affected in other parts of the surface. In Figure 11c, the one that was coated with SiC is shown. It is completely worn out, so its blades had to be welded to have a complete image of this rotor.
