**COB-2023-2115**

**INVESTIGATION OF THE CAVITATION PHENOMENON EFFECT IN THE  
MECHANICAL AND METALLURGICAL PROPERTIES OF THE ROTOR  
OF THE FRANCIS TYPE TURBINE MADE OF STAINLESS STEEL ASTM  
A743 GR CF20**

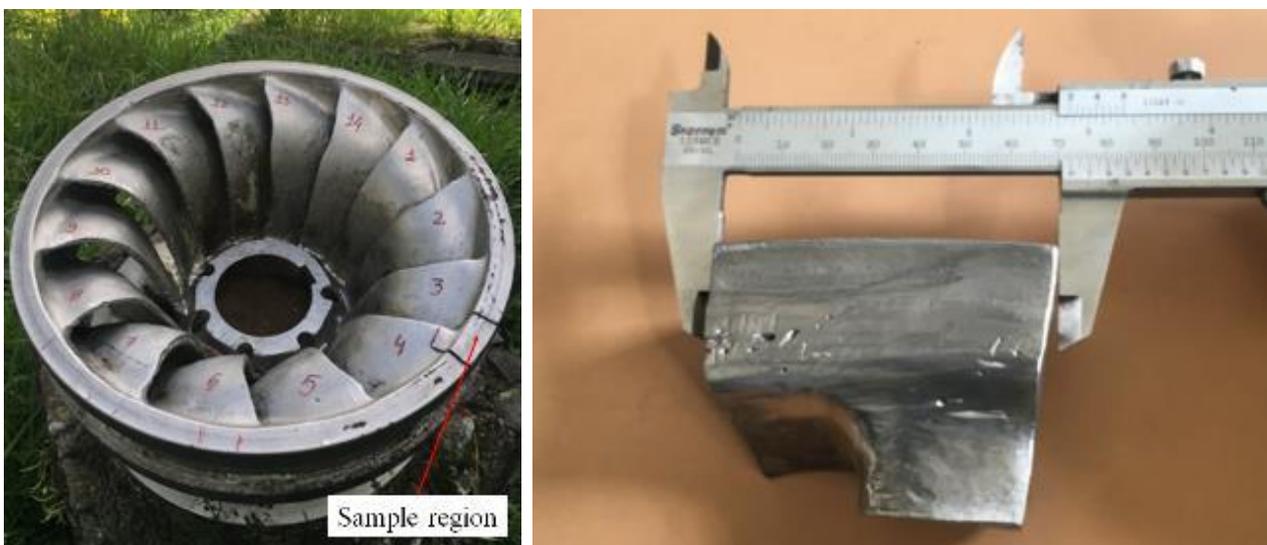
Figure 2. Francis rotor and sample extraction region for analysis, taking part of the crown and part of the rotor blade.

In order to investigate the influence of the cavitation phenomenon on the mechanical and metallurgical properties of the Francis rotor made of ASTM A743 GR CF 20 stainless steel, samples were taken by abrasive disc cutting from the rotor crown and blades in regions that presented wear points caused by cavitation and maintenance welding interventions, as seen in Figure 2.

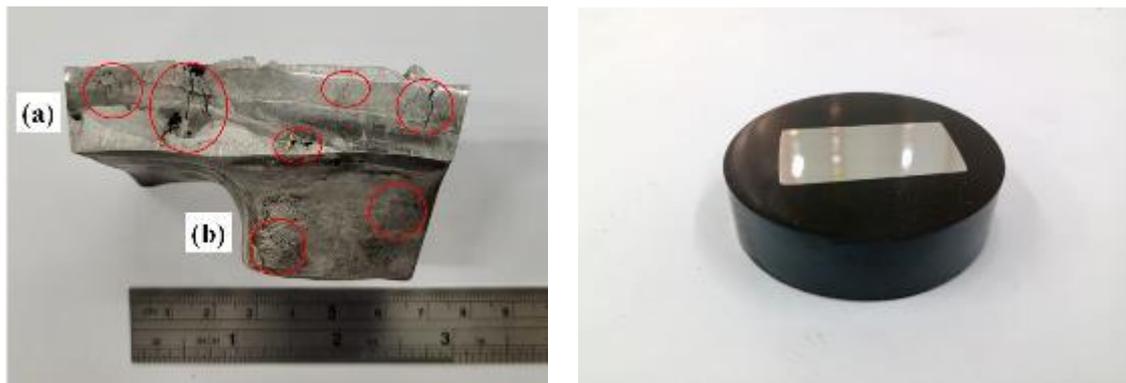
As can be seen from the macrograph obtained from the sample of the Francis rotor shown in Figure 5, the presence of cracks and pits resulting from wear due to cavitation. According to Jiménez (2014), these cracks present on the rotor crown surfaces deplete the energy absorption capacity of stainless steel ASTM A743 GR CF20, a characteristic conferred on the hardness values obtained in cavitated regions in the blade and crown samples of the rotor. The average hardness value obtained in the cavitated region of the rotor blade was 174±3 HB while in the cavitated region of the crown it has an average hardness value of 171±2 HB, values above the recommended by the standard. According to ASTM A743 (2013) standard, the average hardness value of CF20 stainless steel in the state of delivery condition is 163 HB. The increase in hardness of the material is caused by extreme operating conditions, with complex flow and high-water velocity under the turbine, and that the increase in hardness reduces the energy absorption capacity of the material, that is, it weakens it. Due to the nature of cavitation, the result is an accelerated material removal rate. The presence of pits, cracks and craters is also related to the properties of the material.

Figure 5. Macrograph of the rotor sample indicating thermally affected regions, cracks and pits due to cavitation wear in the regions of the crown (a) and blade (b). To carry out the hardness test, it was necessary to embed samples corresponding to the rotor crown and blade.
