COB-2023-0558

INFLUENCE OF TOOL WEAR ON THE SURFACE ROUGHNESS OF SPLINED SHAFTS GENERATED BY HOBBIING PROCESS

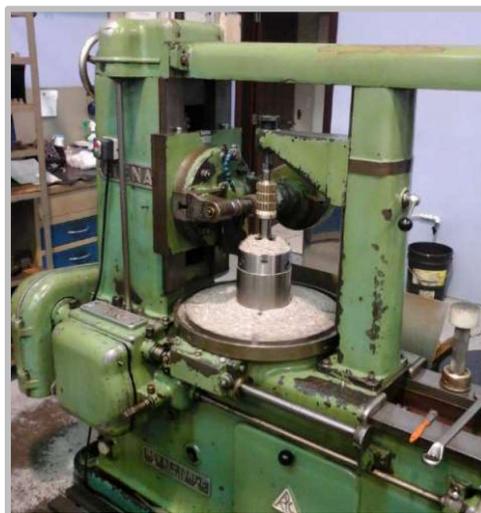
Figure 5. Gear manufacturing machine (Rheinheimer, 2018)

The experiment involved the generation of teeth on SAE 8620 splined shafts (Fig. 4), quenched and tempered with a hardness of 33 ± 1 HRC, by the hobbing process using a generating machine Athena module 8 gear with a 500 mm diameter table and a feed stroke of 300 mm (Fig. 5).

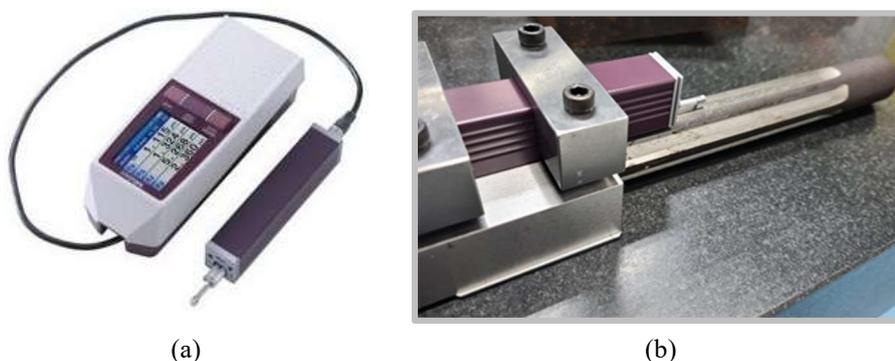
Figure 8. (a) Rugosimeter SJ-210; (b) Surface roughness measurement

In this work, the R_a and R_z values of all samples were measured using the Mitutoyo SJ-210 portable roughness meter (Fig. 8a). Measurements were taken in the middle of the workpiece and the tool feed direction (Fig. 8b). The arithmetic mean of three collected values in each workpiece, in different grooves, was considered. A sampling length $l_e = 0.8 \text{ mm}$ and a measuring length $l_m = 6 \times 0.8 = 4.8 \text{ mm}$ were used.
