24th COBEM - 2017

COBEM-2017-1440

**VORTEX-INDUCED CRACKS ON STAY VANES OF A FRANCIS
TURBINE: AN APPLICATION OF EXPERIMENTAL AND NUMERICAL
ANALYSIS**

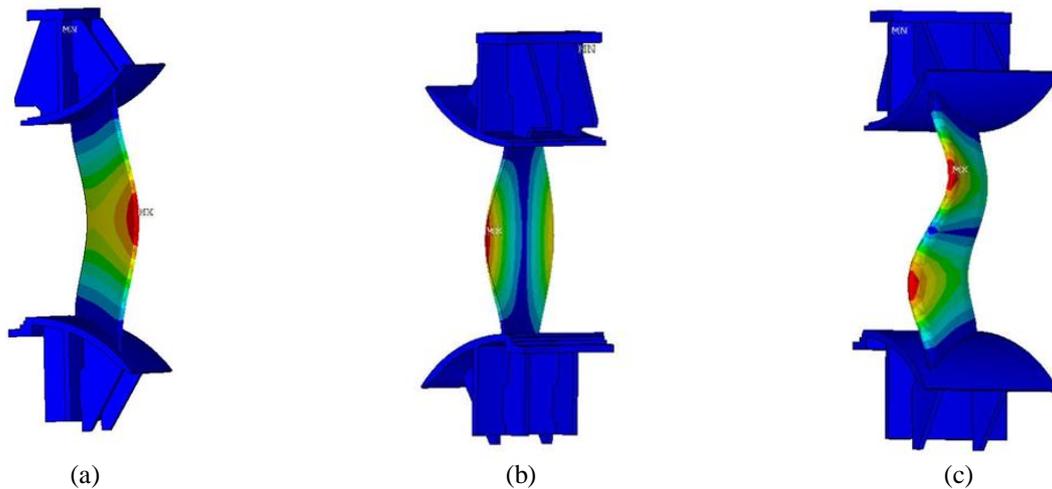
Figure 2. Stay Vane mode shapes: (a) First bending mode, (b) first torsional mode and (c) second bending mode.

Despite being an indirect vibration measure, it was able to identify a characteristic peak frequency of 140 Hz rising at, approximately, 80% of the output until the maximum power available at the moment of the tests, as shown at Fig. 4. This indicated that the first torsional mode of the stay vane which corresponds to the 2nd natural frequency was being excited by the flow.

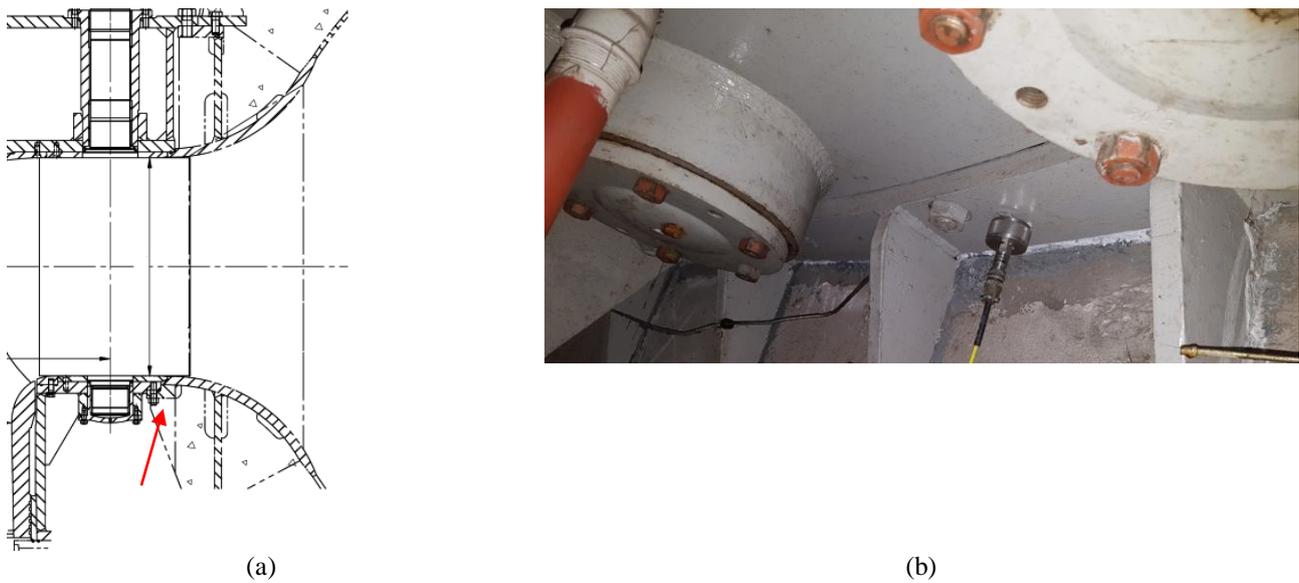
Figure 3. Accelerometer installation position: (a) Cross section view and (b) Photo from the actual installation.

Dynamic tests were also performed at site on PU04 with the machine in operation to characterize the vibrational behaviour of the stay vane. Accelerometers were installed at six different circumferential positions at the coupling region between the stay ring and the bottom ring as shown at Fig. 3, thus indirectly measuring the vibrations on the stay vanes.
