25th ABCM International Congress of Mechanical Engineering
October 20-25, 2019, Uberlândia, MG, Brazil

COB-2019-0983

FAILURE ANALYSIS BY NUMERICAL SIMULATION OF A CRANKSHAFT MODEL MWM 229

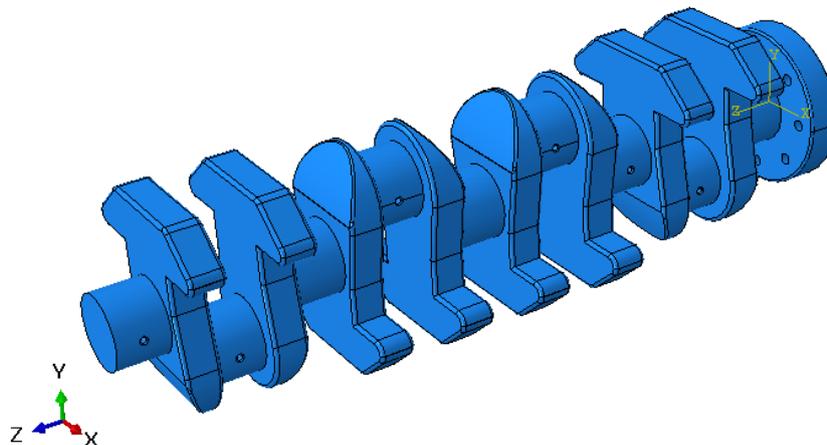
Figure 1. Assembly representation of the crankshaft. Source: Authors (2019)

The boundary conditions for the model, was described pinning the crankshaft on the x and y axis and free in z for a complete freedom in rotation. Then it was applied a 3000 RPM rotation. The Figure 1 shows de assembly representation of the crankshaft.
