25<sup>th</sup> ABCM International Congress of Mechanical Engineering  
October 20-25, 2019, Uberlândia, MG, Brazil

## COB-2019-0275

# FATIGUE FRACTURE ANALYSIS IN DRIVE SHAFTS OF CHIPPING AND REFINING MACHINES IN A CELLULOSE PULP AND PAPER PLANT

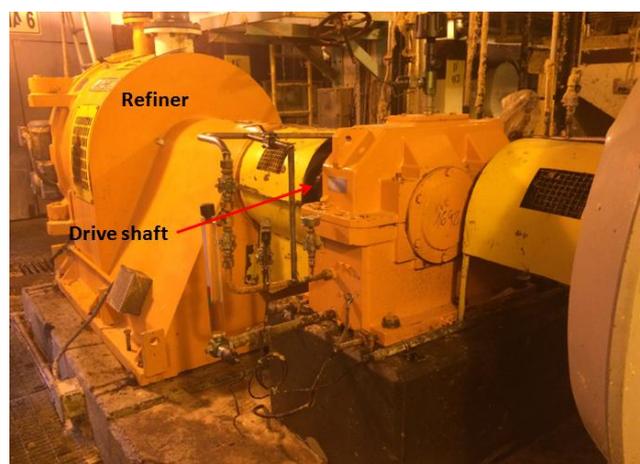
Figure 1. Refiner installation with indication of drive shaft

The fractured shaft was the drive component of a cellulose fiber refiner whose main objective is to mill the fiber in order to adjust its physical-mechanical characteristics such as length and flexibility to provide the requested quality of the paper (Barbosa, 2015). The refiner consists of a rotating rotor and a stator both equipped with bladed tools in the form of a segmented disc that impose mechanical forces in the cellulose fiber. The refining is a high energy demanding process, approximately 150 to 250 kWh/fiber ton that requires sturdy equipments to withstand the stresses involved. Figure 1 shows the refiner unit installation and the drive shaft position.

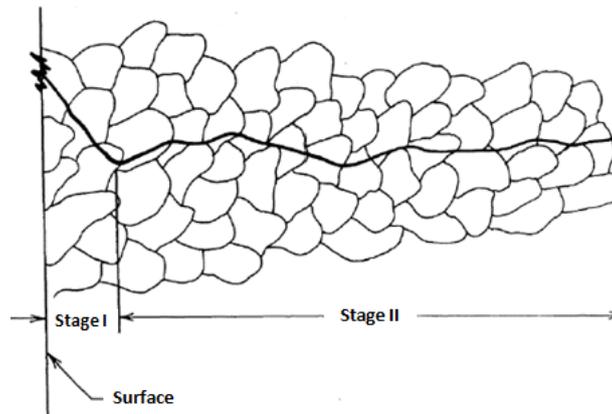
Figure 5. Schematic drawing of transgranular fatigue crack with Stage I and II of fatigue (adapted from Ihara, 2018)

Figure 4 presents a micrographic image from a region at the bottom of the keyseat with nucleation of micro cracks. These cracks are nucleating in a high stress concentration point of the shaft at stage I of fatigue cracking as indicated at Fig. 5.

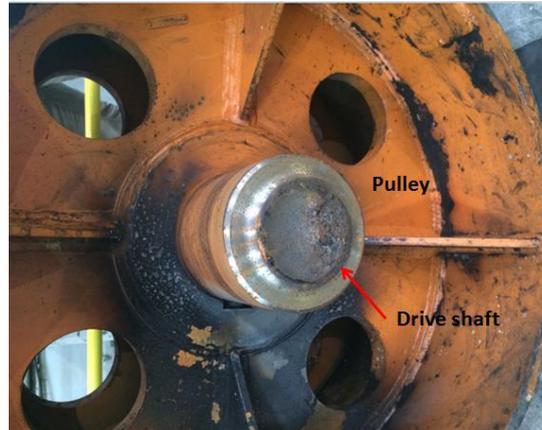
Figure 6. Wood chipper pulley and of drive shaft installation

The fractured shaft was the drive component of a disc wood chipper that consists of a rotating rotor with cutting knives and a feed plate with an anvil that supports the wood log. Chipping is intensive in energy demand and the equipment experiments high intermittent loads due to logs feeding and diameters variation. Figure 6 shows the position of the chipper drive shaft and the drive pulley.
