25th ABCM International Congress of Mechanical Engineering
October 20-25, 2019, Uberlândia, MG, Brazil.

COB2019-2286 PHYSICAL ANALYSIS AND CHARACTERIZATION OF A RAIL *SQUAT* DEFECT

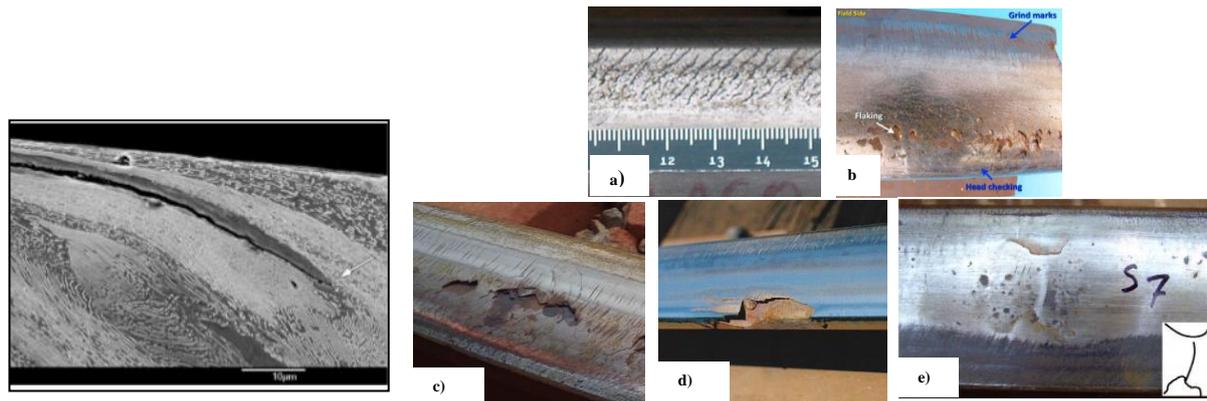
Figure 1. RCF crack propagation, following the sheared, dissociated, and aligned eutectoid microstructure. This deformation is known as ratcheting. Source: Garnham and Davis, 2011. Main RCF rail defects types: (a) Head Check. Source: Popović et al., 2015, (b) Flaking. Source: Zakar and Mueller, 2016, (c) Spalling. Source: From the survey, (d) Shelling. Source: Handbook Rail Track, 2006, and (e) Squat. Source: Li, 2011.

Fig.1a illustrates the head check that is characterized by shallow cracks that are usually visible in the corner gauge regions. Besides, another defect that may originate from this is flaking, shown in Fig.1b. This defect manifests itself as a slight removal of material from the rail surface. Also, Fig.1c shows the spalling, which is characterized as the most severe removal of material from the rail running surface and gauge corner. The literature considers the Shelling shown in Fig.1d (Nielsen et al., 1999; Esveld, 2001; Kondo et al., 1996 and Rice et al., 1994) as subsurface; it is a dangerous defect that initially develops slowly, and over time the cracks in this defect may favor transverse defects. This defect correlates with internal and manufacturing defects in both its initiation and its propagation. Finally, Fig.1e exemplifies a defect known as squat, or dark spot due to the darkened appearance on the rail surface caused by cracks and plastic deformation of the railhead top.

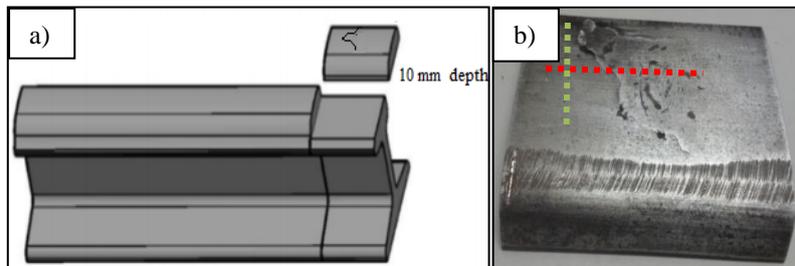
Fig.4 shows the rail that has the defect to be characterized. The image shows oxidation marks that mask the surface aspect of it. A horizontal cut was made at the top of the railhead at about 10 mm depth to obtain the defect sample to be characterized as outlined in Fig.5a. The sample was washed and dried to remove the oxidized layer. Fig.5b illustrates the cuts in the washed part that were made to obtain longitudinal and transverse cross-sections.

Figure 5. a) Schematic of the sample cut from the top of the rail. Adapted from Al-Juboori, 2019. b) Cutting marks on top. Source: From the survey.
