24th ABCM International Congress of Mechanical Engineering  
December 3-8, 2017, Curitiba, PR, Brazil

COBEM-2017-0778

## FRACTOGRAPHIC ANALYSIS OF CO-BONDED CARBON FIBER REINFORCED COMPOSITES JOINTS SUBJECTED TO MODE I DELAMINATION

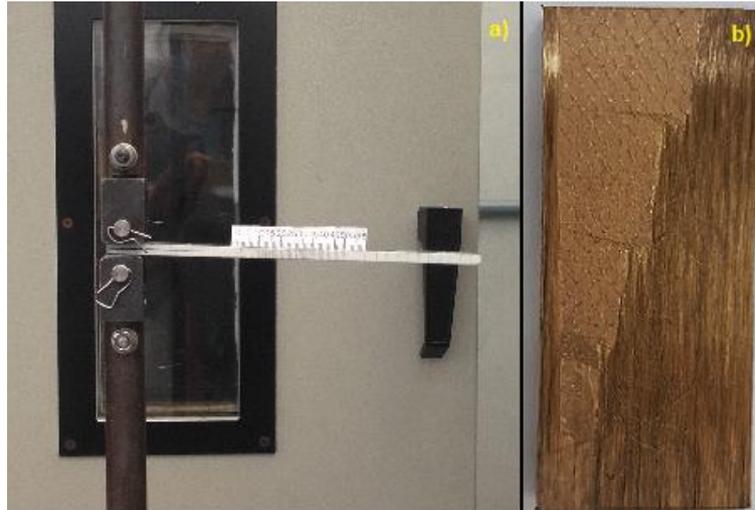
Figure 4. (a) Mode I setup configuration and (b) Sample fracture surface.

After the manufacturing process, the laminate sample was cut from the plate according to standardized dimensions (170x20x5mm) as described in ASTM D 5528 (2013) to perform the Mode I tests as Fig. 4(a). For this, an Instron® 5500R machine with a 2kN load cell was used. The tests were carried out under displacement control with a constant displacement rate of 1mm/min.

The sample analyzed through the SEM technique was cut in dimensions (45x20mm) which allows the inspection of the whole fracture extension. Then, the sample was cleaned using an ultrasonic bath. After drying, it was metallized with gold using Quorum Q150R metallizer. Finally, the sample was placed in the microscope to be analyzed as shown in Fig.4.b.
