24th ABCM International Congress of Mechanical Engineering
December 3-8, 2017, Curitiba, PR, Brazil

FRACTOGRAPHY OF THE FRACTURE MODE ON THE HYBRID POLYMERIC COMPOSITES GLASS / CARBON

Abstract. *The investigation of this work has the objective of studying the failure modes of hybrid laminates composites reinforced by bidirectional E-glass fiber and AS4 carbon impregnated with polymer resin (NOVAPOL L120). The test specimens were initially subjected to mechanical tests of uniaxial traction, three-point bending and interlaminar shear ILSS (Short beam). The fractographic analysis of the final fracture of the laminates was performed by scanning electron microscopy (SEM). The fracture aspects in the fiber / matrix interface region were detailed, so it was possible to determine the direction of crack propagation and to characterize the fractures caused by the loading action.*

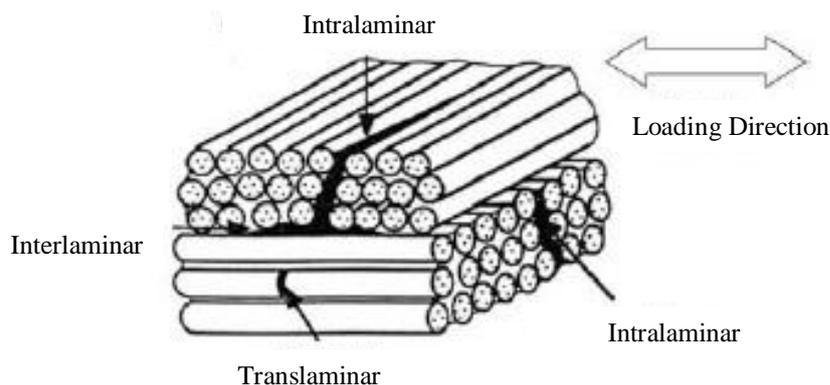
The polymer composites reinforced with continuous fibers exhibit anisotropic behavior, meaning that their mechanical properties show variations in their planes of symmetry. In this way, when subjected to tensile, bending, compression and / or shear stresses, the composites can fail in several ways, these types of faults are directly related to the orientation of the fibers and the direction of application of the load. Damage to the laminate structure can occur in several ways, such as: interlaminar, intralaminar and translaminar, as shown in Figure 1. In the interlaminar fracture the failure occurs between the laminates that make up the laminate; In the intralaminar the fracture is located internally in the matrix, while in the translaminar the fracture is oriented in the transverse direction to the plane of the composite (Franco, 2003).

Figure 1. Failure modes of composite materials: intralaminar, interlaminar and translaminar. Adapted Franco (2003)

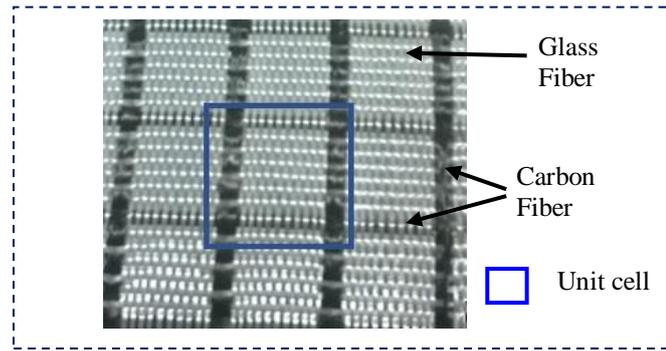
The hybrid composite laminate was made using the manual lay-up process. Using four layers of hybrid fabric glass-E / AS4 carbon commercially identified CVQ-339, manufactured by TEXIGLASS Industria e Comércio Têxtil. Bi-directional hybrid fabric contains 23.35% AS-4 (PAN) carbon fiber, 76.65% E-glass fiber and 340 g / m² fabric weight, see Fig.2.

Figure 2. Configuration of hybrid fabric glass-E / AS4 (CVQ-339)

Hybrid fabric CVQ-339, Figure 2, was impregnated with ortho-terephthalic polyester resin (NOVAPOL L120), without the additional use of styrene. As the catalyst agent, methyl ethyl ketone resin (MEKP) was used.

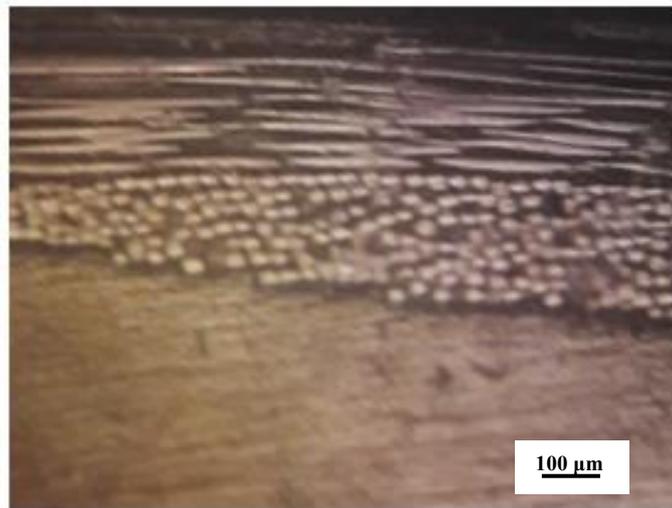
The microstructural analysis of the HVC laminate was performed using the optical microscopy technique prior to the mechanical tests. As can be seen, in Fig. 4, the layers of the composite laminate have a good compaction of the matrix in the reinforcement of the hybrid laminate. These conditions are adequate and expected with good adhesion at the interface between the matrix and reinforcement, a condition necessary to obtain good mechanical and viscoelastic properties in the composite laminate.

Figure 4. Optical photomicrography of composite HVC laminate.

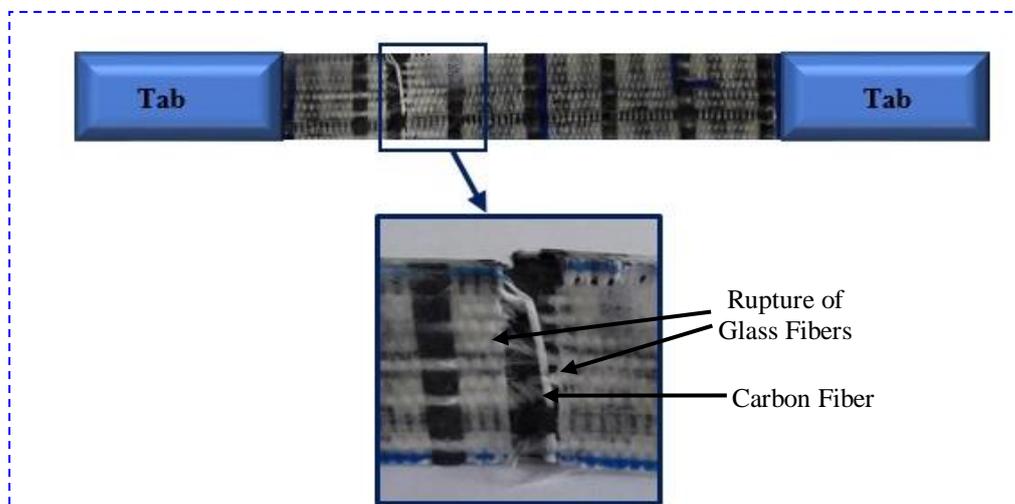
Figure 5 shows the tearing of glass fiber / carbon in the traction direction and the whitening of the region near the rupture site, which may be characterized by the displacement of the glass fibers of the composite interface and resin at the interface. These types of damages are characteristic of composite materials reinforced by synthetic fiber fabrics (Serafim, 2015).

Figure 5. Fracture characteristic - HVC laminate - uniaxial tensile.

In figure 5, it can be seen that no total damage of the carbon wires occurred in the direction of the fabric web. This phenomenon can be justified because the tensile strength of the AS4 carbon fibers is much larger than the E-glass fiber.

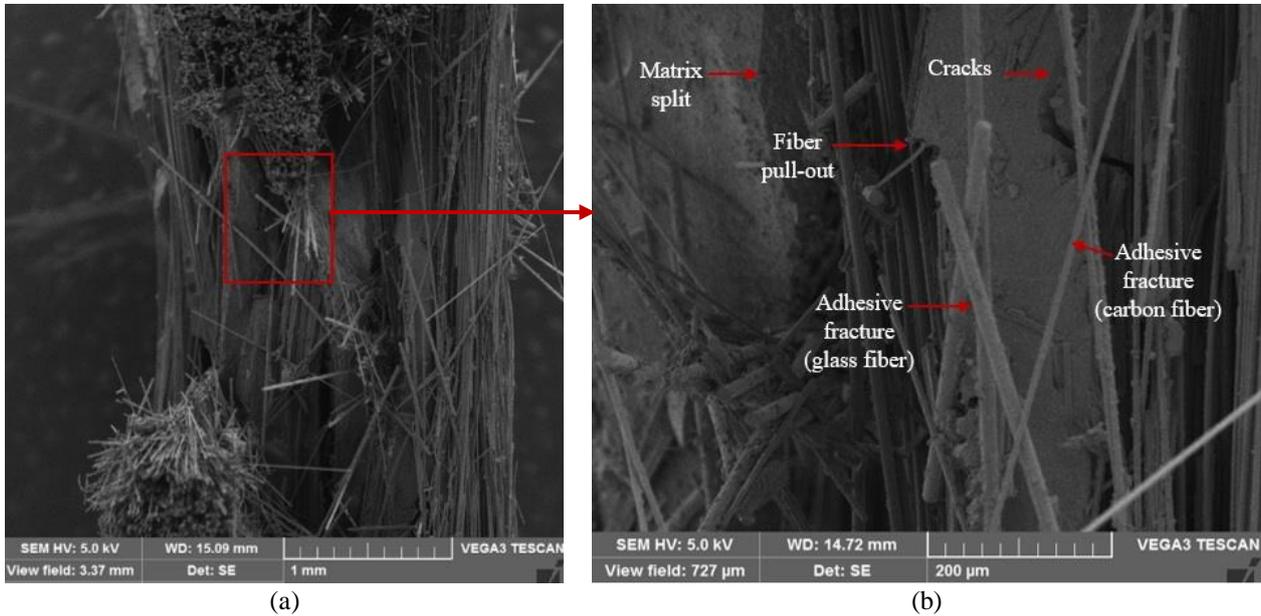
Figure 6, by means of SEM analysis, it is possible to observe in detail, fig.6 (a), the transverse region of the specimen, the presence of microcracks and cracks. Figure 6 (b) shows the presence of adhesive fracture in glass and carbon fibers, cohesive fracture in the matrix (both in the form of microcracks and cracks) and rupture of glass and carbon fibers.

Figure 6. (a) Uniaxial tension – Fracture characteristics – HVC laminate; (b) highlight of the characteristic damage.

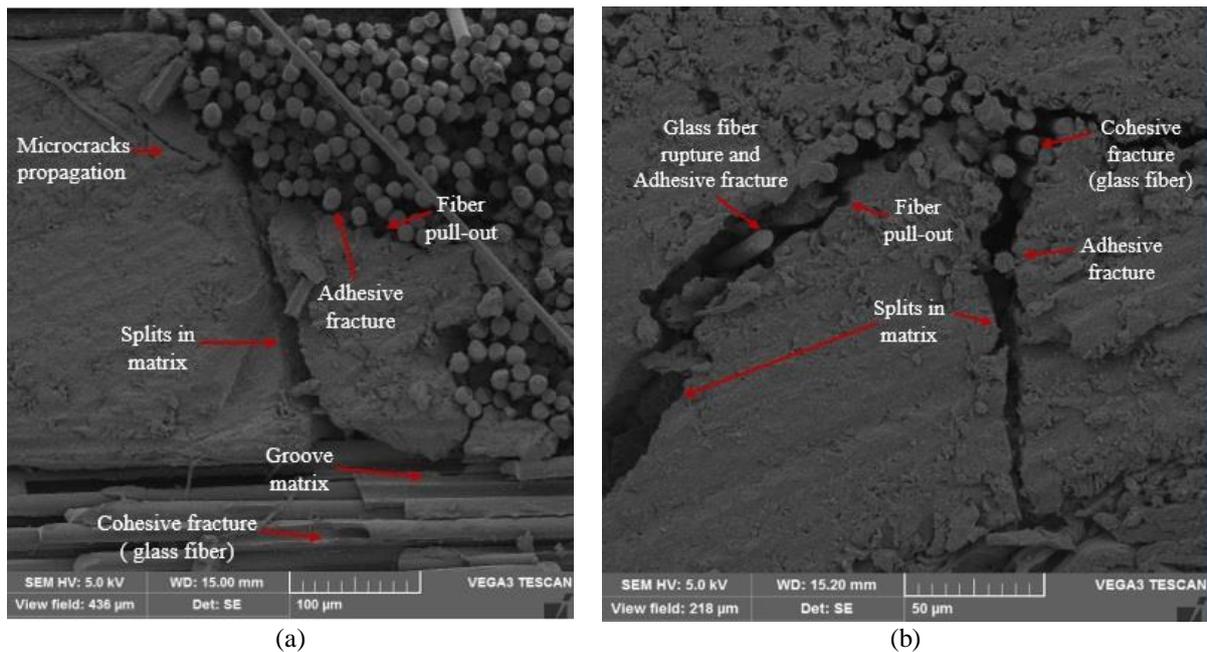
Figure 7 (a) and (b) shows some of the damage characteristics of the HVC laminate. It can be highlighted, Figure 7 (a), the presence of cracks present in the matrix propagate towards the interior of the hybrid reinforcement leading to the fiber-matrix interface, and this type of fracture is called an adhesive fracture. Looking at fig. 7 (b), we can observe the microcracks and cracks in the matrix (cohesive fracture). This type of damage tends to break the fiber, this characteristic was detected in the fiberglass, fig. 7 (b).

Figure 7. (a), (b) Uniaxial tension – Fracture characteristics – HVC laminate.

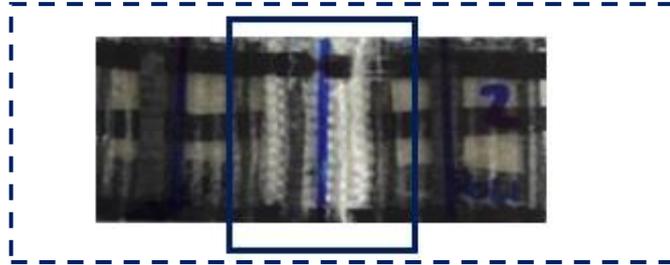
The characterization of the final fracture of the specimen of the three-point flexural test, Fig. 6, is located on the traced surfaces of the specimen. There was no complete fracture of the specimen resulting in bleaching of the final fracture region, fig.8, located in the cross section of the specimen.

Figure 8. Fracture characteristics – HVC laminate – three-point bending.

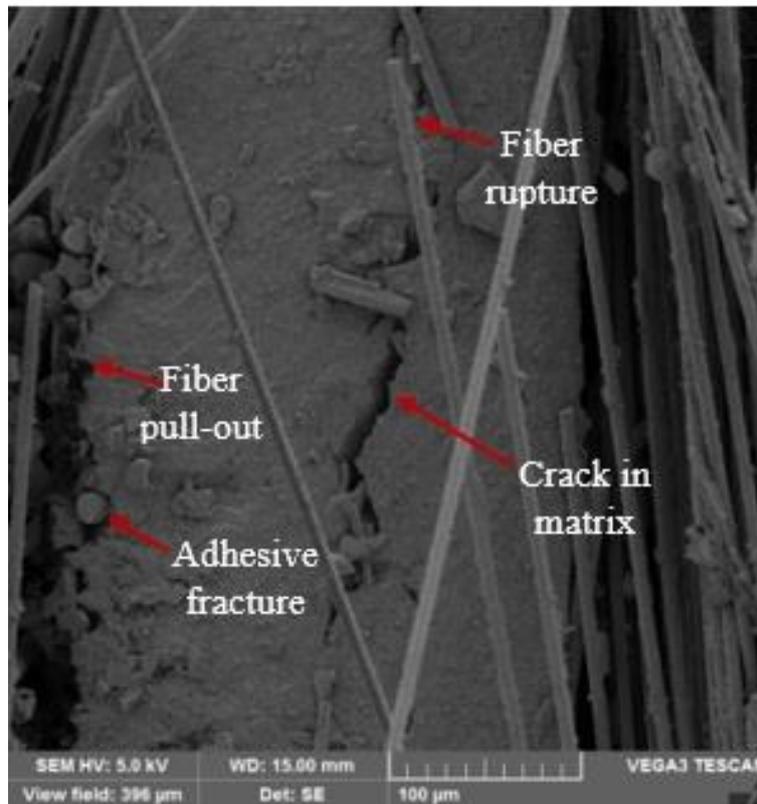
Continuing the analysis of the fracture, but more detailed through the use of SEM, figure 9 shows the fracture of the specimen, linking HVC.

Figure 9. Fracture characteristics – HVC laminate – three-point bending.

Looking at Figure 9 one can see the crack formation in the drawn region, the location of this slit being a good characteristic of the performance of the laminate due to the loading of bending. However, there was also the formation of adhesive fracture, provoked by the adherence loss at the fiber / matrix interface, in addition to fiber bundling.

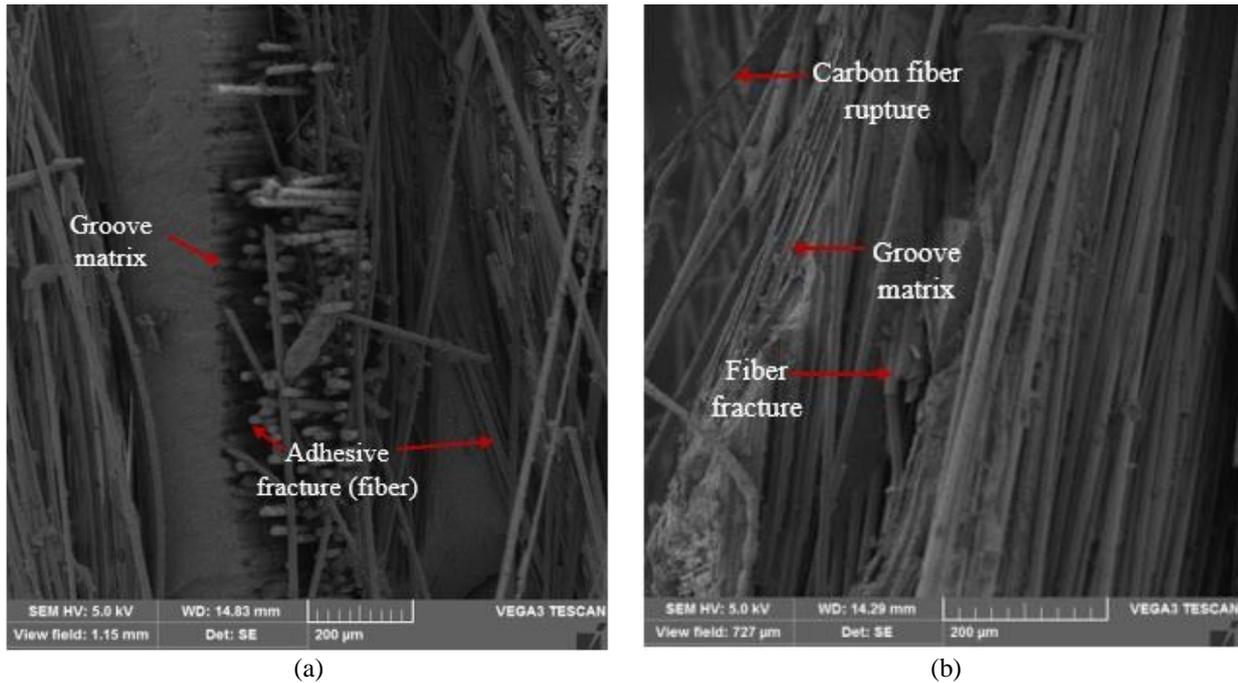
Figure 10 (a) and (b) shows the details of the slit in the cross section of the specimen, where it can be observed the formation of grooves in the matrix characterized by the transfer of tensions from the resin to the fiber, when it is requested by the loading. Figure 10 (b) shows the presence of grooves in the matrix (generation of breaking of the tensile side of the specimen) and its propagation caused adhesive fracture (Fig.10 a) and rupture of carbon and glass fibers. As might be expected due to the flexural loading in the HVC laminate.

Figure 10. (a), (b) Fracture characteristics – HVC laminate – three-point bending.

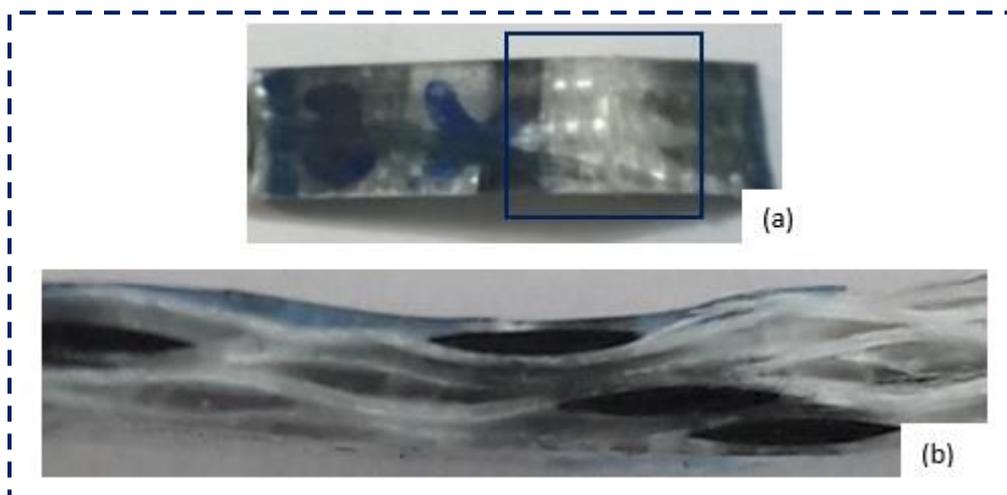
The characteristic of the final fracture in the specimen can be classified as shear and flexion (valid) according to ASTM D2344, Fig. 11 (a) and (b) where delamination fracture is observed (Fig. cross-section along the test piece. Figure 11 (a) shows the fracture zone where the fracture occurred due to the occurrence of resin-rich regions between the composite sheets.

Figure 11. (a), (b) and (c) Fracture characteristics – HVC laminate – Interlaminar shear (ILSS)

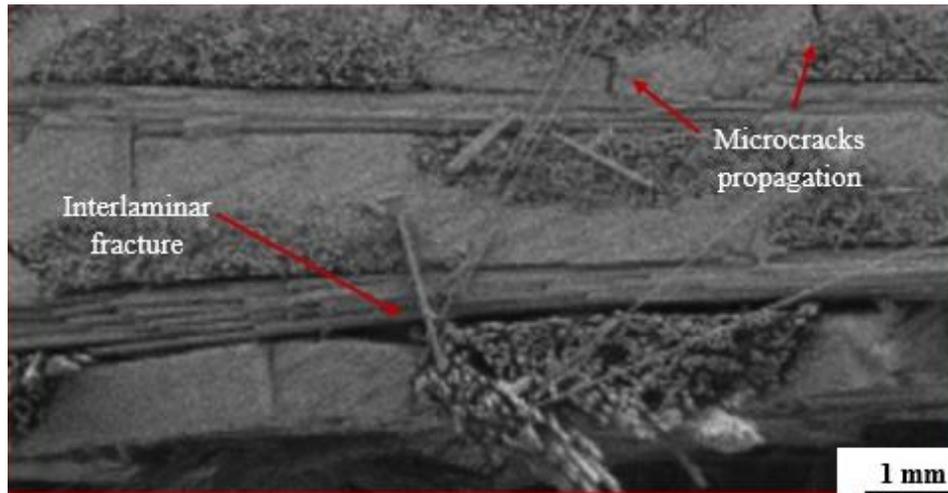
Figure 12 shows the photomicrograph of the fracture characteristic of the HVC laminate. The interlaminar fracture (delamination) between the layers of the laminate, as well as the propagation of the transversal cracks along the specimen, evidences the breakage of the same by the action of the interlaminar shear loading.

Figure 12. Fracture characteristics – HVC laminate – Interlaminar shear (ILSS).

From the photomicrograph of the HVC laminate it can be seen that there were separations (microcracks) between the layers of the laminates towards the fibers, fig.

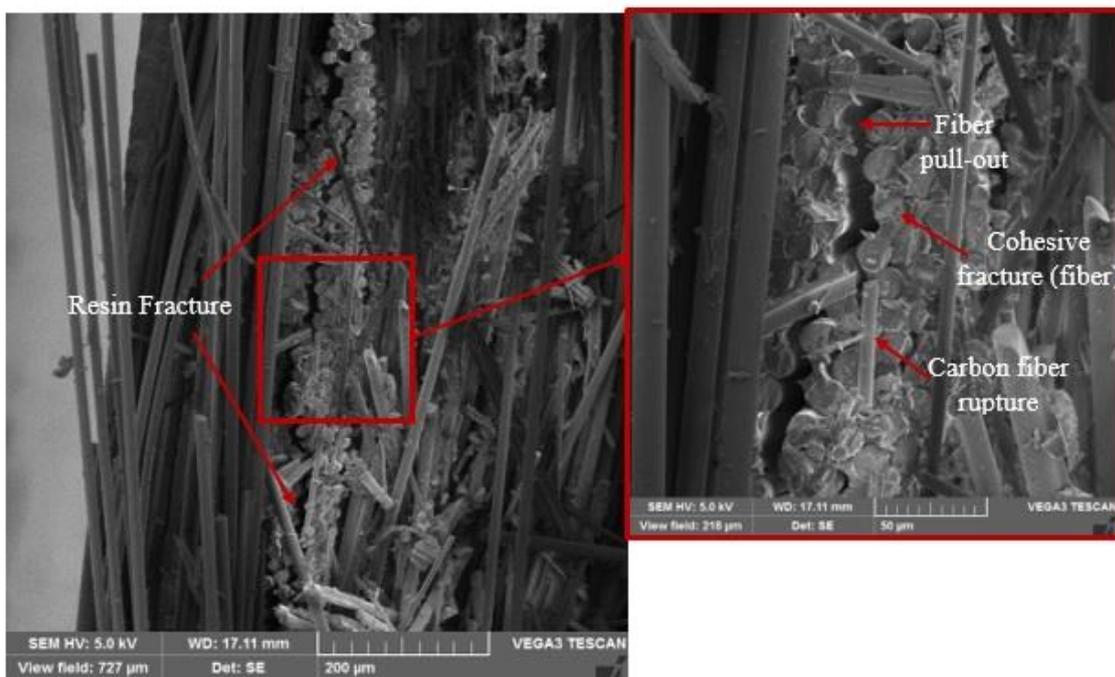
Figure 13 (a) and (b) show photomicrographs obtained by MEV from the HVC laminate, in which it can be verified that, after the interlaminar shear test of the specimens, the fracture mode was classified as corroborating with macroscopy of the test body, as stated above.

The fracture region indicated in Figure 13 (a) indicates the crack propagation forming grooves within the matrix of the fractured laminate, i.e., the rupture occurred at the interface of the matrix (cohesive fracture). Figure 13 (b) shows the detail of shear failure between the fiber bundle of the laminated fabric causing fiber pullout as well as fiber breakage by the stresses transferred from the resin to the fiber.

Figure 13. (a) Fracture characteristics – HVC laminate – Interlaminar shear (ILSS); (b) highlight of the characteristic damage.
