24th ABCM International Congress of Mechanical Engineering
December 3-8, 2017, Curitiba, PR, Brazil

COBEM-2017-2080

BALL ON PLANE ROLLING TESTS TO EVALUATE GEARS CONTACT FATIGUE

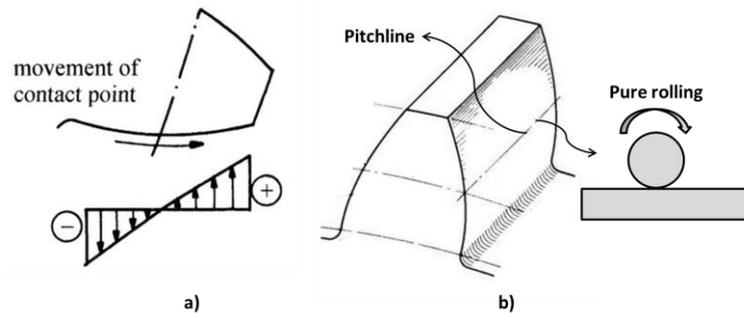
Figure 1. a) Relative surface velocity among the contact point of a gear tooth; b) Proposed system modeling

Therefore, an attempt to evaluate gear fatigue was conducted in this work. The pure rolling phenomenon that occurs on the diametral pitch of a gear was reproduced by means of bearing balls rolling on a plane, by using in-house developed equipment (Neves, 2006). Figure 1a presents the relative velocity between two teeth surfaces along the contact region (Suresh, 1998). In this figure, the sliding velocity is null at pitch line, meaning that only rolling is present. In this way, the ball on disk test may be able to recover the type of damage that occurs on tooth pitch line (Figure 1b).

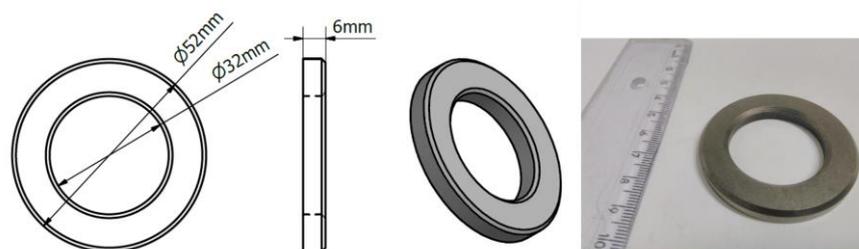
Figure 2. Specimens' dimensions

All the specimens were grounded to improve surface finishing and avoid geometrical errors. Further, the samples were submitted to a carbonitriding process to increase surface hardness. The specimen main features and dimensions are shown on Fig. 2.

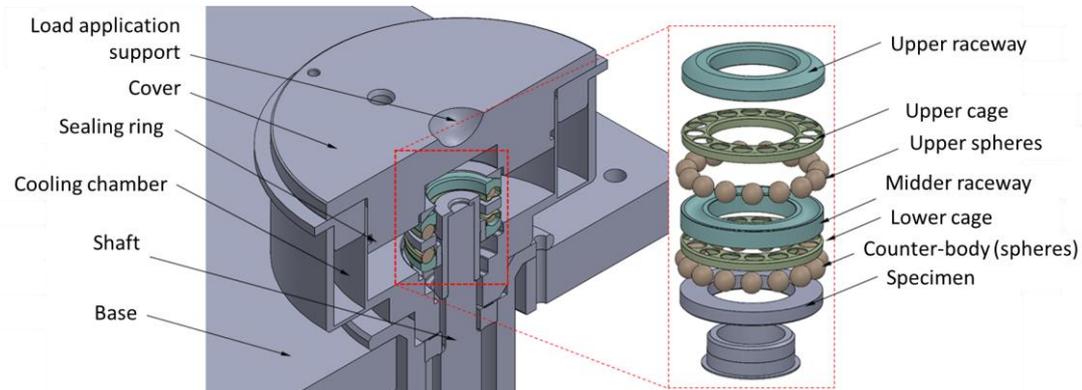
Figure 3. Section view of RCF machine chamber

Load is applied by a lever arm using dead weights. The load alignment is maintained using a spherical coupling between the chamber and the lever. Figure 3 displays a section view of the equipment's chamber, in which the contact occurs. The chamber is filled with lubricant whose temperature is monitored by a thermocouple, allowing temperature control near the contact region. An external pump provides temperature controlled water to maintain the temperature of the chamber.

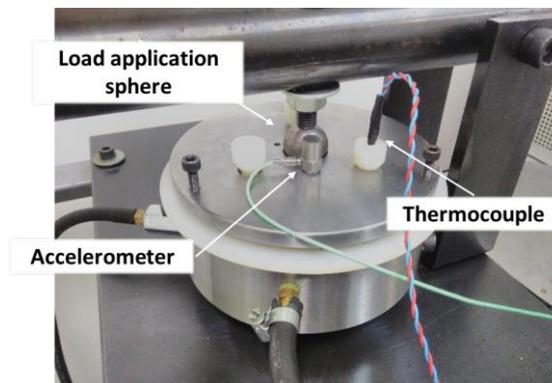
Figure 4. Photograph of RCF machine chamber's cover

Figure 4 shows a picture of the system and the positions of the accelerometer, the thermocouple and the load application support.

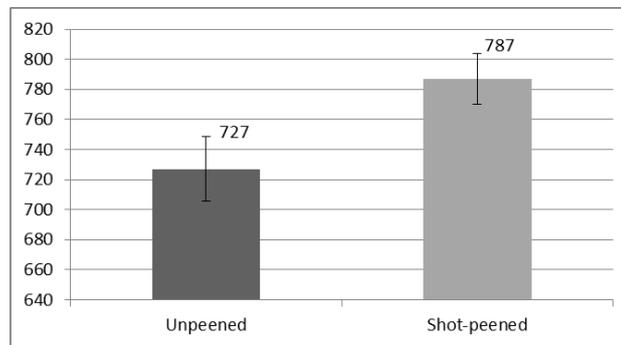
Figure 6. Surfaces hardness for both groups of specimens

Vickers hardness measurements are displayed in Figure 6. These results indicate a slight increase on surface hardness of group S, and it can be related to the shot-peening process. The maximum indentation depth was about 20 μm , which is in the region affected by the shot-peening.

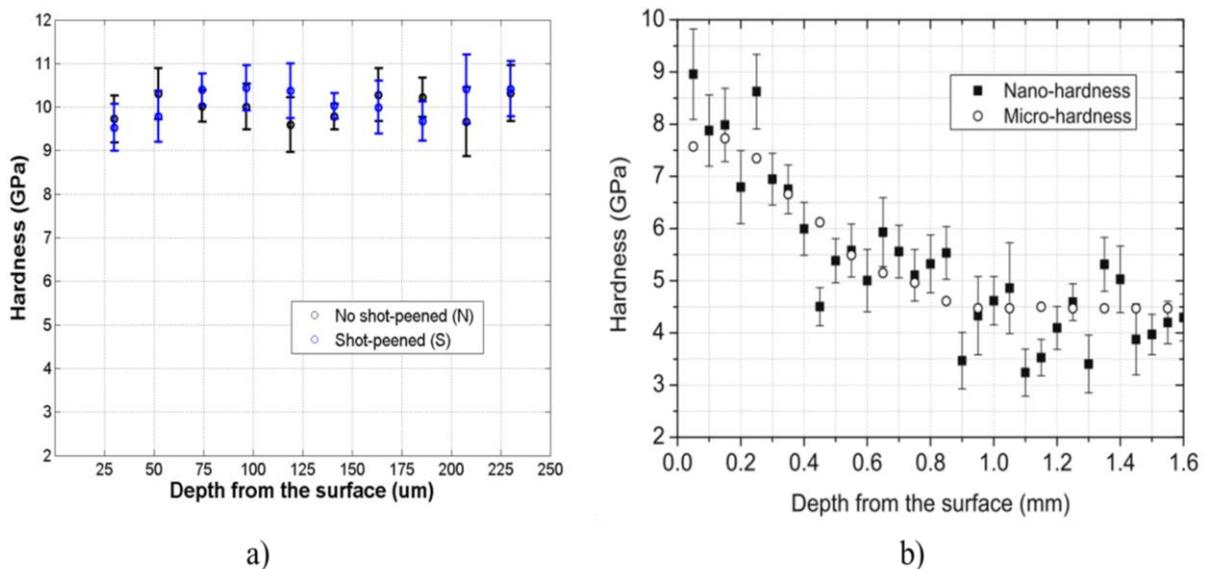
Figure 7. Hardness measurements along the depth in a transversal section: a) nanoindentation hardness profile measurement done in this work and b) nanoindentation hardness profile measured by Fukumasu et al. (2016).

The hardness along the depth on the transversal section of the specimen for both groups is presented in Figure 7a. The shot-peening process didn't appear to cause significant difference at the near surface region. Fukumasu et al. (2016) measured hardness with the same method for deeper regions on a similar material without shot-peening (Figure 7b). This figure indicates a decreasing hardness profile associated to the carbonitrided layer, which ranges from top surface down to 0.8 mm.

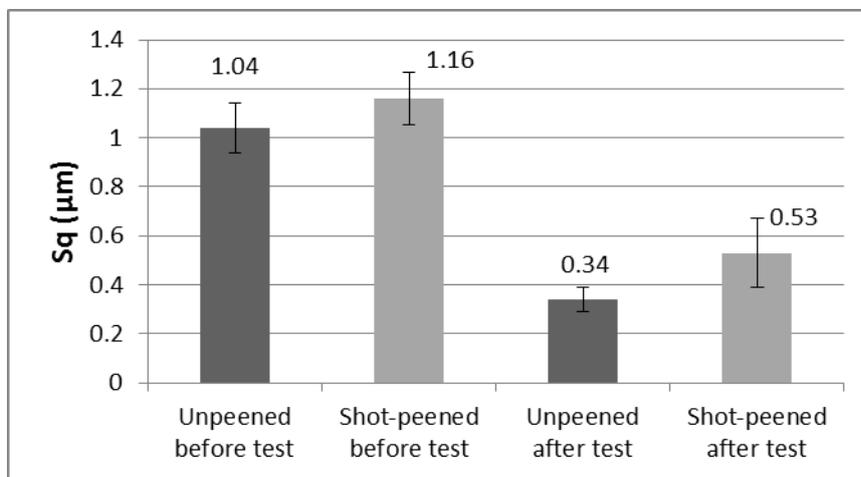
Figure 5. Roughness values for both groups of specimens, before and after experiments.

The lesser reduction of Sq after test and the boundary lubrication condition at the contact region of the specimen with shot-peening (group S) may indicate a reduction on the surface wear given by the higher surface hardness and due the residual stresses generated by the shot-peening process. Focusing on the Sq roughness parameter, Figure 5 indicates the comparison between the measurements before and after the RCF experiments.

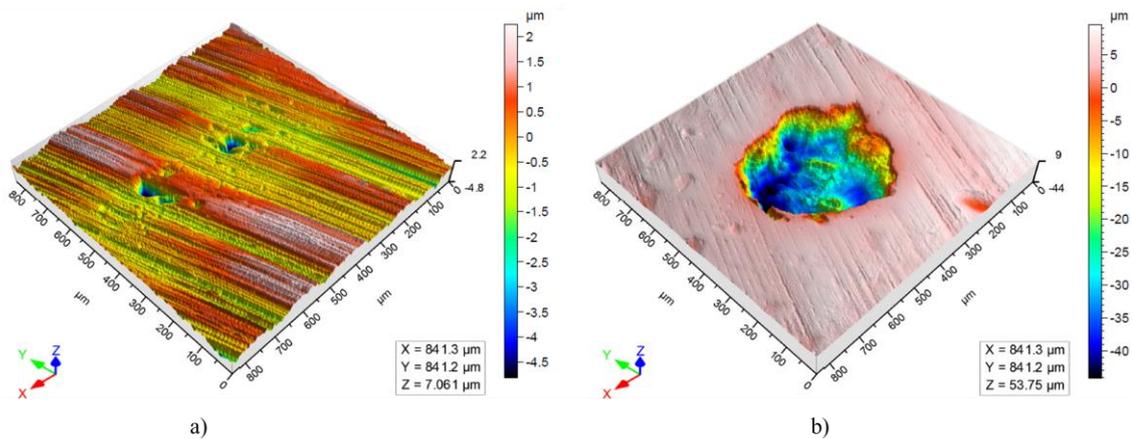
Figure 8. a) Pitting surface generated (N group); b) Spalling subsurface generated (S group)

In the present work, the pitting was generated on both tested groups (with and without shot-peening). A shallow damage located at the same depth scale as the roughness was found, as shown generally on Fig. 8a, which represents a pitting damage at the race track of group N specimen. This figure indicates craters formed with about 4 μm in depth for both groups N and S.

On the other hand, the spalling occurrence increased vibration signal. This kind of damage was observed in all specimens, forming a punctual crater with a depth associated to the Hertz maximum orthogonal shear stress depth, as shown in Fig. 8b. This figure shows the race track of a group S representative specimen, in which the damage occurred at a maximum depth of 53 μm from the surface.

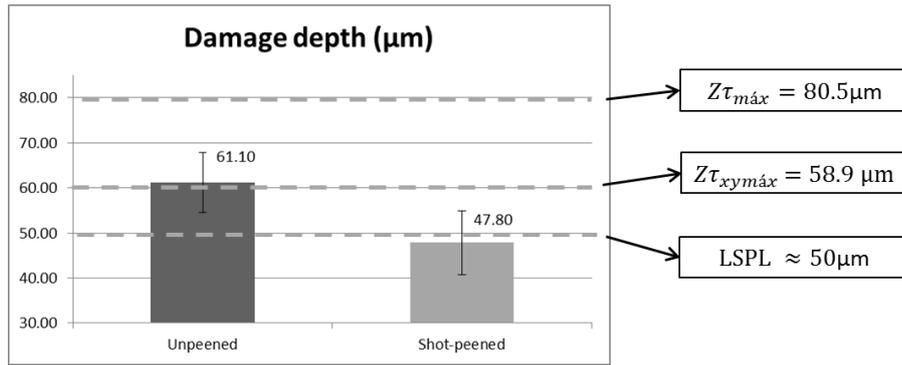
Figure 9. Average damage depths for both groups of specimens. $Z\tau_{m\acute{a}x}$: depth of maximum shear stress (80.5 μm); $Z\tau_{xy\acute{m}a\acute{x}}$: depth of maximum orthogonal shear stress (58.9 μm); LSPL: theoretical limit of shot-peened layer (50 μm).

The spalling depths of all specimens were measured and the average results and standard deviation are shown in Fig. 9. It is important to point out the proximity of Hertz maximum orthogonal shear stress depth ($Z\tau_{xy\acute{m}a\acute{x}} = 58.9 \mu\text{m}$) in the N group and the proximity of the theoretical limit of shot-peening's affected layer (LSPL = 50 μm) in the S group. These results indicate that the critical depth for the N group is associated to the maximum orthogonal shear stress depth, while for the S group, the critical depth would be the interface between shot-peening affected layer and bulk material. The interface region is critical since it denotes an important gradient in stresses, going from high compressive values (shot-peened region) to low values (non-affected region).

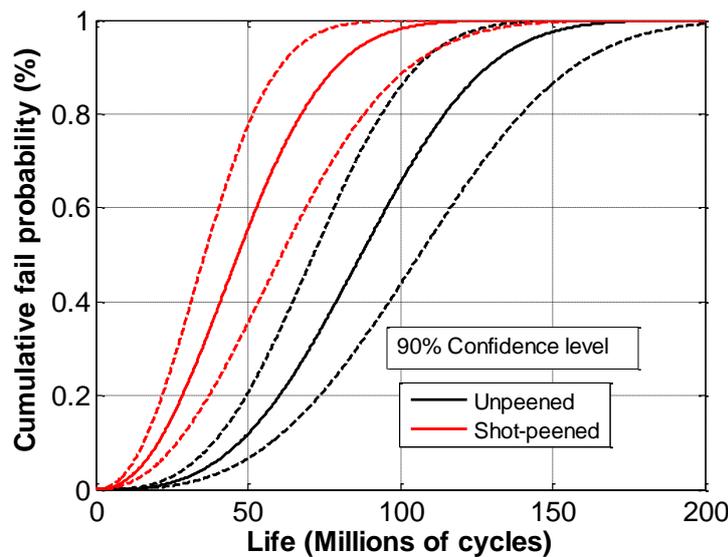
Figure 10. Cumulative fail probability Weibull plot for both groups of specimens

Figure 10 presents the Weibull cumulative fail probability plots for both groups S and N. The bounds represent 90% confidence level calculated by MLE. The failure, as mentioned before, is considered as the raise on vibration signal, probably due to spalling generation. From this figure, the shot-peening group presents lower life compared to the group without shot-peening.

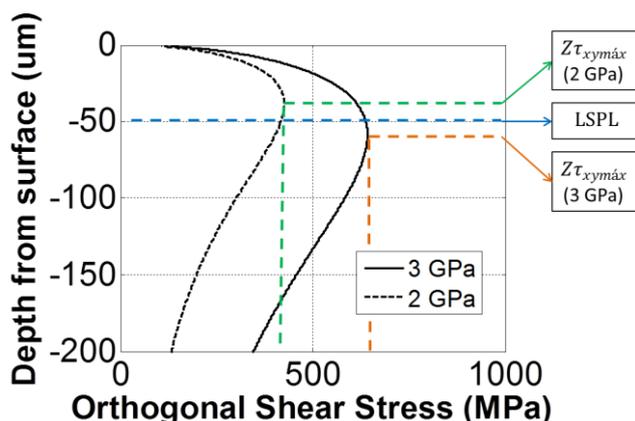
Figure 11. Orthogonal shear stress along depth. $Z\tau_{xymáx}(2\text{ GPa})$: depth of maximum orthogonal shear stress for 2 GPa maximum Hertz pressure (40.0 μm); $Z\tau_{xymáx}(3\text{ GPa})$: depth of maximum orthogonal shear stress for 3 GPa maximum Hertz pressure (58.9 μm); LSPL: theoretical limit of shot-peened layer (50 μm).

Firstly, in this work, the shot-peening process was similar to a commercial process used in the automotive gears industry. It was set to produce a compressive residual stressed layer of about 50 μm in thickness, considering the gear regular stress conditions. The RCF tests imposed a Hertz maximum contact pressure of 1.5 times higher than regular contact pressures presented during the gear coupling. Consequently, the stress distribution changed and was moved towards a deeper position. One can assume that the shot-peening affected layer, adjusted to the regular gear scenario, may not be deep enough to present similar effect on the RCF critical depths. The orthogonal shear stresses as a function of depth calculated based on Moyer and Sharma (1997) and using 2 and 3 GPa maximum Hertz pressure conditions (regular gear coupling and RCF present work experiments, respectively) are shown on Fig. 11.

Hence, for the regular gear coupling condition at 2 GPa maximum Hertz pressure, the critical depth, $Z\tau_{xymáx}(2\text{ GPa})$ is located inside the shot-peening affected layer. On the other hand, for 3 GPa maximum Hertz pressure RCF set in the present work, the critical depth, $Z\tau_{xymáx}(3\text{ GPa})$ is located outside the shot-peening affected layer, which indicates the benefits of shot-peening are not achieved because the thickness of shot-peening affected layer is shallower than the critical depth for the accelerated RCF experiments. Furthermore, the interface of the shot-peening layer behaves as a stress raiser, promoting crack nucleation and propagation in this region. This result is corroborated by the average spalling depth, which correlates directly to the position of this interface on RCF accelerated tests.
