24th ABCM International Congress of Mechanical Engineering
December 3-8, 2017, Curitiba, PR, Brazil

COBEM-2017-2687

FIRST RESULTS OF THE CAVITATION EROSION BEHAVIOR FOR LOW-TEMPERATURE PLASMA CARBURIZED MARTENSITIC STAINLESS STEEL

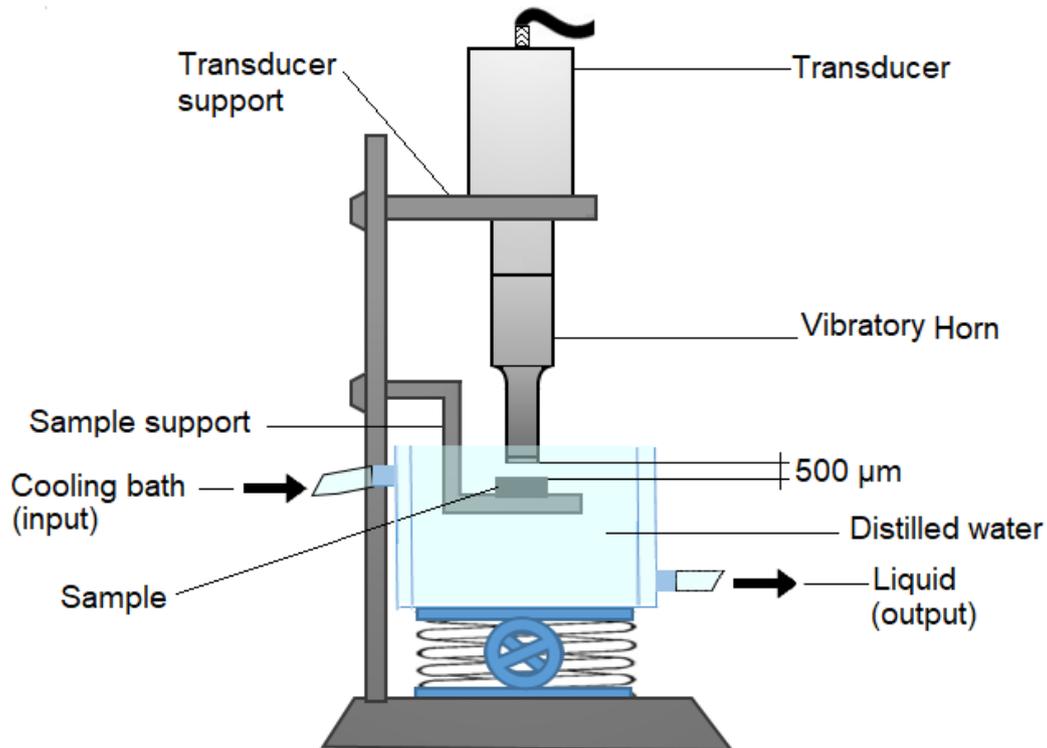
Figure 1. Cavitation test by indirect method

Cavitation erosion tests were carried out in accordance with ASTM G32-10 standard. The vibratory ultrasonic equipment was set by the indirect method test configuration. The apparatus setup is schematically presented in Figure 1. Samples were cut by water jet technique in 33 x 20 x 10 mm³ dimensions (proper to be attached to the sample support). Samples were placed to 500 µm distance of the vibratory horn tip. The test liquid was distilled water, which temperature was monitored by means of a thermocouple device and controlled by a cooling bath of a cooled and transient water flux, in order to limit the distilled water to the 25 ± 2 °C temperature range. Vibration frequency was 20 KHz, the peak-to-peak displacement amplitude of the horn was 50 µm and the immersion deep of the sample tested (33 x 20 mm²) surface in distilled water was 12 mm. The cumulative mass loss of the specimens was determined by means of 0.1 mg precision balance.

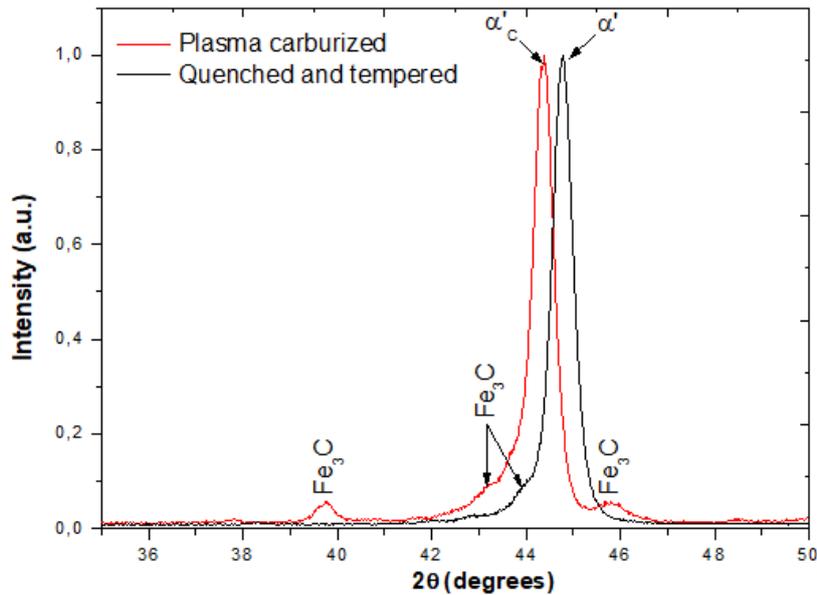
Figure 2. X-ray diffraction patterns of untreated (quenched and tempered) and plasma carburized AISI 420 MSS samples.

Figure 2 shows the X-ray diffraction patterns of untreated and plasma carburized samples. Regarding to untreated samples, it can be seen an asymmetrical peak related to Fe_3C phase (43.92° degree), identified at the left-side of α' phase peak, which is a result of the tempering process of the reference sample, supposedly leading the martensite structure to be changed from b.c.t. to b.c.c.. Nevertheless, in spite of it, the X-ray diffraction pattern still presents the main peak at 44.8° degree, which is attributed to the martensite phase (α'), being in accordance with the expected for the low-temperature tempering and with the substantial carbon content of the studied steel.

In relation to the carburized samples, some significant changes can be observed after the carburizing treatment. First, the martensite peak was broadened and slightly shifted to lower angle ($\sim 44.32^\circ$), indicating (compressive) residual stress occurrence and lattice parameter expansion, respectively. Second, from the α' -peak position shift, it can be also expected that during the treatment, the carbon diffusion into the martensite phase tends to result in its carbon content enhancement, forming the so called carbon-expanded martensite phase (α'_c), as previously presented by Angelini et al. (2016) and Scheuer et al. (2012; 2013). Likewise, Fe_3C peaks are clearly distinguished at 39.78 , 43.23 and 45.96° reflections.

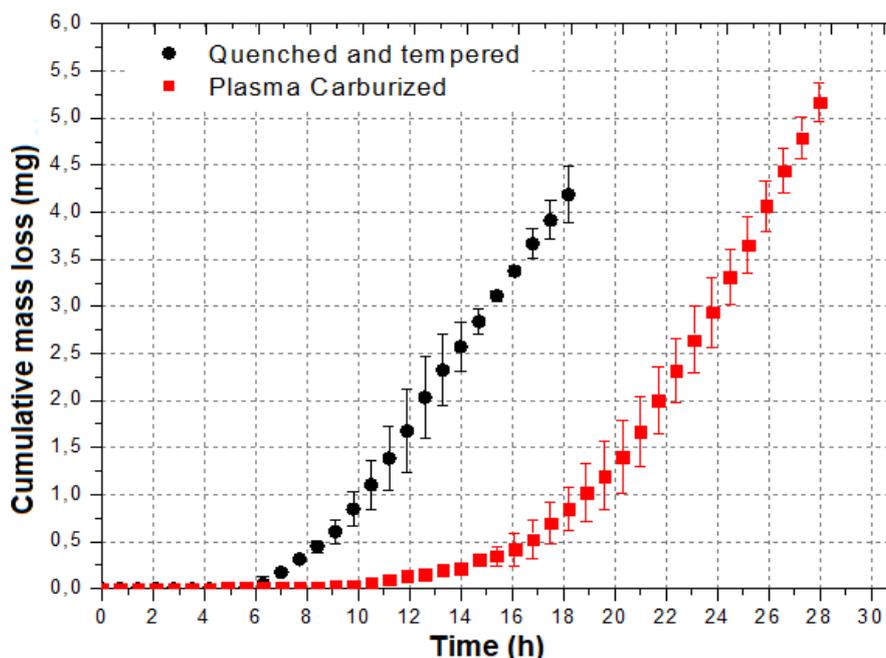
Figure 3. Cumulative mass loss (CML) as a function of the cavitation exposure time for untreated (quenched and tempered) and plasma carburized samples.

Figure 3 presents the cumulative mass loss (CML) as a function of the cavitation erosion testing time for the untreated (quenched and tempered) and plasma carburized samples. It was evidenced that the cavitation erosion resistance of the low-temperature plasma carburized AISI 420 martensitic stainless steel is strongly increased in relation to the untreated material (related to the quenched and tempered reference condition). From Figure 3 it is verified an incubation period around 6.3 h for the quenched and tempered reference condition samples, while the carburized samples show mass loss starting from 11.3 h testing time, which means that the AISI 420 MSS presented an increase of approximately 1.8 times in the cavitation erosion incubation period, after carburizing treatment application. In addition, nominal incubation periods of 7.8, and 17.9 h for the untreated, and carburized samples were observed, respectively. This result is due to the increased surface hardness, promoted by the carburized layer ($\alpha'_c + \text{Fe}_3\text{C}$) formation, which leads to the obtainment of a more resilient surface. The cavitation performance of the carburized samples indicates the very well established correlation between hardness and cavitation erosion resistance for the material, corroborating with Hattori and Ishikura (2010), and Heathcoc et al. (1982) observations, concerning stainless steels.

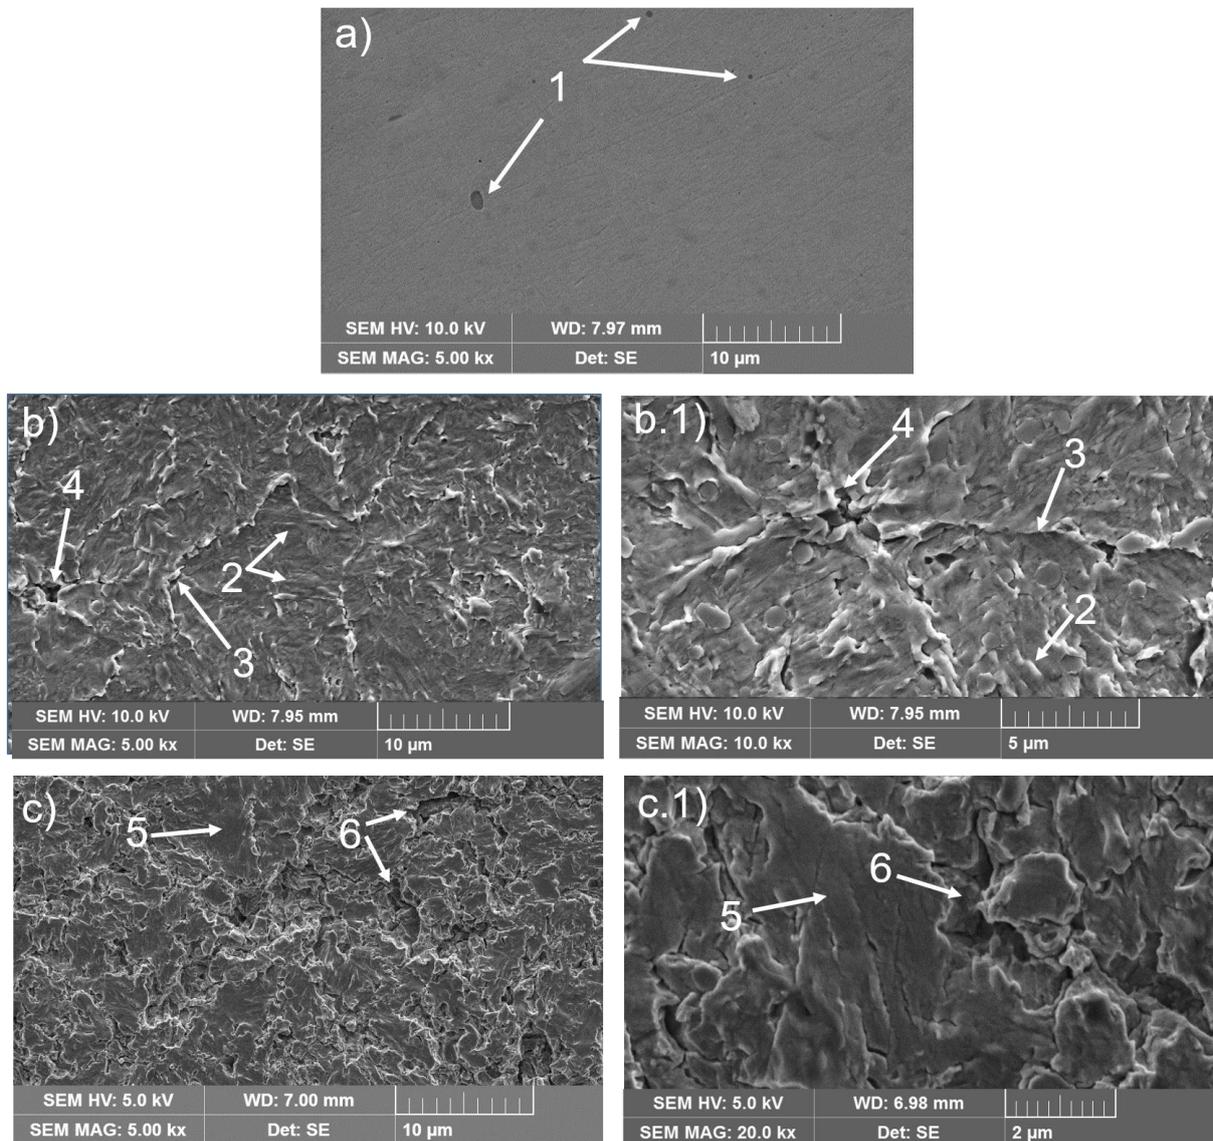
Figure 4. Surface morphology aspect for untreated sample: a) before cavitation erosion test; b) and b.1) after 4 h cavitation testing for two different magnitudes; and c) and c.1) after 9 h cavitation testing for two different magnitudes.

The SEM images of AISI 420 plasma carburized at 350°C presented a rough surface aspect, which is characterized by the presence of island-like particles nucleated at the surface, as it can be seen in Figure 4a ahead. According to Chapman (1980), sputtered atoms from the cathode surface can backscatter in the plasma phase, moving back to the original surface and condensate on the substrate surface.

Figure 4(a; b, b.1; c, c.1) shows the surface morphology aspect for untreated sample before the cavitation erosion testing; after 4 h cavitation testing time for two different magnitudes; and after 9 h cavitation testing time for two different magnitudes. Untreated sample presents an initial smooth aspect (Figure 4a), which is typical for polished surfaces. Pre-existent defects (pores) can be seen in the studied surface (indicated by arrows 1). After 4 h testing time (time interval that is inside the incubation period, which means none or negligible mass-loss), it is verified that the untreated sample (Figure 4b, b.1) presents evidences of plastic deformation, since small undulations (arrows 2) can be observed (probably embossing the original martensite laths). It is supposed that the parent austenite grain boundaries were also revealed (see arrow 3), as a result of material flow, similarly to reported by Espitia et al. (2015), however, the changes on the surface here observed are lesser pronounced than the presented by those authors, as a consequence of the too small ductility demonstrated for the present material, corroborating with its relatively high hardness. This surface aspect occurs because dislocations are created during plastic deformation and dislocation lines cannot begin or end within the crystal, thus new dislocations can be created either innerly to the crystal surfaces, especially at grain boundaries, or in special configurations (Rösler and Harders, 2007). During the incubation period, the non-treated material responds to cavitation by elastic and plastic deformation. After reached the material strength limit, the strain hardened regions become less resistant to stresses generated by cavitation and act as initiation sites of erosion (arrow 4), as shown in Figure 4(b, b.1). This statement is supported by surface morphology after 9 h testing time (Figures 4c, c.1), which appearance suggests the erosion taking place mainly from grain boundaries (arrows 6).

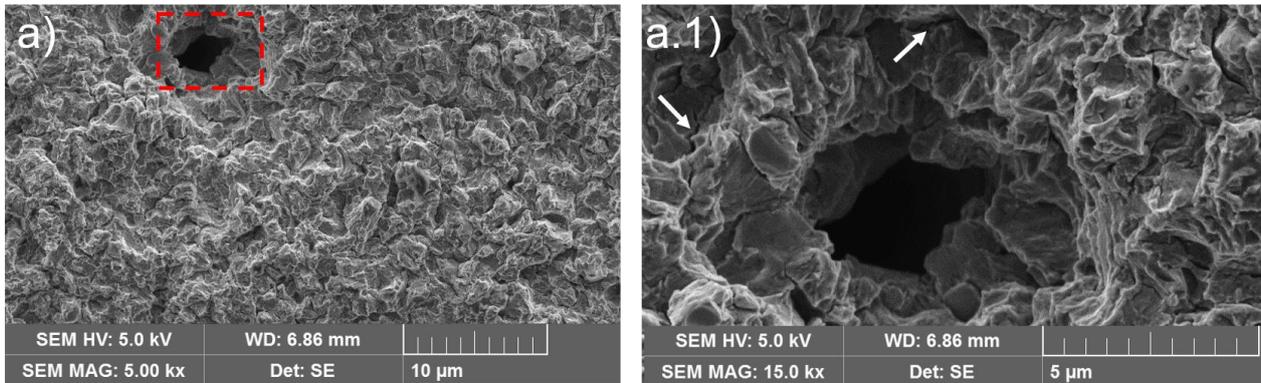
Figure 5. Worn surface for untreated sample after 18 h testing time.

Figure 5 demonstrates the worn surface after 18 h testing time. Figure 5a.1 presents the detail in higher magnitude image from Figure 5a. In Figure 5a.1 it is possible to observe a deep hollow probably previously existent on the material surface before cavitation test (as shown in Figure 4a), that could have been enlarged by cavitation erosion, trough debris cracking in its boundaries. The arrows show that cracks also propagate inside the bulk direction.

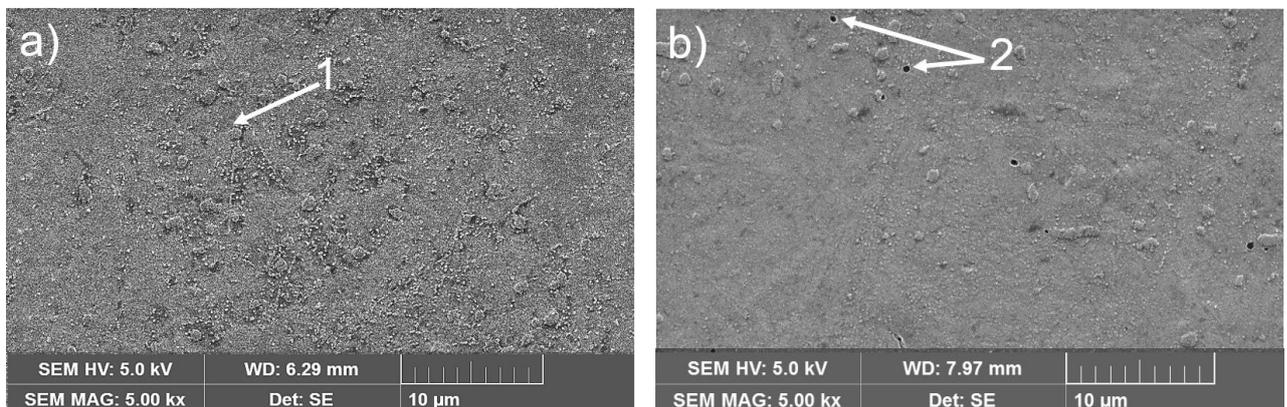
Figure 6. Removal of island-like particles during initial moments of cavitation testing.

Figures 6 and 7 show the wear evolution on the carburized sample surface. Cavitation exposure tends to remove the like-island particles (arrow 1), previously observed to cavitation testing from the surface (Figure 6a). At 1.3 h testing, some residuals particles can be seen (Figure 6b), in addition, some superficial pores (as presented by untreated condition previously to cavitation erosion testing, in Figure 4a) before occult by those particles can be seen. After 4 h testing (Figure 7a), the island-like particles have been totally removed and then the sample presents a surface nearest to smooth aspect. At this time, cavities (arrow 1) and thin shallow cracks connected (arrows 2) or around it (arrow 3) appear. Figure 7a.1 shows in higher magnitude that initial cracks arise from surface defects borders (arrow 2), as well as the first debris formation appears, still in the incubation period. Finally, after 13 h testing (time which the incubation period was exceeded, as shown in Figure 7b), it is possible to verify deeper cracks (arrow 4) on the surface, which ones convert in craters and expand by formation (arrow 5) and detaching of debris. It is to be observed the absence of plastic deformation on the cavitation erosion tested surface, which characterizes the elastic response of the carburized surface when subjected to cavitation generated stresses during the incubation period, being the carbon-rich layer eventually removed by a brittle manner (arising and deepening of cracks and posterior cracks broadening into craters). On the other hand, the increased incubation period presented for this condition suggests the increment in the elastic deformation capacity of the treated surface, which characterizes a more resilient surface.
