COBEM-2019-1477

FRICION HIDRO PILLAR PROCESSING APPLIED TO PLATFORM ANCHOR CHAINS WITH USAGE OF PRE AND POST HEATING

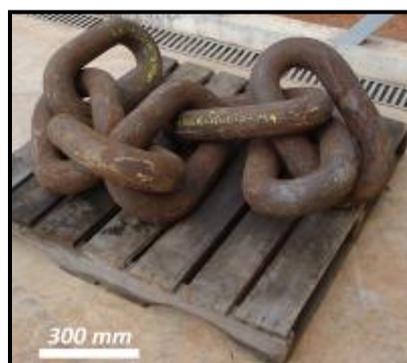
The blocks for carrying out the repair tests were taken from chain links of offshore oil platforms, shown in Fig. 4. The chemical compositions of the repair blocks (chain) and the filler studs are shown in Table 1

Figure 4. Segment of an anchor chain.

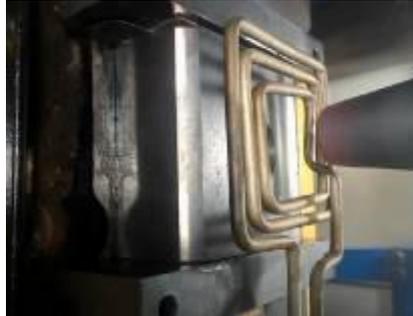
For the preheating tests, an induction heating unit was mounted with a coil that allows the stud to pass through, as shown in Fig. 7.

Figure 7. Repair block fixed on the vise and induction coil that allows the passage of the fill stud through it.
