25th ABCM International Congress of Mechanical Engineering
October 20-25, 2019, Uberlândia, MG, Brazil.

ASPECTS ABOUT THE RCF RAIL DEFECT CLASSIFIED AS SQUAT: A STATE OF THE ART

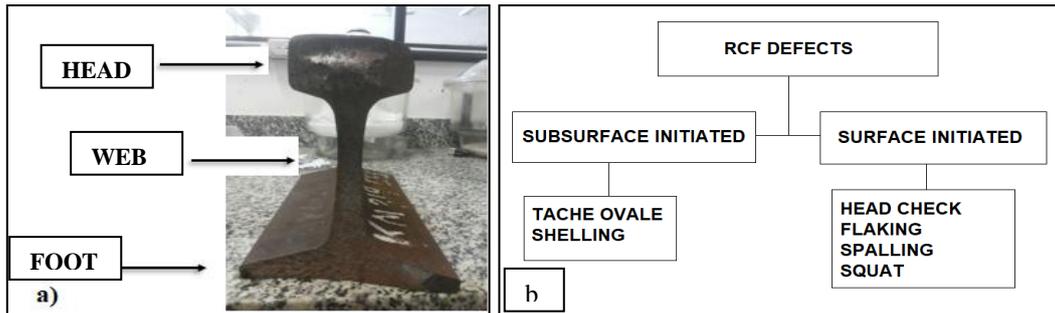
Figure 1. a) Railway rail parts. Source: From the survey. b) RCF defects classification. Source: From the survey.

The head that presents the contact with the wheel, the narrowest region linking the head to the foot, called web, and the foot that is the base of the rail (Figure 1a).

Rail is a structure that often suffers from fatigue. The rolling contact fatigue - RCF is the formation of cracks in the railhead surface, on the repeated rolling / sliding action between two metallic surfaces, in this case, the wheel and the rail (Carrol, 2005). RCF defects can be classified into two categories: subsurface and superficial defects (D173, 1990), as shown in Fig. 1b.

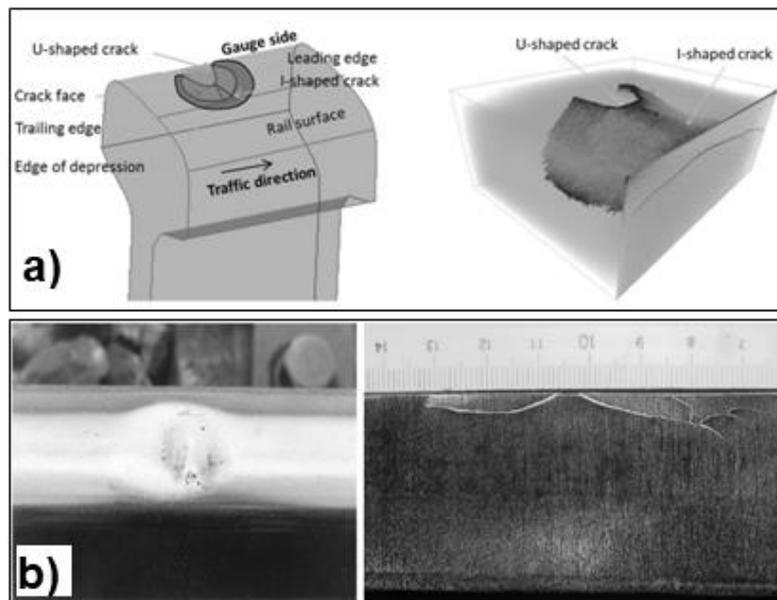
Figure 2. a) Schematic illustration of 3D squat crack and computed tomography. Adapted from Deng et al, 2018. b) Squat in the running surface, sharing the same aspects illustrated in a) and longitudinal cut of the same, showing cracks propagation. Source: Magel, 2011

Squats are defects classified as superficial originated from rolling contact fatigue, or RCF (Steenbergen, 2012; Grassie, 2012). Its aspect is diversified, however in most cases cracks are seen in the region of the rail head. They appear on the running surface as branched (typically V or U) or unbranched cracks (Steenbergen, 2013) and a local darkening (sometimes called dark spot) around the cracks caused by the crushing of the cracked region (Zerbst, 2009). Fig. 2 shows an example of a squat with these characteristics.

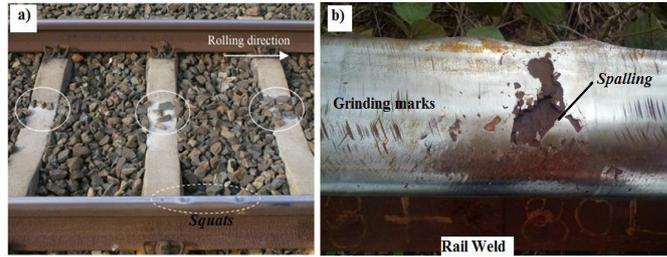
Figure 3 – a) Squats near to sleepers. Adapted from Zhao, 2008. b) Severe Spalling in Aluminothermic (Thermite) weld. Other irregularities can be seen next to the spalling. Source: From the survey.

This defect requires attention for its immediate elimination or, if not, smoothing. Fig.3 shows an example of the drastic nature of the defect.

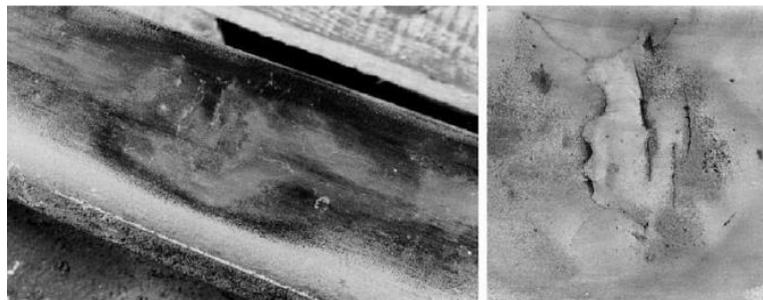
Figure 4. Dark spot and squat cracks on the running surface of the rail. Source: Zerst, 2009

Squats are one of the most frequent defects in international heavy haul railways and low/high speed (Ishida, 2013). The historic report squats since the 1950s on Japanese railways where they were named dark / black cracks due to darkening in the region. Also was called Rail Surface Shelling to differentiate from another defect known as Gauge Corner Shelling. The main difference between the two would be in the place of its origin. The term “Squat” appeared on the railways of the United Kingdom when it was reported (Ishida, 2013). Fig.4 illustrates a typical squat with dark spot presence.

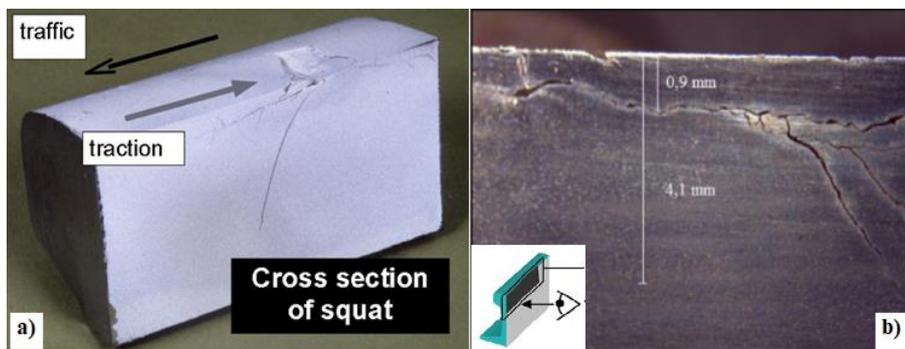
Figure 5. a) Aspect of squat cracks in rail head. Source: Railmeasurement.com. b) Longitudinal section of dark spot illustrating the subsurface propagation and branching of the cracks. Source: From the survey.

There are several causes of squat: Indentations caused by hard objects on wheel/rail boundary, defects caused by wear and plastic deformation, corrugation, etc. Examination of the section of rails containing squats reveals that the cracks generated on the surface grow longitudinally and laterally at an angle between 10° and 30° relative to the running track, and then begin to transverse downward growth, as exemplified in Fig.5a and 5b. Other cracks return to the surface and may form other defects (li, 2009).

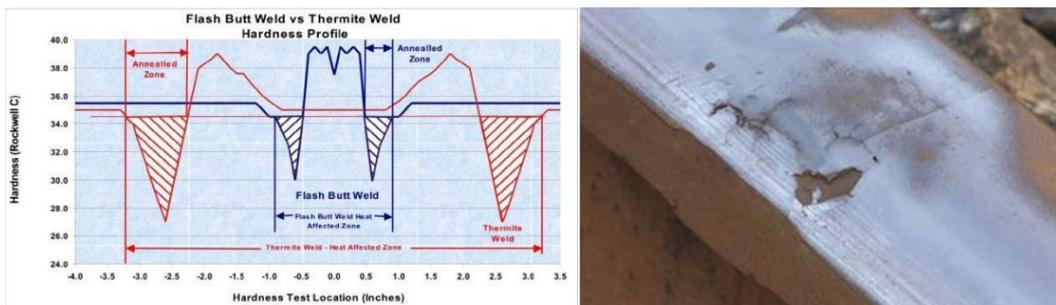
Figure 6 – a) Hardness profile comparison between flash butt and aluminothermic weld. Source: Micenko, 2013.
 b) Squat in aluminothermic weld. Source: Steenbergen, 2008

Welds represent discontinuity along the rail due to the variation of material properties such as strength, hardness and microstructure. Compared with typical aluminothermic (thermite) weld, the flash butt welding tends to produce narrower ZTA, as shown in Fig. 6a. It is important to understand the microstructural evolution and the phase transformation, particularly the spheroidization or divorced eutectoid, leading to the reduction of hardness in the ZTA during the welding process that causes canoamento (dipped weld) and squat defects (Fig. 6b). In addition, welded rails may contain burrs and high level of residual stresses. All these factors contribute to produce localized wheel impact, generating rail fatigue failures (Micenko, 2013).

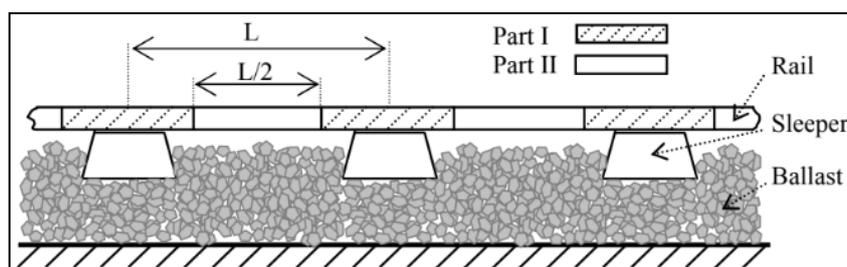
Figure 7- Definição de parte I e II. Fonte: Zhao, 2012.

According to (Zhao, 2012), this defect is more frequent in external rails of curves and on the sleepers. They are also found in tangent and smooth curve tracks (Pal et al, 2013). This is directly related to the wheel-rail dynamics and the stresses involved. In addition, studies carried out on Dutch railways showed the correlation between Squats and the characteristics of the other components of the track. Approximately 75% of registered Squats were found in the rail region over the sleepers. For example, if the analyzed track is divided into two parts, as shown in Fig. 7, about 74% of the squats occur in part I and the remainder in part II. In other words, 74% of the squats were found in the rail region over the sleepers (Li, 2009; Zhao, 2012). It is possible that this preference occurs by pure action / reaction phenomenon between the sleeper and the wheel / rail pair due to the absence of damping in part I well characteristic in part II.

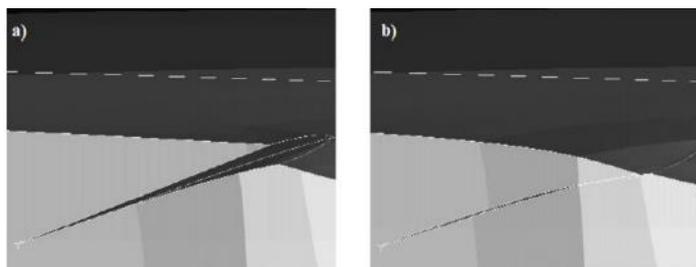
Figure 8. Modeling the crack to determine the volume of fluid trapped under the conditions a) open crack and b) closed crack. Source: Bogdanský, 2008

Bogdanski et al. (2008) investigated the fracture and mechanism of fluid/water entrapment in squat cracks and stress intensity calculations using fracture mechanics. Fig. 8 shows the crack modeling.

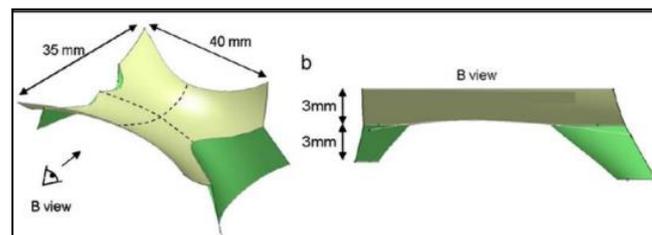
Figure 9. 3D Modeling of the Squat crack plane. Isometric and lateral view. Source: Simon et al, 2012

Simon et al. (2012) presented the tribological characterization of squats considering plastic deformation, microstructure and front of cracks. The defect is modeled three-dimensionally with the "saddle shape", as in Fig. 9.

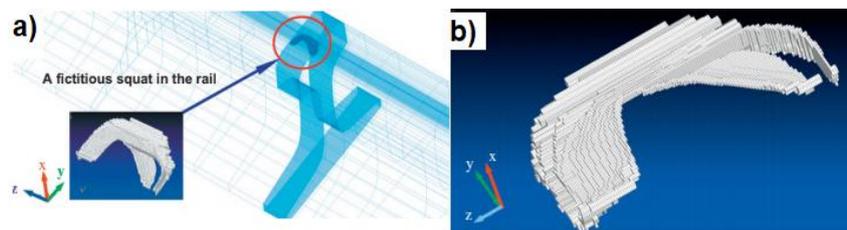
Figure 10. Model by finite elements of a) squat implanted in the rail head and b) three-dimensional aspect of squat cracks. Source: Peng and Jones, 2013

Peng and Jones (2013) presented modeling in Fig. 10, using finite element method (FEM) and non-destructive tests based on thermography to estimate squat size. This thermal evaluation uses infrared camera to detect the thermal waves and then produce the image of the defect. The experimental results showed that the finite element 3D model can be used to determine the squat location and crack depth.

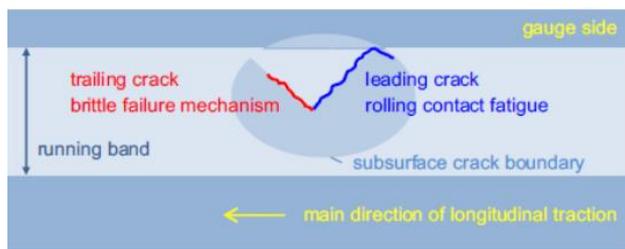
Figure 11. Schematic of the two squat cracks (Leading and Trailing crack) and their propagations. Source: Steenbergen, 2015.

Steenbergen et al (2015) studied the squat formation from RCF that produce the leading crack (Fatigue propagation) and the subsequent development of the trailing crack by brittle failure mechanisms. Fig. 11 shows the schematic of the cracks and the propagation in the rolling and the opposite direction.

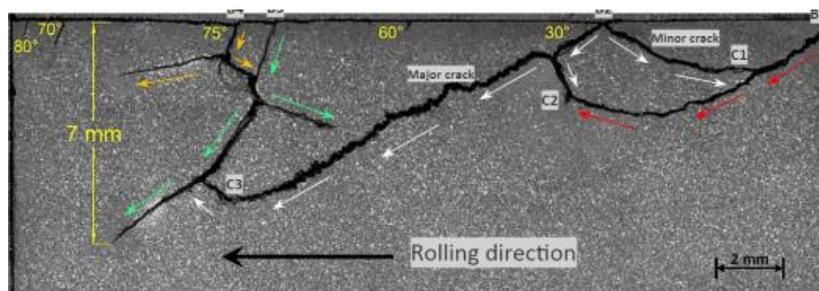
Figure 12. Longitudinal section of squat cracks, influenced by water, indicating 7mm maximum crack depth and crack angle. Source: Al-Juboori, 2019

More recent works such as Al-Juboori et al. (2019) presented an interesting fact that had already been noticed by several authors: The almost nonexistence of squats in tunnels, highlighting in this way the influence of water (mainly from rain) or other contaminating fluid in the degradation of the rail due to squat. The results showed that the rail tracks subjected to water influence showed deeper cracks reaching up to 7 mm deep, providing evidence regarding the theory of fluid entrapment (Fig.12).
