COB-2021-1199
**FEASIBILITY ANALYSIS OF QUANTITATIVE THERMOGRAPHY FOR
FAILURES AND THE LACK OF LUBRICATION DETECTION IN
CYLINDRICAL SPUR GEARS**

Abstract. *Gear failures generally result from contact fatigue caused by cyclical stresses originated by tooth contact. Additionally, the lack of gear lubrication increases the temperature of the arrangement, which may cause gear failure. In this framework, this paper aims to verify the feasibility of using quantitative thermography in its active and passive modes to analyze these anomalies. The experiments were performed in a controlled environment to detect the lack of lubrication and faults in the pinion teeth surfaces of a spur gear transmission. Although thermography detected the lack of lubrication, our data indicate that this technique was not able to detect pinion defects. This work reveals that quantitative thermography is not efficient in identifying small flaws in the teeth surfaces of cylindrical spur gears. Although the temperature gradient associated with the lubricated and non-lubricated pinion was obtained, it was not expressive enough to distinguish the difference between a small flaw and an environmental temperature chan

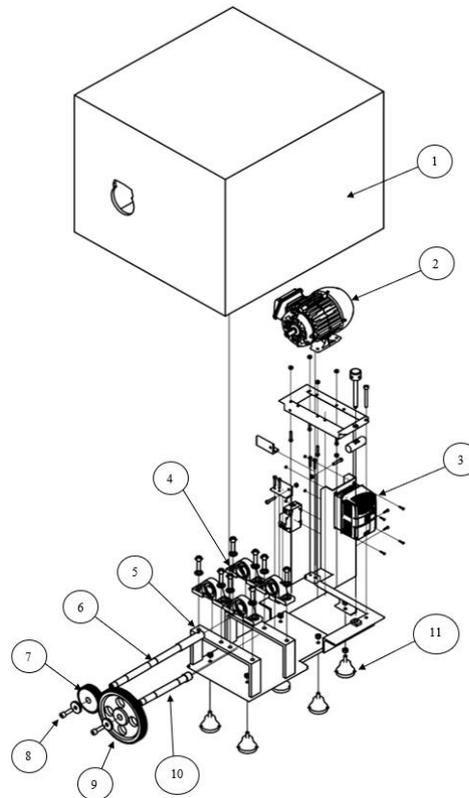
The experimental setup components highlighted in Fig. 1 are:

1. Thermal insulation cabin;
2. WEG W22 engine - 0.5 CV;
3. Frequency inverter WEG - CFW 08;
4. Bearing ($\varnothing = 20$ mm);
5. Bearing support;
6. Pinion shaft;
7. Pinion;
8. Screw and washer to attach the gears;
9. Gear;
10. Gear shaft;
11. Shock absorbers.

Figure 1. Experimental setup.

In order to evaluate the feasibility of thermography to detect gears' anomalies, we reproduced the operation of a pair of cylindrical spur gears, as shown in Fig. 1. The tests were conducted in the Laboratory of Ergonomics and Safety Engineering at the Federal University of Campina Grande (LEEST / UFCG). Some additional experimental data were set

The thermal insulation cabin consists of laminated aluminum sheets with 0.1 mm thickness to reflect the heat from the environment and not interfere with the results. The engine worked at 1200 rpm with a frequency inverter. As support elements, we used the P204 bearing model with self-aligning ball bearings. Also, the shafts and gears are made of SAE 1020 and SAE 1045 steel, respectively. To set the gears, we used hexagonal screws with a nominal diameter of 10 mm, tightened before starting each test to avoid clearances to interfere in the system temperature. Regarding vibration control, we applied rubber dampers at the bench base to mitigate its causes.

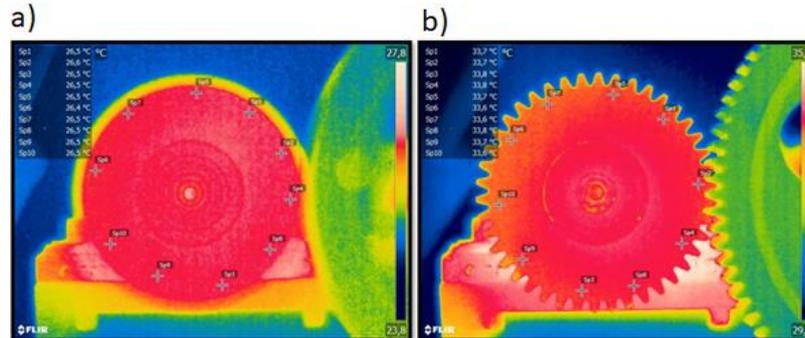
Figure 2. a) Thermograms taken with the operating pinion using active thermography, and (b) Using passive thermography in its cooling state.

In order to perform the experiment, thermograms (photos) were taken at 5 minutes intervals from its stationary condition until the last minute of the gears operation. The total experimental time was 60 minutes, leading to 13 thermograms per experiment. Two quantitative analysis techniques were used in these tests: a) active thermography (60 minutes of the gears operation) and b) passive thermography (60 minutes of the gears cooling) right after the machine stopped, as shown in Fig. 3.

Lower wind speeds are expected for lubricated gears because of the damping properties of the lubricant. In order to acquire the thermograms of the pinion surface, we used a T620 thermal imaging system from Flir Systems with a resolution in the infrared mode of 640x480 pixels, operating in the spectral range of 7.5-14 μm , temperature range from -40 °C to 650 °C, and minimum focal length of 0.25 m. After acquisition, the thermal images were treated using the Flir Tools software to implement the data of relative humidity, reflected temperature, room temperature, and to adjust the position of the temperature measurement points, as shown in Figs. 2 and 3.

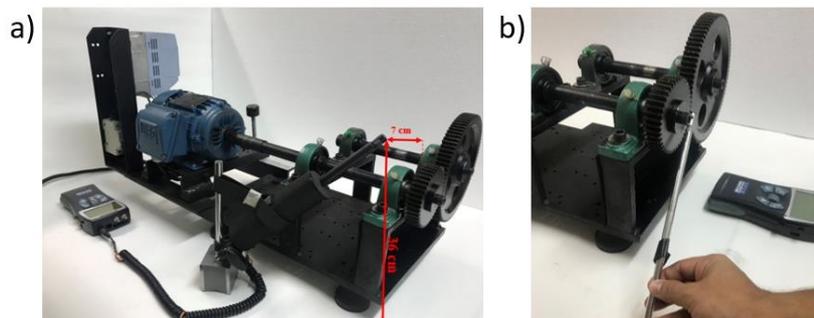
Figure 4. Instruments positioning for (a) room temperature and relative humidity measurement, and (b) wind speed.

For the quantitative thermography evaluation, the following parameters were measured: reflected temperature (T_{ref}), room temperature (T_{room}), relative humidity (RU%), and wind speed (WS). This step was performed by using the AMI 300 probe from Instrutemp, positioned close to the pinion, as shown in Fig. 4.

We positioned the probe as near the pinion as possible to measure the room temperature and relative humidity. Table 2 shows the average values obtained for each test condition.

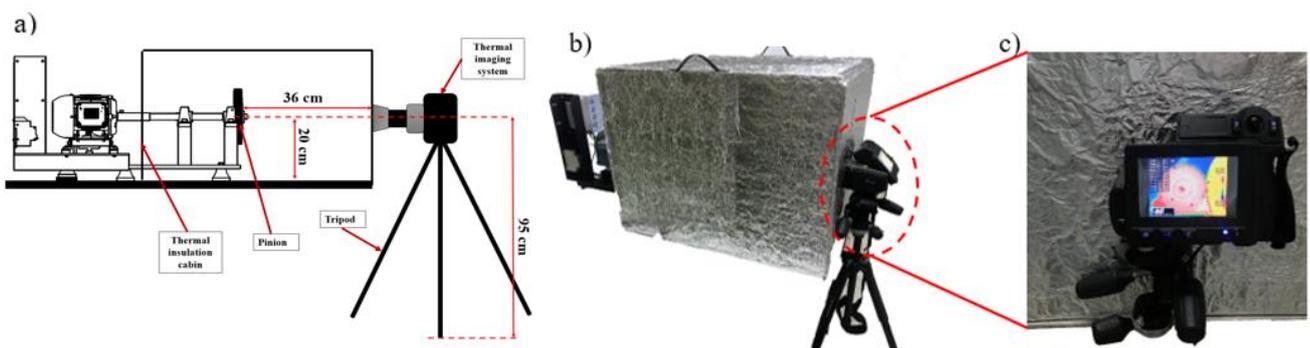
Figure 6. (a) Experimental setup of the thermal imaging system; (b) thermal imaging system position; (c) thermogram of the pinion surface.

The thermal imager was positioned to acquire high quality images. Thermogram generation were performed according to the configuration shown in Fig.6. For the faulty pinions, flaws were introduced as follows: first, the primitive diameter region was defined and then hammering with a flat-tip tool was performed to generate the flaws that structurally approach pittings in five teeth.

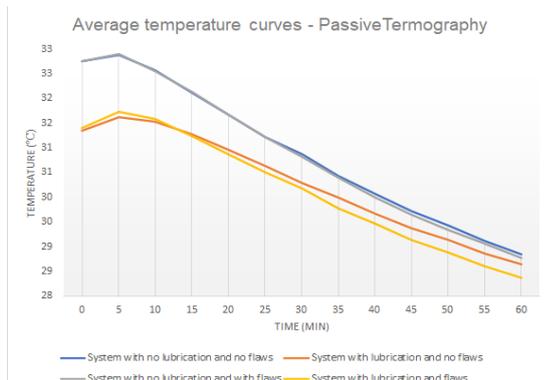
Figure 8. Average temperature curves by passive thermography for the four operating conditions.

For the experiments performed using healthy pinion via passive thermography, the systems with and without lubrication had their temperature stabilized in about 60 minutes, as demonstrated in Tables 6 and 7, and Figs. 8 and 10. For these tests, the temperature averages and the normalized values in the final minutes indicated this equivalence. For the non-lubricated gear, the temperature decreased by 12% and, for the lubricated gear, the temperature decreased by 8%. As with the first experiments by active thermography, in average, the standard deviation for lubricated gears was smaller. In non-lubricated gears, this deviation decreases over time, as shown in Fig. 12.

For all tests carried out by passive thermography, a temperature peak appeared in about 5 minutes of the experiment, as demonstrated in Figs. 8 and 10. This phenomenon is attributed to pinion heat dissipation not being noticeable immediately after the system is stopped. As expected, for the lubricated geared pair, this peak was slightly less expressive as the grease acts as a thermal insulator, promoting an adhesive film of undefined thickness capable to generate greater thermal resistivity than the air. On the other hand, when the geared pair is not lubricated, air is the only fluid acting in heat transfer from the gear.

Similarly to what was observed with healthy pinions, passive thermography experiments with faulty pinions also showed no significant variation in temperature values that could characterize the presence of an anomaly, as may be seen in Tables 10 and 11, and Figs. 8 and 10. The normalized and standard deviation values were analogous to those obtained for the passive tests in lubricated gears with or without flaws, presented in Tables 6 and 7. However, for the non-lubricated geared pair, the behavior of the deviations was homogeneous and 1% lower than the previous condition, as demonstrated in Fig. 12.

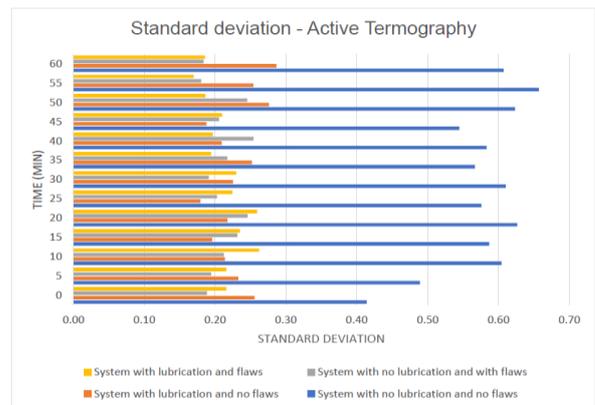
Figure 11. Average standard deviation via active thermography.

Normalized data indicates that a 28% increase in temperature was achieved in systems operated with no lubrication, while with lubricated gears the observed temperature increased by 24% temperature after 60 minutes of continuous operation as shown in Fig. 9. In the operating situation without lubrication, data standard deviation decreased with time, starting at approximately 3% and ending with values below 1%. During operation with lubricated gears, the standard deviation of the gear temperature (for the pinion in its healthy condition), was more homogeneous, remaining at approximately 1% of the average value throughout the experiments as observed in Fig. 11.

Figs. 7 and 10 illustrate the average temperature values that testify the proximity between the final values for experiments with healthy and faulty pinions, using active and passive thermography techniques. Figs. 9 and 10 illustrate this behavior with the normalized data for the same conditions. Figs. 11 and 12 illustrate the standard deviation behavior for tests performed via active and passive thermography, respectively, showing each operating condition of the geared pair.

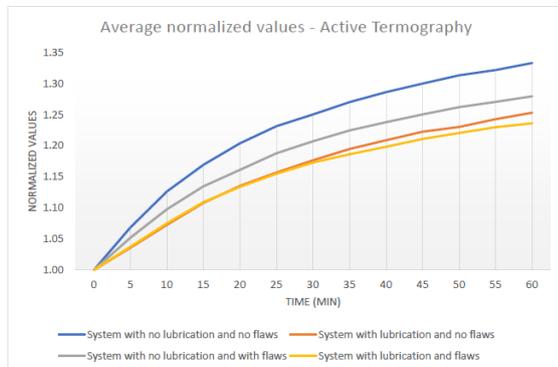
Figure 9. Average normalized values by active thermography for the four operating conditions.

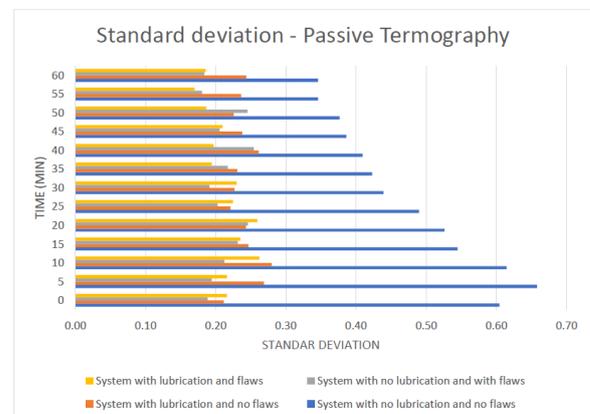
Figure 12. Average standard deviation via passive thermography.

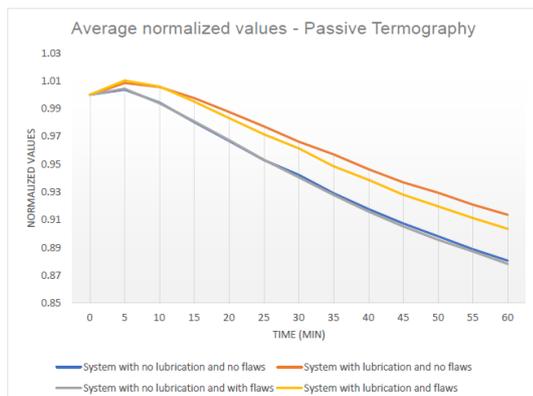
Figure 10. Average normalized values by passive thermography for the four operating conditions.
