Structural Health Monitoring of Thermoplastic Composite Beams via Vibration-based Method

Abstract: The present study aims to investigate the capability of new sensors to detect impact-induced damage in composite beams via VBM (Vibration-based Method). Laminated thermoplastic composite beams made of carbon fiber-reinforced polymer (CFRP) made of unidirectional layers are used as specimens in this investigation. Any deviation in vibrational parameters of beams such as mode shapes, natural frequencies, and more importantly frequency response functions (FRFs) by using damage metrics, before and after impact, will be considered as a criterion to identify damage and structural integrity degradation. Besides experimental procedure, numerical simulation of low-velocity impact and vibrational analyses of composite beams will be performed to evaluate the possible advantages/disadvantages of the computational procedure, as well as the potentialities and limitations of the new sensors to be used in SHM (Structural Health Monitoring) systems.

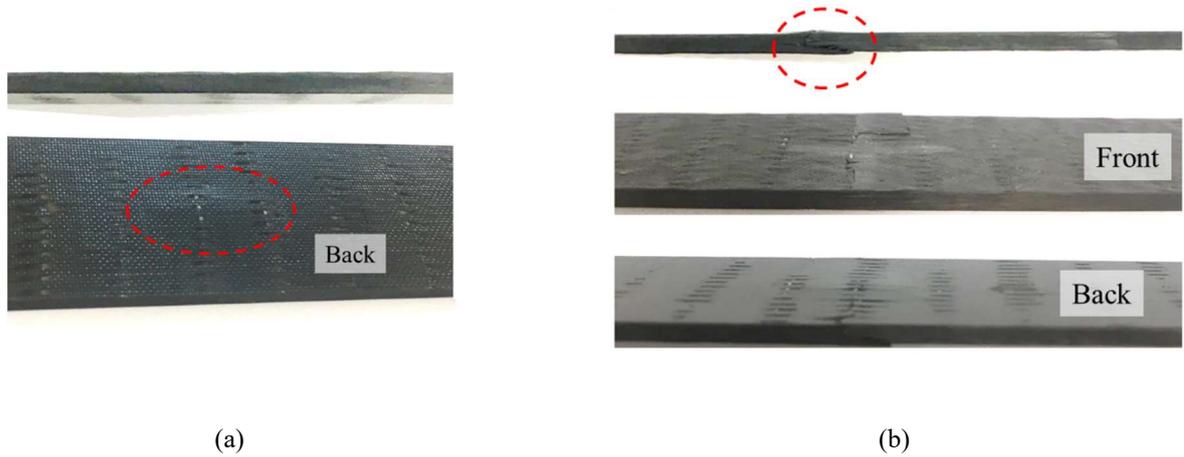
Figure 6 – Visual damage level inspection; (a) Damage level due to the first impact with 3.1J energy, (b) Damage level due to the second impact with 4.34 J energy.

Figure 6 illustrates the damage to the beam after the impact tests. Based on the visual inspection the damage due to impact with the higher energy is more remarkable than the 3.1 J impact energy scenario, however, the invisible damages on the beam after the lower impact energy, like delamination, could be significant. The more reliable NDT test methods like the ultrasound test could be used to detect the damage extent.
