COB2023-2138

EFFECT OF SILICA ADDITION IN THE ADHESIVE PRIMER LAYER OF COMPOSITE SYSTEMS USED TO REPAIR LEAK DEFECTS IN PIPELINES

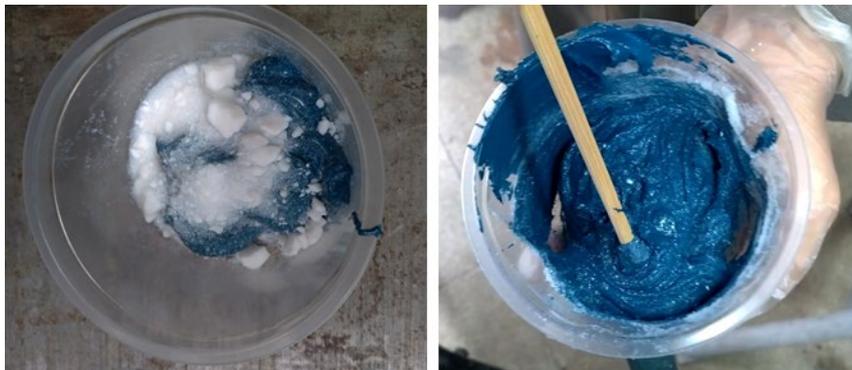
Figure 1. Addition of silica in the adhesive

The adhesive consisted of a two-part epoxy-based adhesive with excellent mechanical and corrosion resistance. The tests have been performed with the addition of pyrogenic silica powder (0%, 1% and 2% by weight. See Fig. 1). 5 Specimens were used for each silica fraction. The technical data about this pyrogenic silica are depicted in table 3.

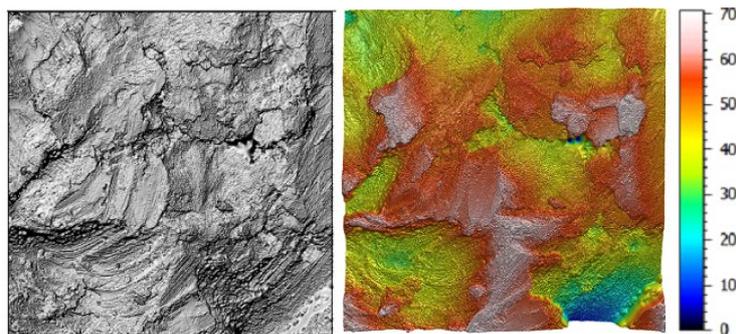
Figure 2. Roughness measurement.

The first step to the preparation of the joints is to guarantee a minimum roughness is obtained on the surface of the metallic substrates, to obtain a proper adhesion between adhesive and substrates. For this matter it was used a shot peening machine with steel grit G40 and a compressed air pressure of 0.45 MPa. Later, the metallic substrates are cleaned with acetone. A Taylor-Hobson CCI-MP non-contact profiler was used to make sure the necessary roughness was obtained, and the results are presented in Figure 2. The parameter R_t (total roughness) was used, following the standard ISO 4288 and the values obtained were between $51.7 \mu\text{m}$ and $70.9 \mu\text{m}$. Next, a base is prepared to maintain the alignment of the joints with holders being placed on the opposite side of the base of the joint to assure the desired adhesive thickness. A thin layer of adhesive is placed in the metallic substrate, then it is positioned in the cast and the composite substrate is carefully positioned over the metallic substrate. Finally, a steel plate closes the cast. Once the single lap joints are finalized, it is given a one-week period to make sure the adhesive is fully cured before the beginning of the tests.

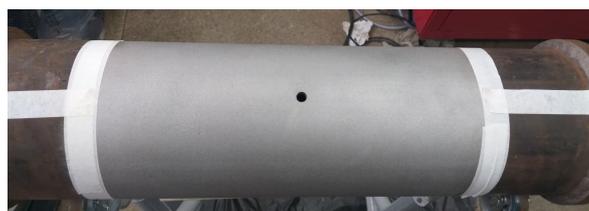
Figure 3. Pipe specimen after surface preparation.

The external pipe wall surface was prepared using a bristle blaster tool for systems 1 and 2 and shot peening for repair system 3. Fig. 3 shows an example of a pipe specimen after the surface preparation process. Figs. 4 and 5 show, respectively, the application of adhesive layer and the application of the composite repair. All tests (tensile tests in lap joints and hydrostatic tests) were performed one week after the specimens' fabrication.

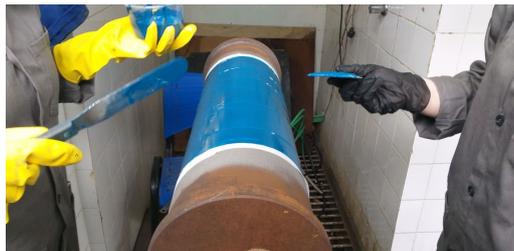
Fig. 4. Application of adhesive layer.

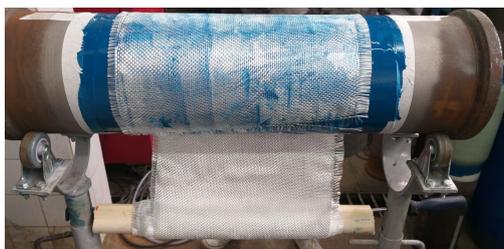
Fig. 5. Composite repair application.

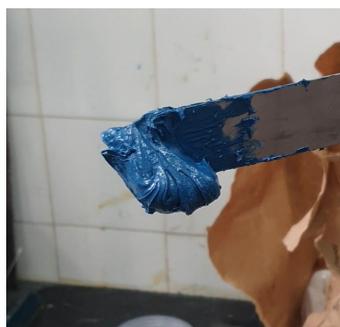
Figure 6. Adhesive after the mixture with the thickener.

The addition of silica changes a lot the behaviour of the adhesive as it can be seen if Fig. 6.
