**COB-2023-0301**

## **STRUCTURAL HEALTH MONITORING OF A FIXED STRUCTURE BASED ON THE ULTRASONIC TECHNIQUE**

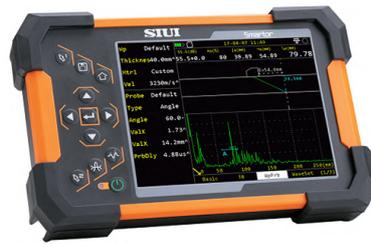
Figure 3. SIUI Smarlor Flaw Detector & Thickness Gauge.

The *A – scan* signals were obtained using the SIUI conventional ultrasound equipment, Fig. 3. Before the first cut, baseline measurements were taken for all transducers. Subsequently, measurements were performed after each subsequent cut. A predefined gain value was applied to each transducer during the baseline measurement, which remained constant for all following measurements. By maintaining this consistent gain setting, the variation in signal amplitude, indicative of material damage, could be evaluated after each cut. Higher signal amplitudes indicated the grater region where the ultrasonic sound beam would reflect, thus facilitating the identification of damage growth in the material while keeping the transducer position fixed.

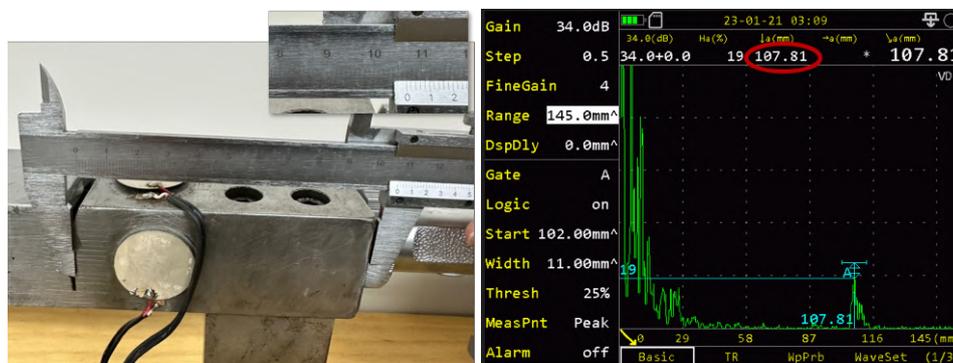
Figure 5. Signal position of transducer 0°

The 0° transducer was positioned at the end of the steel beam, approximately 107 mm away from the cut, as shown in Fig. 5(a). According to the measurements taken, an ultrasonic signal was detected at the same position as the transducer, as illustrated in Fig. 5(b).

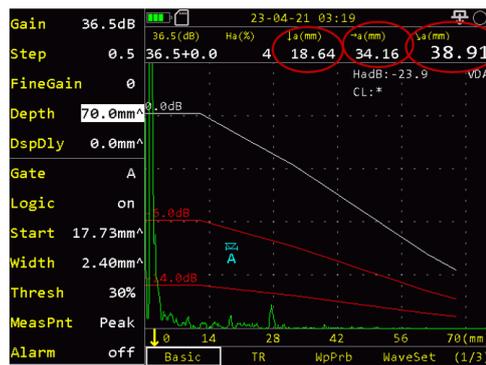
(a) Position of transducer 60°.

(b) Signal indication for transducer 60°.

Figure 10. Signal position of transducer 60°.

The 60° transducer was positioned so that the ultrasonic sound beam intersected the central region of the cut, as depicted in Fig. 10(a). The accuracy of this position is evident as given by Fig. 10(b), which displays the signal obtained by the ultrasound equipment.
